## AC Inspection as Found

Draslovka  
2571 Fite Road  
Millington, TN 38057

### AC Inspection - Rev. 2

Description: 250 Hp Allis Chalmers

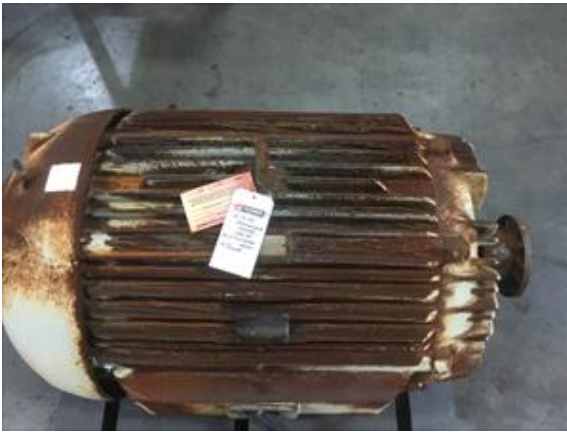
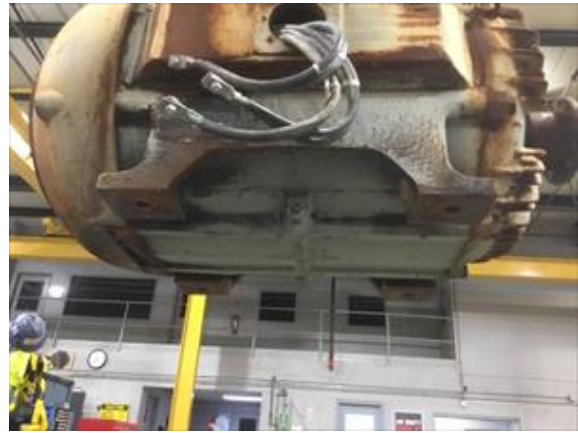
4.	Describe the Overall Condition of the Equipment as Received		
	<i>Good</i>		
5.	Distance from the end of the shaft to the Coupling/Sheave	0 inches	
6.	Report Date [COPY]		
Initial Mechanical/Electrical			<input type="checkbox"/>
7.	Does Shaft Turn Freely?	(Y) Yes	
8.	Does the shaft require T.I.R in Lathe to identify additional repairs?	(No) No	
9.	Does Shaft Have Visible Damage?	(No) No	
10.	Assembled Shaft Runout	0.002 Inches	
11.	Assembled Shaft End Play	0.002 inches	
12.	Air Gap Variation <10%		
13.	Lead Condition	(P) Pass	
14.	Lead Length	25 Inches	
15.	Does it have Lugs?, If so what is the Stud Size?	(Yes) Yes	
	3/8		
16.	Lead Numbers	t1-t3	
17.	Frame Condition	good	
18.	Fan Condition	(F) Fail	P18

19. Broken or Missing Components fan

46.	Growler Test	(Pass) Pass
47.	Number of Rotor Bars	50
48.	Rotor Condition	good
49.	List the Parts needed for the Repair Below 2-6315 bearings 1-aluminum fan

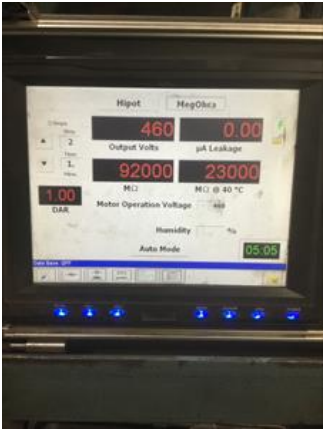
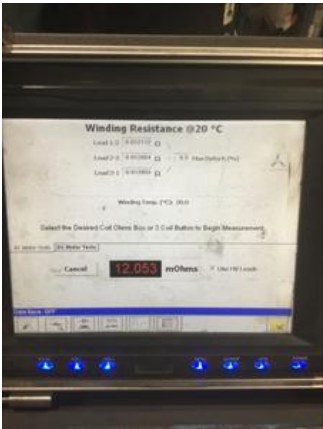
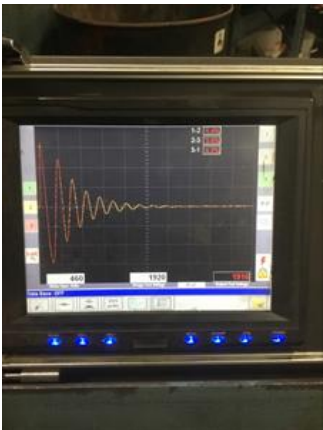
### Initial Electrical Inspection

1-2

1-3

2-3
