**AC Inspection as Found**  
**Nucor-Yamato Steel Co. (0000418)**  
5929 Highway 18 E.  
Armored, AR 72310

**AC Inspection - Rev. 2**

Description: 15 HP

Manufacturer: P&H

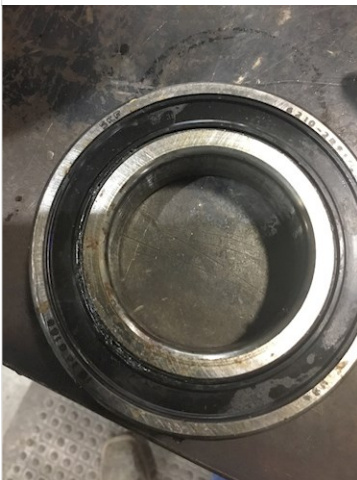
P29

## 26. Drive End Bearing Brand

SKF

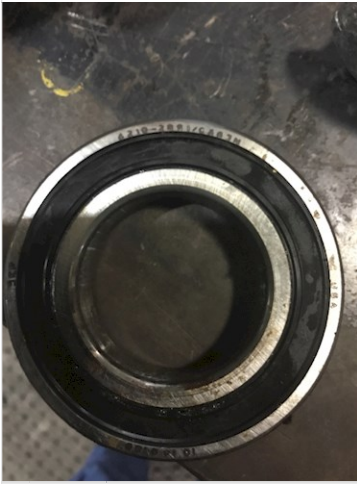
28. Drive End Bearing Qty.	1
29. Drive End Bearing Type	(Ball) Ball Bearing
30. Drive End Lubrication Type	(Grease) Grease Lubricated
31. Drive End Bearing Insulation or Grounding Device?	none present
32. Drive End Wavy Washer/Snap-Ring Other Retention Device?	none present
33. Drive End Bearing Condition

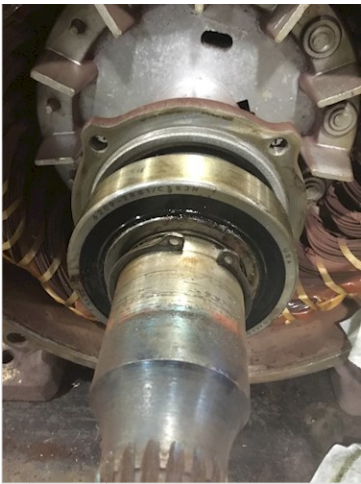
P38

34. Opposite Drive End Bearing Brand	SKF
35. Opposite Drive End Bearing Number-	62092RSC3

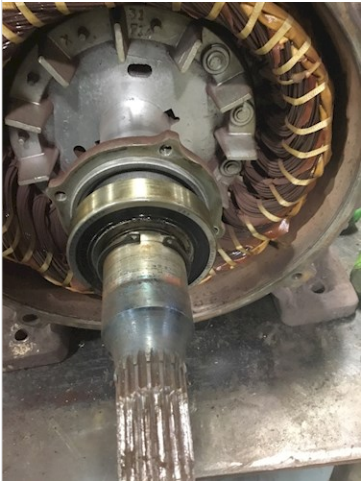
36. Opposite Drive End Bearing Qty.	1	
37. Opposite Drive End Bearing Type	(Ball) Ball Bearing	
38. Opposite Drive End Lubrication Type	(Grease) Grease Lubricated	
39. Opposite Drive End Bearing Insulation or Grounding Device?	none present	
40. Opposite Drive End Wavy Washer/Snap-Ring Other Retention Device?	snap ring	P43
