## AC Inspection as Found

US Zinc

### AC Inspection - Rev. 2

Serial Number: 20121634

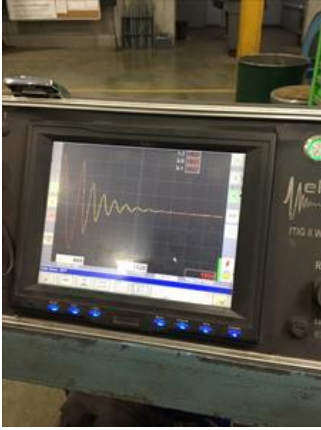
21. Number of Stator Slots	48
22. Stator Condition	acceptable
23. Stator Thermistors/Ohms	none
24. Stator Overloads/Ohms	none

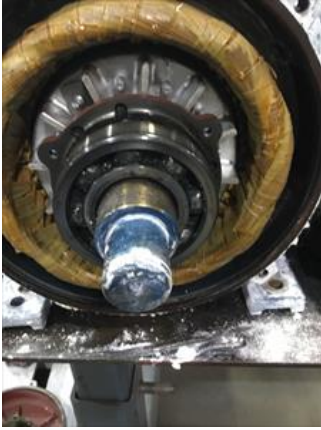
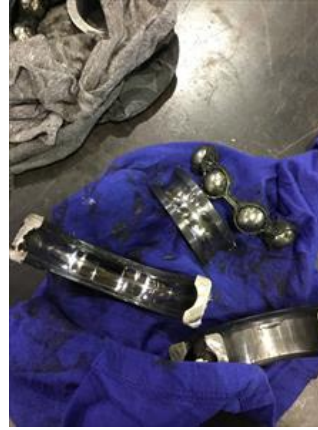
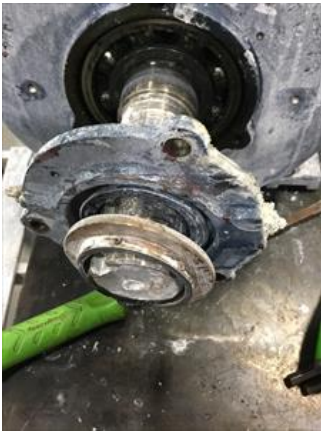
33. Opposite Drive End Bearing Brand	C&U
34. Opposite Drive End Bearing Number-	6312 ZZ C3
35. Opposite Drive End Bearing Qty.	1
36. Opposite Drive End Bearing Type	(Ball) Ball Bearing
37. Opposite Drive End Lubrication Type	(Grease) Grease Lubricated
38. Opposite Drive End Bearing Insulation or Grounding Device?	none
39. Opposite Drive End Wavy Washer/Snap-Ring Other Retention Device?	snap ring
