AC Inspection as Found

UNITED SOLUTIONS
1052 INDUSTRIAL PARK RD
SARDIS, MS 38666

AC Inspection - Rev. 2

Hi-Speed Job Number:	152050
Manufacturer:	US Motors/Nidec
Serial Number:	R087441476-0002M0001
HP/kW:	25 (HP)
RPM:	2905 (RPM)
Frame:	256JM
Voltage:	460
Current:	29 (Amps)
Phase:	Three
Hz:	60 (Hz)
Service Factor:	1.15
Enclosure:	DP
# of Leads:	12
J-box Included:	Half
Coupling/Sheave:	None
Date Received:	02/20/2024
Bearing RTDs:	No
Stator RTDs:	No
Repair Stage:	Teardown Inspection
Rewind:	No
Shaft Machined Fit Repairs Required:	Yes
Bearing Housing Machined Fit Repairs Required:	No
Bearing Type:	Rolling Element

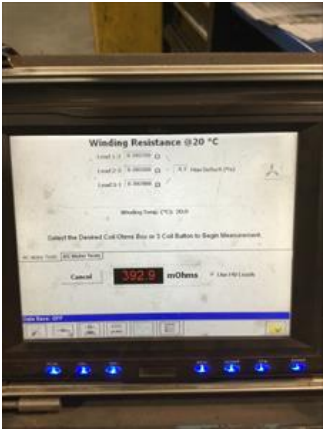
9.	Assembled Shaft End Play	inches
	Unable to record	
10.	Air Gap Variation <10%	good
11.	Lead Condition	(P) Pass
12.	Lead Length	14 Inches
13.	Does it have Lugs?, If so what is the Stud Size?	(No) No
14.	Lead Numbers	1 thru 12
15.	Frame Condition	good
16.	Fan Condition	(N) NA
17.	Heater Quantity, Ratings	
	Quantity	Volts/Watts
		Pass/Fail
	N/a	
18.	Broken or Missing Components	none
Initial Electrical Inspection		
19.	Insulation Resistance/Megger	392 Megohms

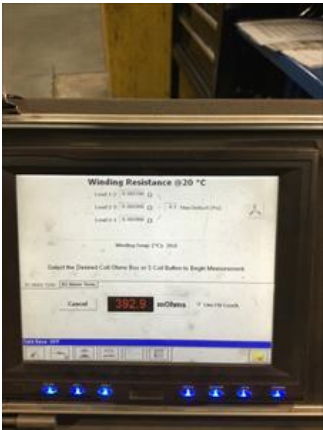
20.	Winding Resistance	
	1-2	1-3
	.0393700	.383300
		2-3
		.392900

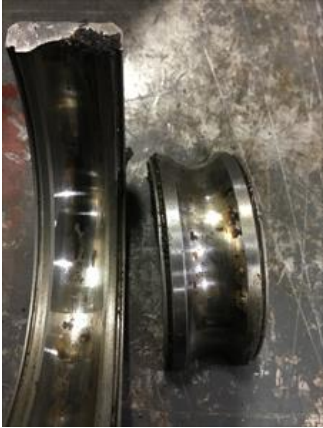
4. Describe the Overall Condition of the Equipment as Received
*Electrical good.
Bearing failure.*

26. Drive End Bearing Brand	peer	
27. Drive End Bearing Number-	6310	
28. Drive End Bearing Qty.	1	
29. Drive End Bearing Type	(Ball) Ball Bearing	
30. Drive End Lubrication Type	(Grease) Grease Lubricated	
31. Drive End Bearing Insulation or Grounding Device?	none	
32. Drive End Wavy Washer/Snap-Ring Other Retention Device?	none

67. Failure locations		
D/e bearing		
68. Root cause of failure		P68
Excessive dirt.		
Not a complete bearing shield
