Hi-Speed Industrial Service
7030 Ryburn Dr
Millington, Tn 38053
901-873-5300

AC Inspection as Found

KTG USA
400 Mahannah
Memphis, TN 38107

Description: 125 HP AC

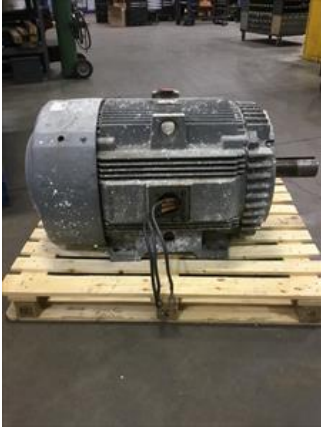
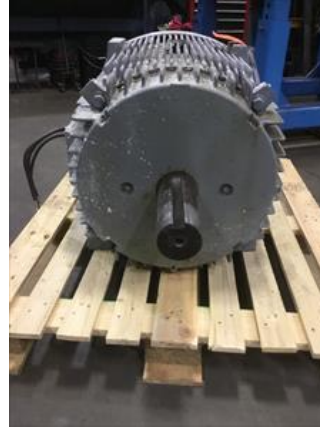
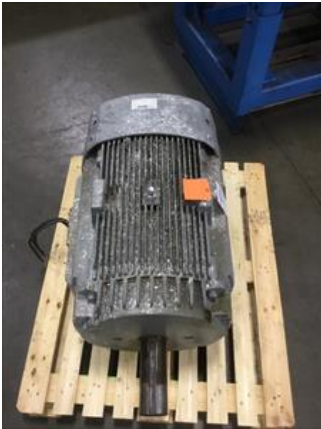
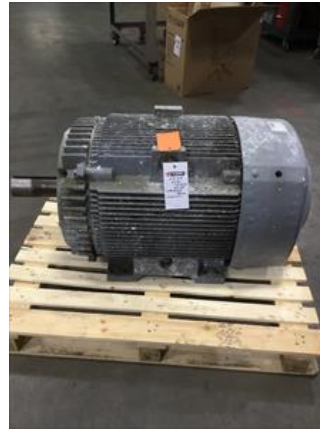
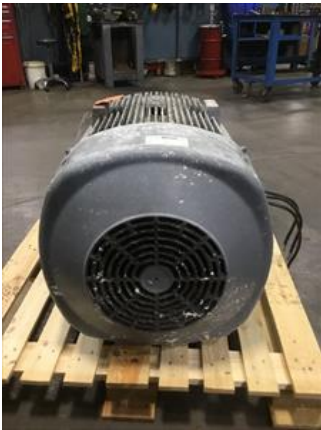
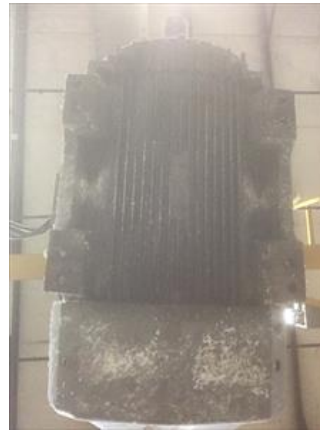
Good condition. Drive end bearing spun on shaft and shaft requires repair. Passed all electrical tests. Drive end bearing was electric fluted. Recommend adding AEGIS ring and insulated bearing.

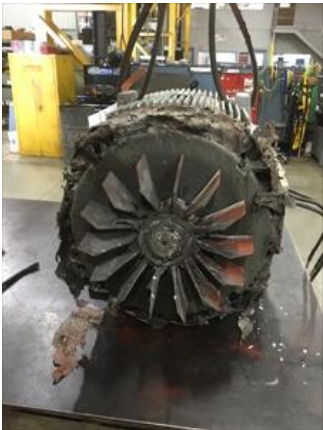
14. Lead Numbers	None	
15. Frame Condition	Pass	
16. Fan Condition	(F) Fail	P16
<div>Cracked and needs replaced</div>

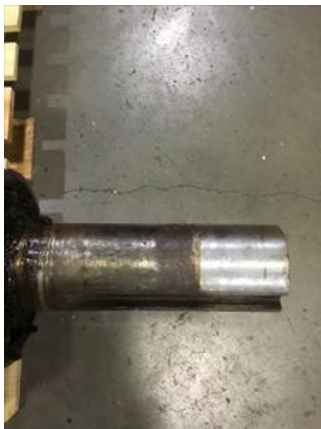
P51

Tolerance is 3.5434-3.5440
Bearing pulled of shaft. Requires repair.

54. Drive End Bearing Shaft Fit Condition (F) Fail

Repair drive end shaft bearing fit. Normal turn and metalizing.
