# LR Field Services

Prepared for Bridgestone Americas Tube (10108-FTD)

## DC Motor Maintenance Inspection Form

1. Job Number	103074
2. Customer	Firestone
3. Report Date	07/02/2024
4. Machine	Banbury
5. Manufacturer	GE

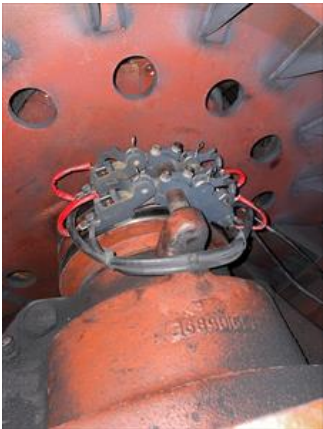
### 21. Motor Evaluation

*One brush was down to the point that the hammer wouldn't let it go down any further. Rotor has 2 megaohms because of carbon buildup and is very humid down in the pit. Rings need turned and brush rack needs fixed when the motor is pulled from service for recondition.*

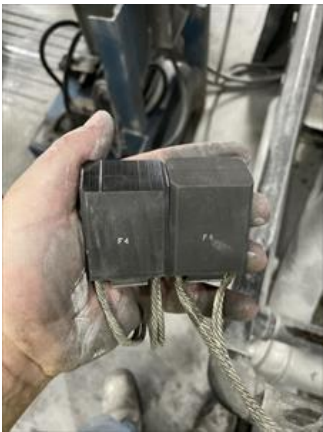
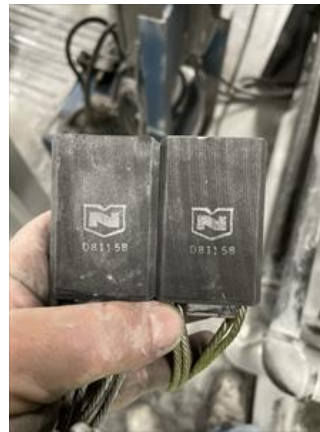
16. Remaining Brush Length

Brushes are in new shape.

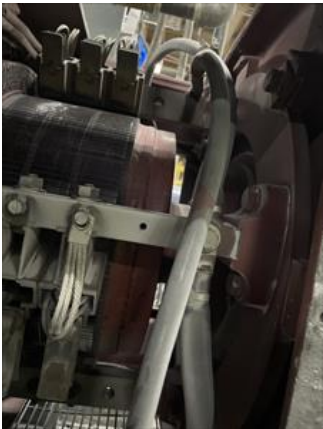
18. Brush Holder Condition

(P) Pass

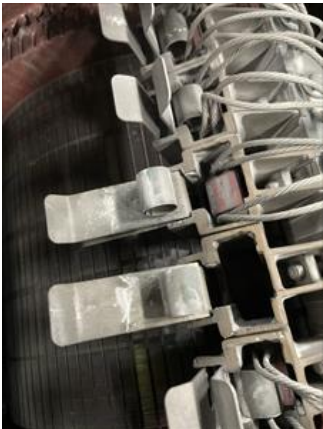
20. Commutator Condition

Commutator is grooved. Has a good carbon film.

*Motor needed brushes changed so I changed them. Commutator needs turned and undercut when motor is pulled for service. I smoothed out commutator as best as I could with two stones. Coupling needs to be moved back about a quarter inch so it isn't so close to gearbox coupling.*
