Harlow's
Casino Resort & Spa

2024 Infrared Electrical Survey Report

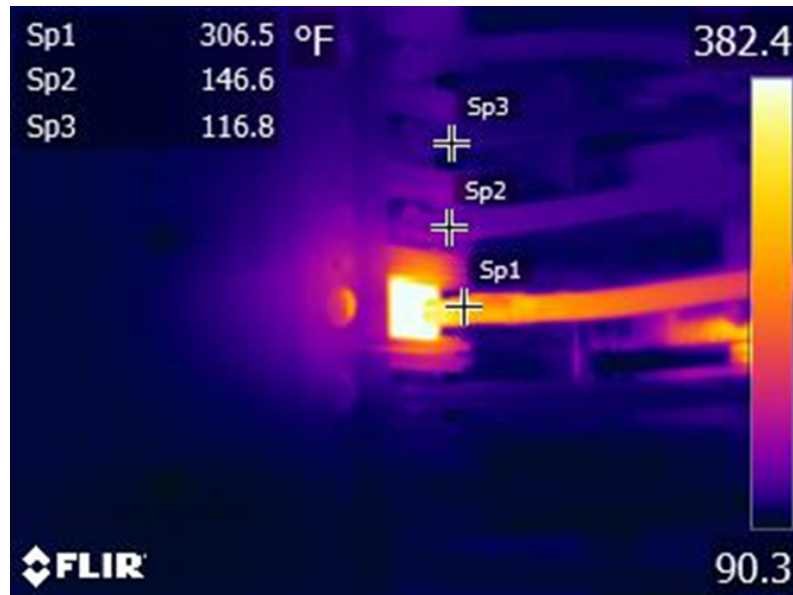
Surv Electrical Room Panel HBOH1 Breaker lead 35

Breaker lug connection

Lead 35 likely has an issue with the lug connection according to the IR image. Image shows heat to be on the lug which may indicate internal connection issue with the lug. Inspect breaker lug and lead ensuring a clean tight connection. Breaker may need to be replaced.
