★ *SOUTHLAND CASINO HOTEL* ★

West Memphis, AR
2024 Infrared Survey Report

October 9, 2024

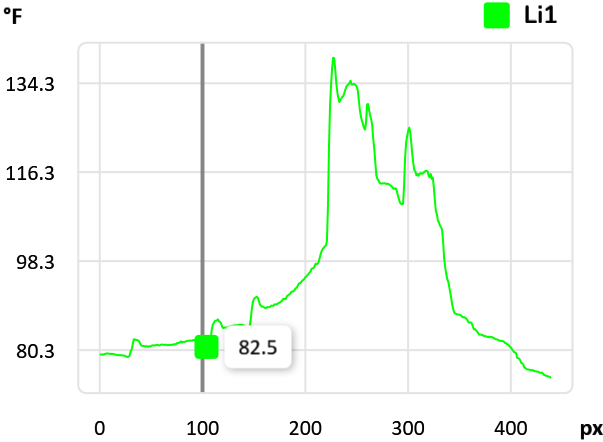
Breaker circuit 44

Li1	
Max	139.5 °F
Avg	94.0 °F
Min	74.7 °F
Sp1	133.7 °F
Sp2	93.9 °F

Overloaded circuit

CLASS II

IR image shows heat on breaker 44. Amps were checked and found to have 22 amps on 20 amp breaker. Wire size will allow for 30 amp breaker. It is recommended to swap out breaker to 30 amp breaker if possible.

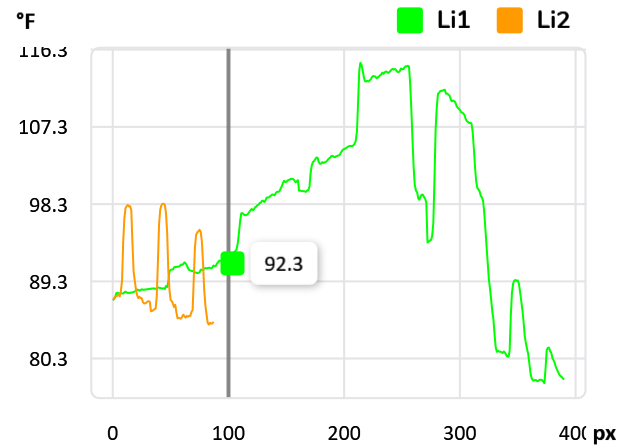
Breaker circuit 51-55

Li1	
Max	114.8 °F
Avg	96.7 °F
Min	77.5 °F
Li2	
Max	98.4 °F
Avg	89.4 °F
Min	84.3 °F
Sp1	120.6 °F

Faulty breaker

CLASS II

IR image shows delta-T on 3 phase breaker 51-55. Amp reading was performed and circuits appeared to have no load. Breaker may have internal faults. Plans should be made to inspect/change breaker as scheduling allows.

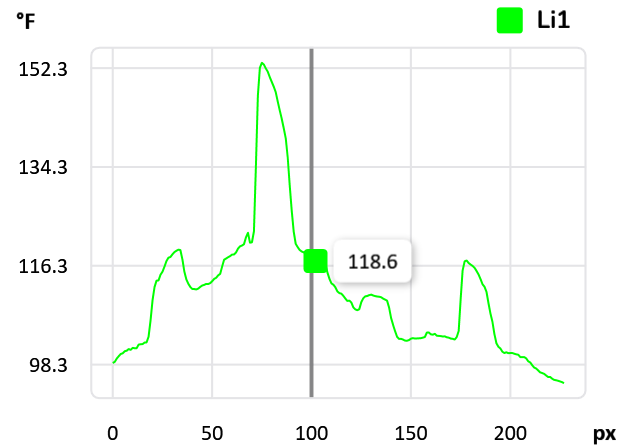
Breaker circuit 71

Li1	
Max	153.3 °F
Avg	111.8 °F
Min	95.0 °F
Sp1	140.9 °F

Overloaded circuit

CLASS II

Breaker 71 has high delta-T. Connections was found to be tight. Amps were checked and circuit is overloaded. Breaker had 22 amps an 20 amp breaker. Upsize breaker to 30 amps if applicable.

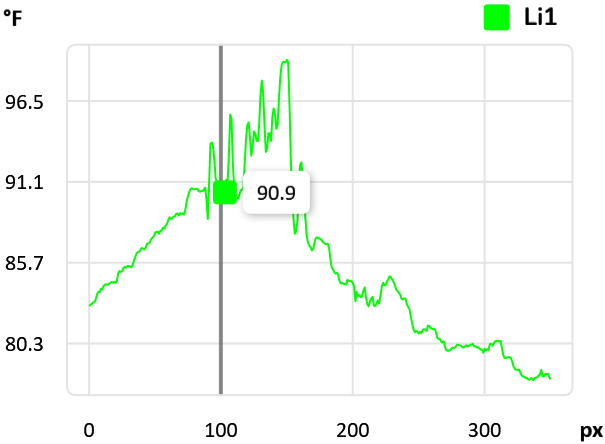
2N/VA

Li1	
Max	99.3 °F
Avg	85.6 °F
Min	77.9 °F
Sp1	95.0 °F

Connection/lug issue

Image shows characteristics of a loose connection. Ensure connection is clean and tight. Ensure lug is not loose internally.
