AC Inspection as Found

AC Inspection - Rev. 2

Description: ROOTS BLOWER

Hi-Speed Job Number: 103920

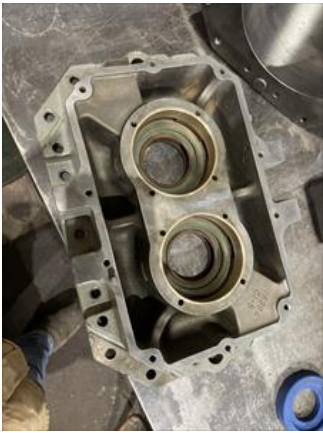
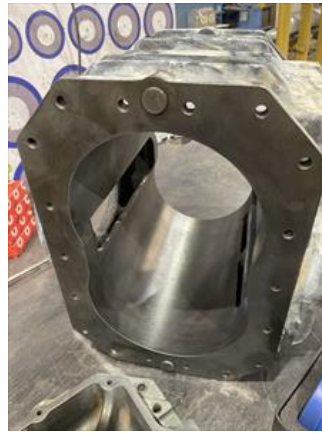
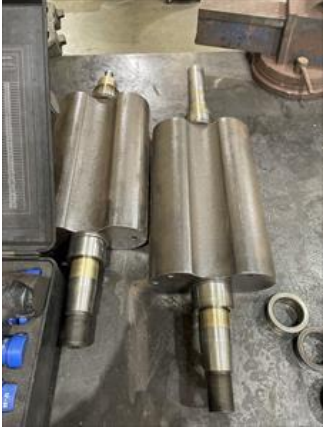
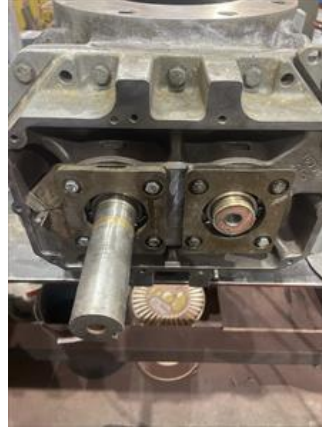
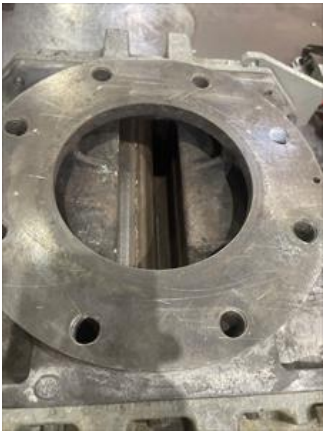
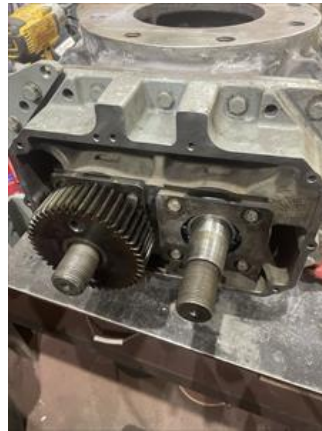
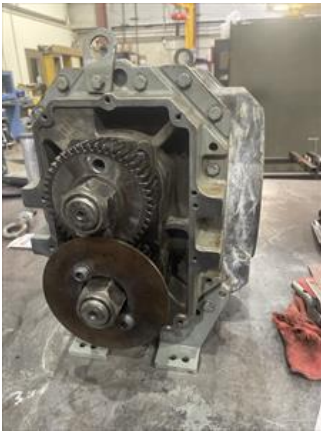
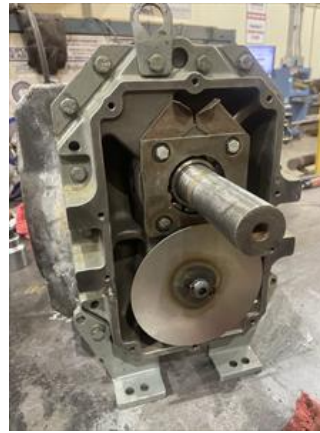
74.	Bearing Cap Condition Post Repair			
	Drive End Bearing Cap	Opposite Drive End Bearing Cap		
75.	End Bell Air Seal Fits Post Repair			
	Drive End Air Seal	Opposite Drive End Air Seal		
76.	End Bell Repair Sign-off			Gary
Assembly				
77.	QC Check All Parts for Cleanliness Prior to Assembly			
78.	Photograph All Major Components prior to assembly			P17

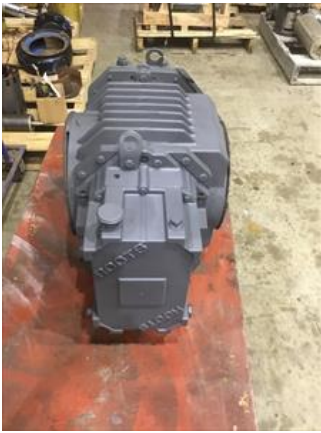
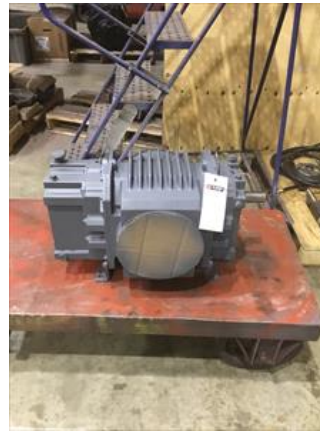
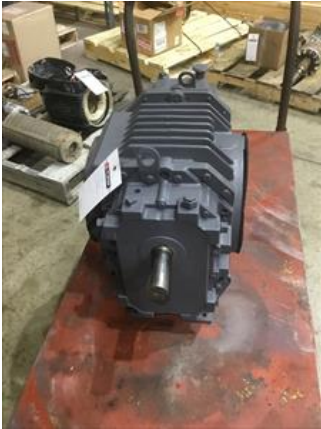
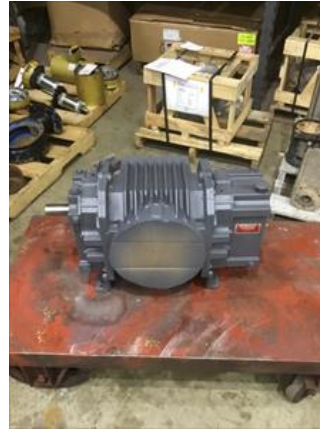
79.	Final Insulation Resistance Test	Megohms		
80.	Assembled Shaft Endplay	inches		
81.	Assembled Shaft Runout	inches		
82.	Test Run Voltage			
	Volts	Volts	Volts	
83.	Test Run Amperage			
	Amps	Amps	Amps	
84.	Drive End Vibration Readings - Inches Per Second			
	Horizontal	Vertical	Axial	
85.	Opposite Drive End Vibration Readings - Inches Per Second			
	Horizontal	Vertical	Axial	
86.	Ambient Temperature - Fahrenheit			
87.	Drive End Bearing Temps - Fahrenheit			
	5 Minutes	10 Minutes	15 Minutes	
88.	Opposite Drive End Bearing Temps - Fahrenheit			
	5 Minutes	10 Minutes	15 Minutes	
89.	Stator Temperatures- Fahrenheit			
	5 Minutes	10 Minutes	15 Minutes	
90.	Document Final Condition with Pictures after paint
