## AC Inspection as Found

### AC Inspection - Rev. 2

Location: LR MOTORSHOP  
Serial Number: 1PC31042AA600FB4  
Description: 45.0 KW SIEMENS

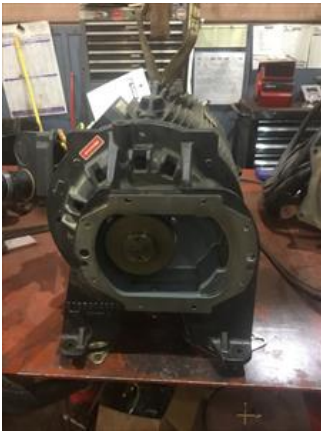
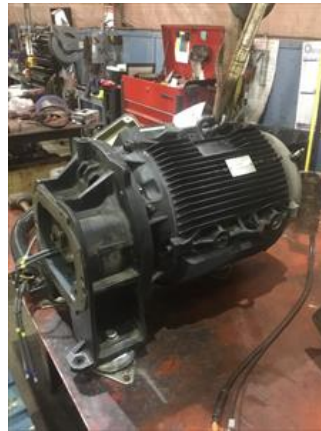
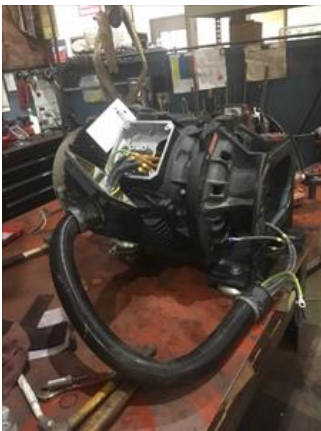
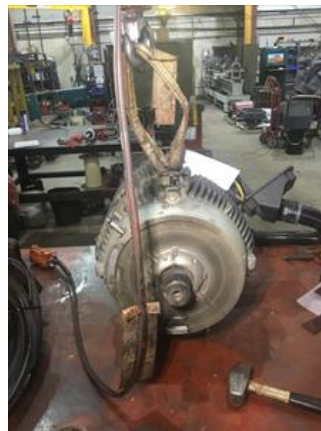
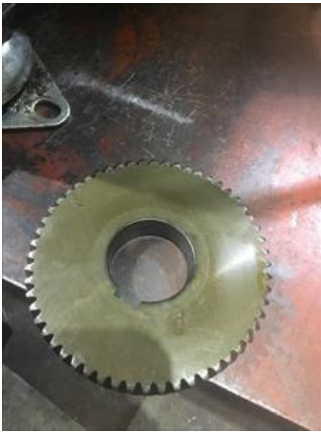
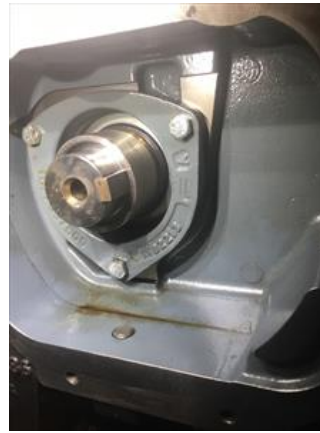
## 3. Photos of all six sides of the machine.

4. Describe the Overall Condition of the Equipment as Received  
*Serviceable*

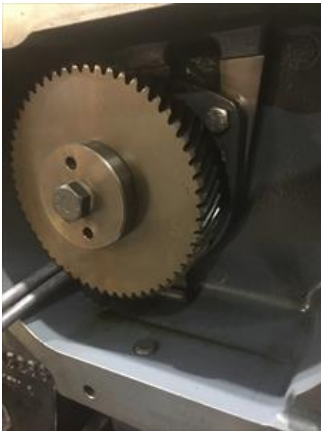
5. Distance from the end of the shaft to the Coupling/Sheave

**0 inches**

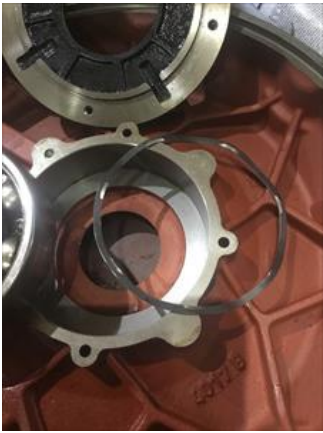
28. Drive End Bearing Qty.	1
29. Drive End Bearing Type	(Ball) Ball Bearing
30. Drive End Lubrication Type	(Grease) Grease Lubricated
31. Drive End Bearing Insulation or Grounding Device?	none
32. Drive End Wavy Washer/Snap-Ring Other Retention Device?	wavy washer

33.	Drive End Bearing Condition	replace	
34.	Opposite Drive End Bearing Brand	un-readable	
35.	Opposite Drive End Bearing Number-	un-readable	
	<i>Requires a C4 fit.</i>		
36.	Opposite Drive End Bearing Qty.	1	P103
