AC Inspection as Found
DEWITT MUNICIPAL WATERWORKS
428 COURT SQUARE

AC Inspection - Rev. 2

Location: LR MOTOR SHOP
Serial Number: C1983937
Description: PUMP FOR EVALUATION NO DATA

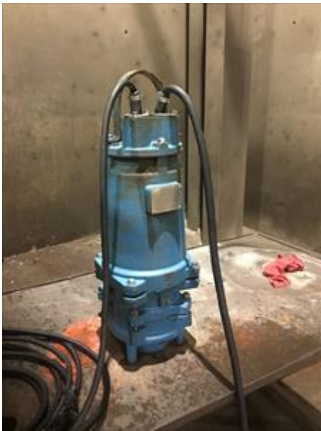
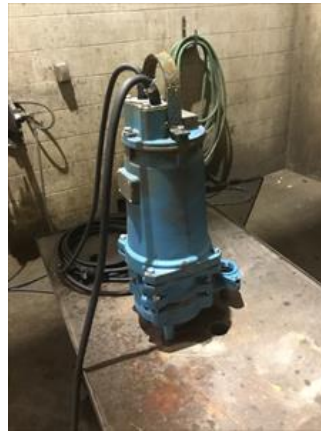
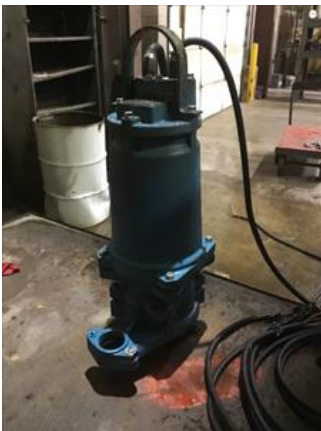
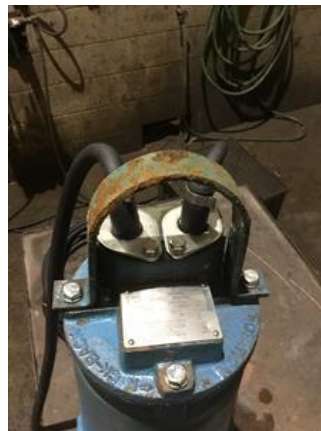
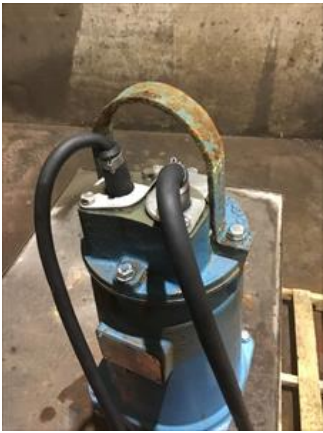
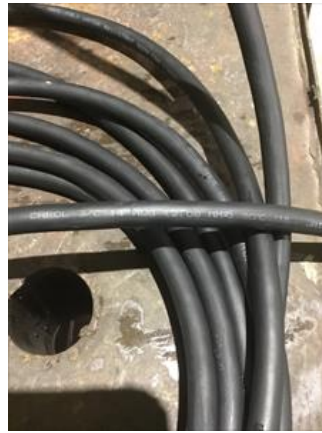
3. Photos of all six sides of the machine.

4.	Describe the Overall Condition of the Equipment as Received	
	<i>Leaking oil, but serviceable.</i>	
5.	Distance from the end of the shaft to the Coupling/Sheave	inches
Initial Mechanical/Electrical		<input type="checkbox"/>
6.	Does Shaft Turn Freely?	(N) No
7.	Does the shaft require T.I.R in Lathe to identify additional repairs?

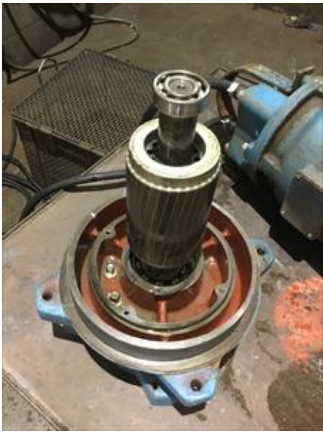
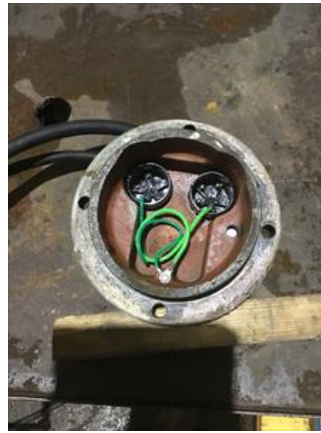
Outer seal O.D 1.7560
Shaft diameter: 1.1255
Carbon ceramic

Outer seal surface has wear.

68.	Failure locations <i>Windings show open between leads 1&2, & leads 1&3. Both bearings show water contamination.</i>		
69.	Root cause of failure <i>Seal failure allow water to saturate the stator windings.</i>		
Dynamic Balance Report

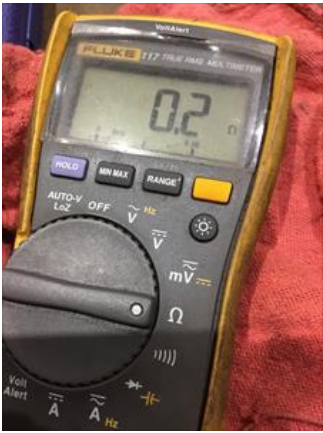
21.	Winding Resistance		
	1-2	1-3	2-3
	0	0	0.9
● 22.	Perform Surge Test	(NA) Not Applicable	
23.	Number of Stator Slots	24	
24.	Stator Condition	rewind	
25.	Stator Thermistors/Ohms		
26.	Stator Overloads/Ohms

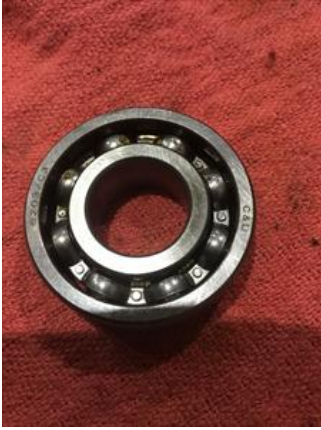
</div>			
29. Drive End Bearing Qty.	1		
30. Drive End Bearing Type	(Ball) Ball Bearing		
31. Drive End Lubrication Type	(Oil) Oil Lubricated		
32. Drive End Bearing Insulation or Grounding Device?	none		
33. Drive End Wavy Washer/Snap-Ring Other Retention Device?	snap ring		
34. Drive End Bearing Condition	replace		
35. Opposite Drive End Bearing Brand	CU		P92
<div>
