AC Inspection as Found

FUTURE FUEL CHEMICAL

Location: LR MOTOR SHOP

Description: 75 HP BALDOR

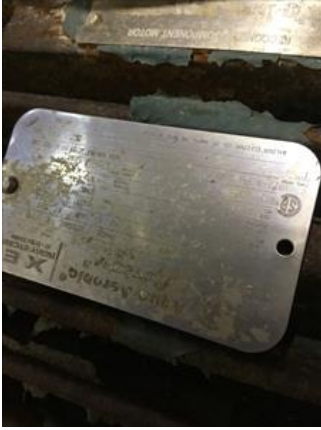
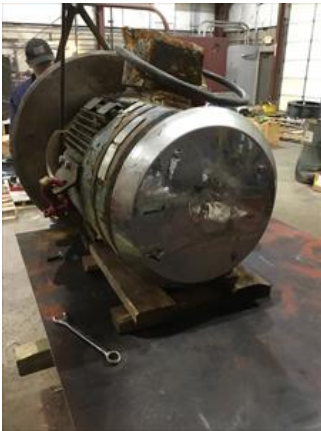
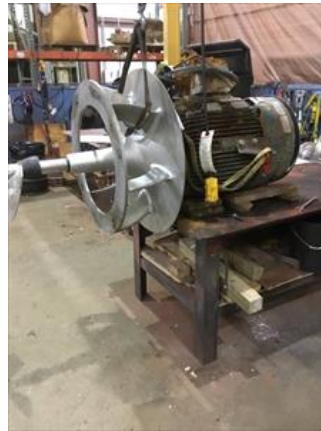
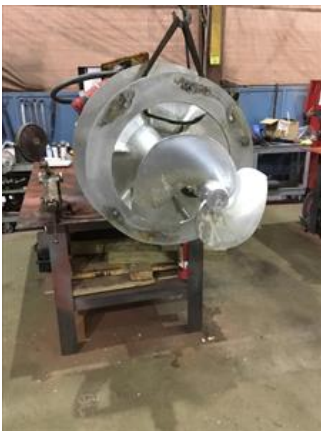
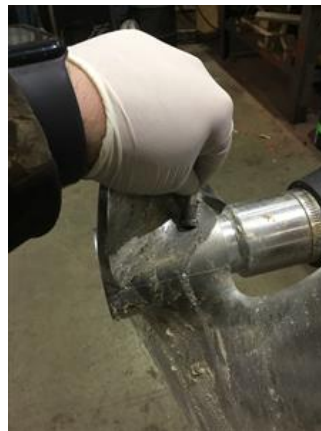
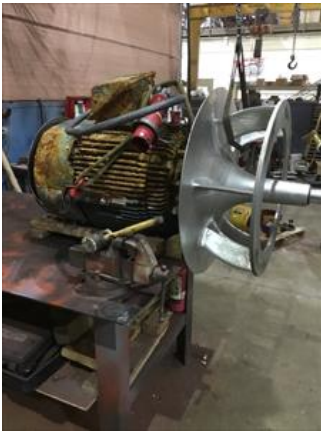
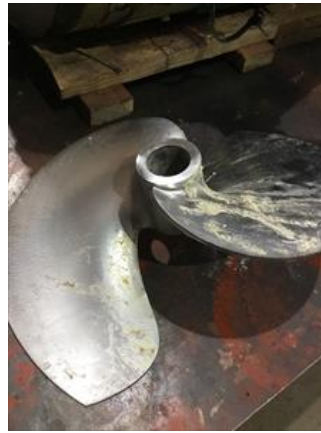
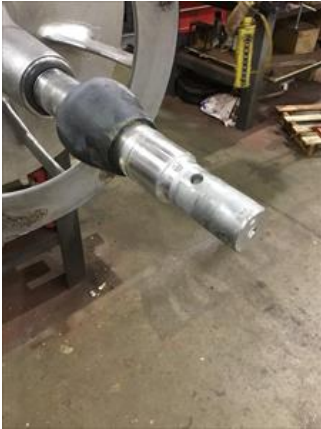
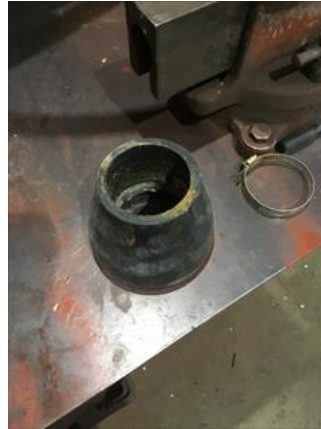
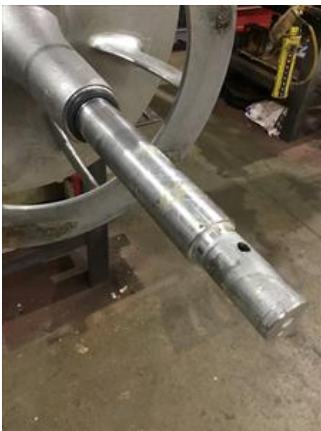
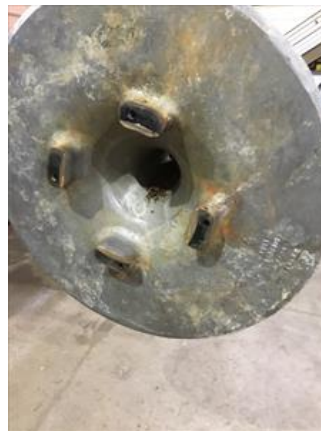
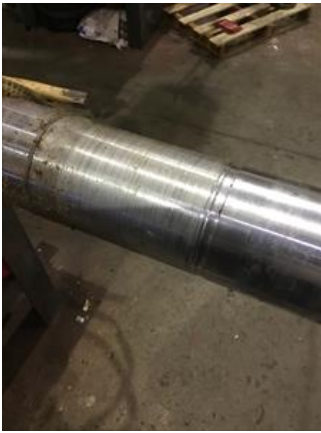
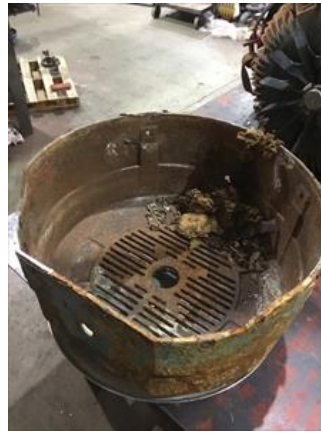
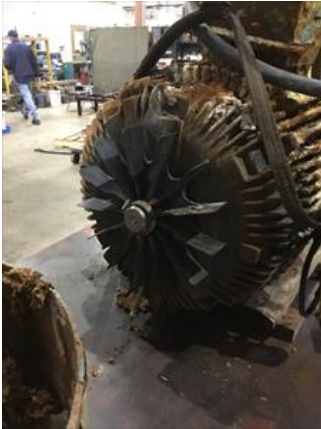
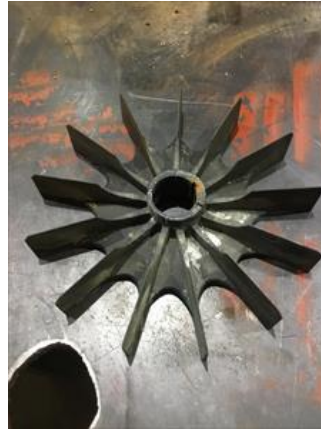
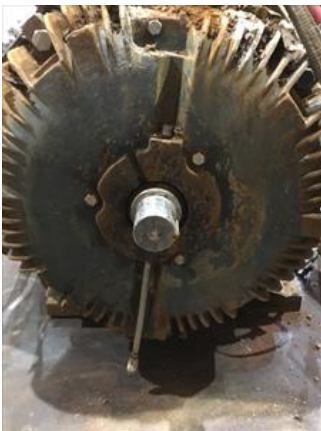
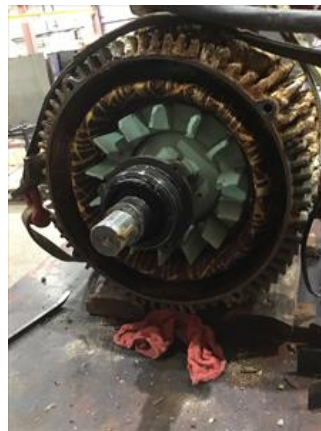
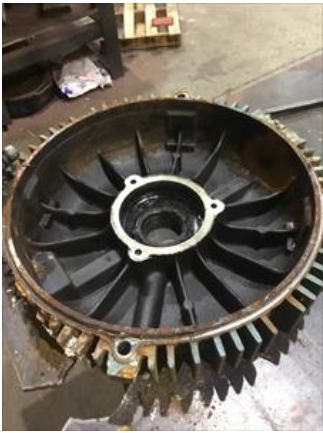
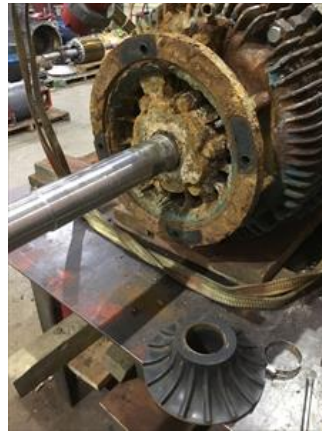
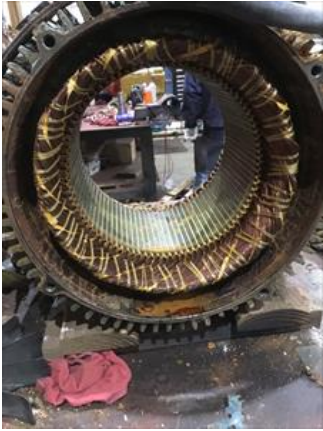
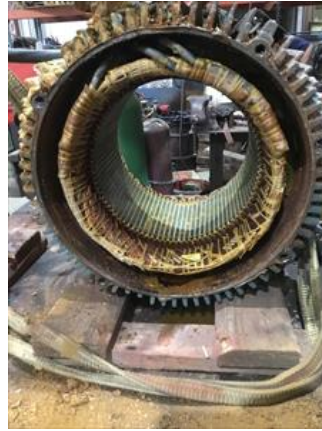
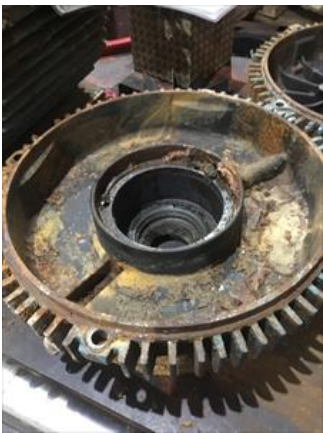
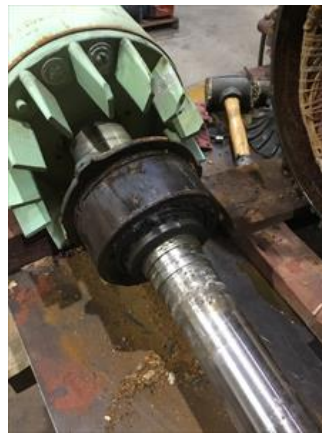
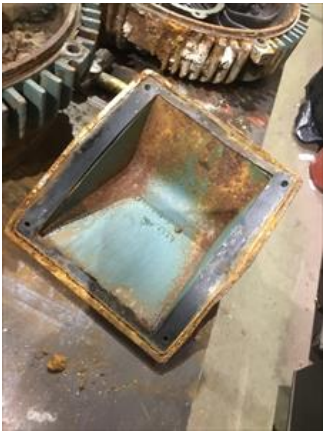
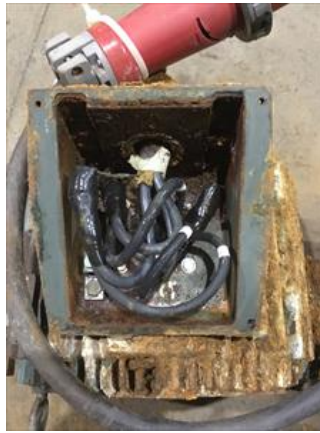
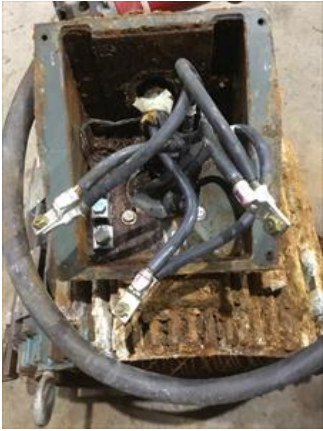
4. Describe the Overall Condition of the Equipment as Received
Dirty

| | 8. Does Shaft Have Visible Damage? | (Yes) Yes |

10.	Assembled Shaft End Play	inches
11.	Air Gap Variation <10%	
12.	Lead Condition	(NA) Not Applicable
13.	Lead Length	12 Inches
14.	Does it have Lugs?, If so what is the Stud Size?	
	Yes	
15.	Lead Numbers	1-3
16.	Frame Condition	pass
17.	Fan Condition	(P) Pass
18.	Does motor have internal fan?	(No) No
19.	Broken or Missing Components	propeller pin is broke in half

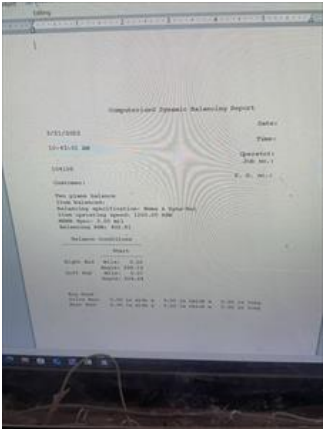
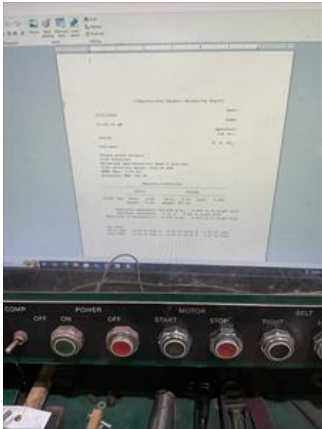
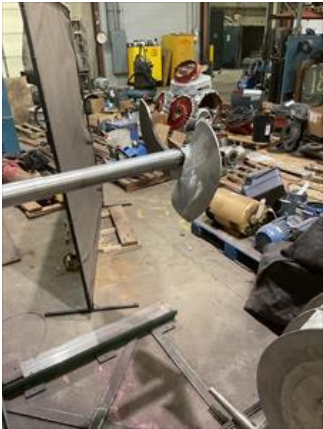
Rotor Weight Balance Grade

Drive End	Opposite Drive End
0.28	0.07
