AC Inspection as Found

Tyson Foods (10914)

AC Inspection - Rev. 2

Description: 5 HP PUMP
GOULDS WATER TECHNOLOGY

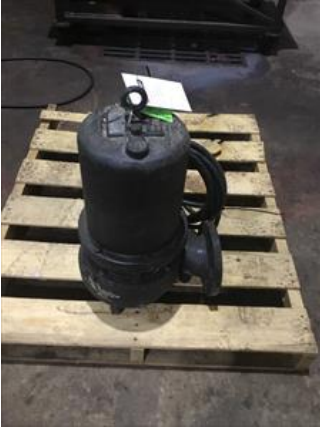
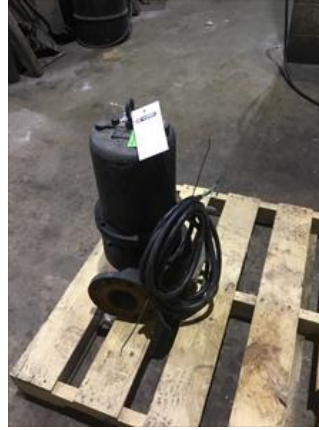
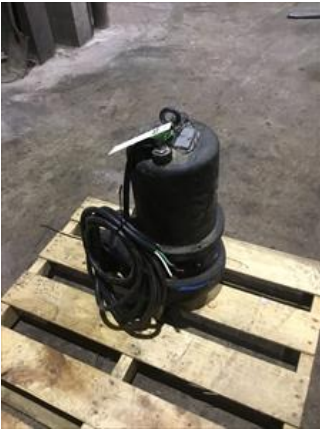
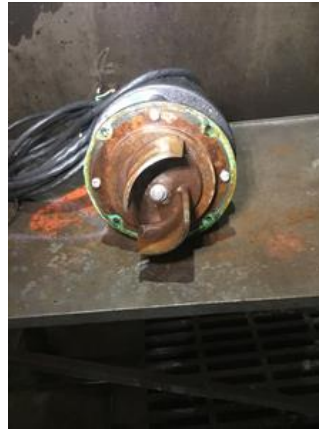
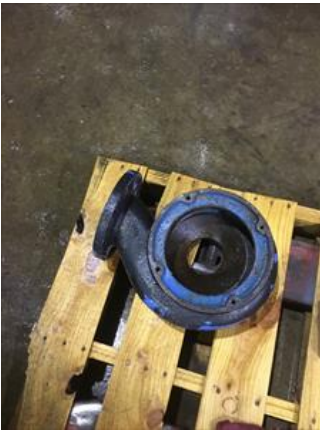
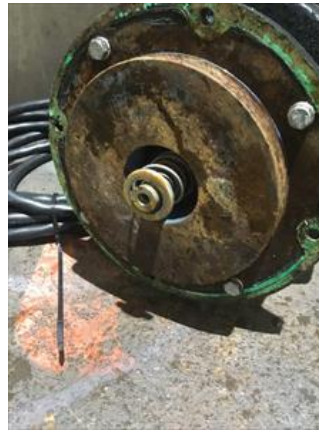
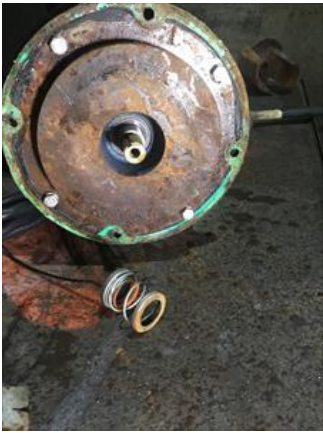
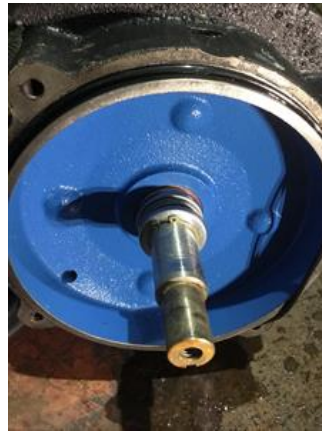
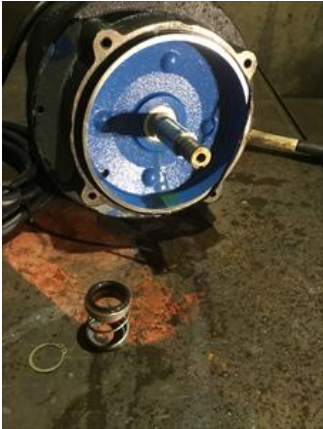
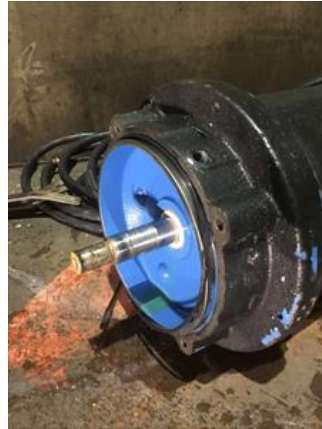
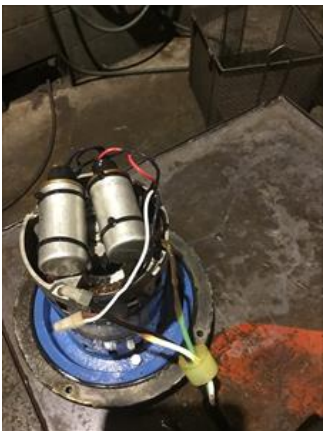
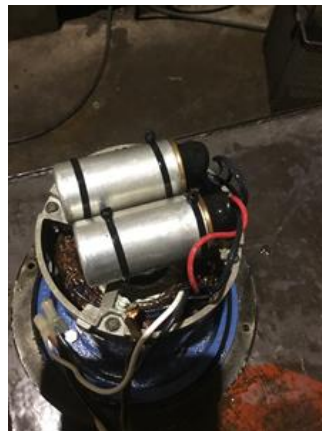
4. Describe the Overall Condition of the Equipment as Received

5.	Does Shaft Turn Freely?	(N) No
6.	Does the shaft require T.I.R in Lathe to identify additional repairs?	(No) No
7.	Does Shaft Have Visible Damage?	(No) No
8.	Assembled Shaft Runout	Inches
	<i>Locked up, unable to perform</i>	
9.	Assembled Shaft End Play	inches

10.	Air Gap Variation <10%		
● 11.	Lead Condition	(F) Fail	P69

12.	Lead Length	10 Inches	
● 13.	Does it have Lugs?, If so what is the Stud Size?	(No) No	
■	Terminals		
14.	Lead Numbers		
■	Not numbered		
15.	Frame Condition	pass	
16.	Fan Condition		
● 17.	Does motor have internal fan?	(No) No	
18.	Broken or Missing Components	none	
Initial Electrical Inspection			📷
19.	Insulation Resistance/Megger	Megohms	
■	Rewind		
20.	Winding Resistance		
	1-2	1-3	2-3
■	Rewind		
● 21.	Perform Surge Test	(F) Fail	P57

22.	Number of Stator Slots	36	
23.	Stator Condition	rewind	
24.	Stator Thermistors/Ohms		
25.	Stator Overloads/Ohms

48. List the Parts needed for the Repair Below <i>Rewind stator. Replace bearings: 6206Z & 6204Z</i> <i>Replace both capacitors and O-rings plus power cord grommet</i> <i>Inner seal: Carbon-Ceramic with viton elastomer OD 1.7575: ID 1.1250</i> <i>Outer seal: Tungsten with viton elastomer: OD 1.7575: ID 1.1250</i>
