AC Inspection as Found

Tyson Foods (10914)

AC Inspection - Rev. 2

Description: 5 HP PUMP
GOULDS WATER TECHNOLOGY

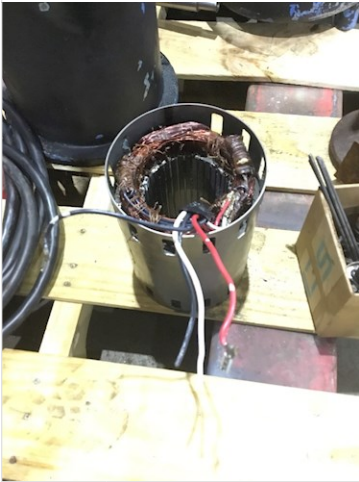
4. Describe the Overall Condition of the Equipment as Received
Debris has impeller locked up.

5.	Does Shaft Turn Freely?	(N) No
6.	Does the shaft require T.I.R in Lathe to identify additional repairs?	(No) No
7.	Does Shaft Have Visible Damage?	(No) No
8.	Assembled Shaft Runout	Inches
	<i>Locked up, unable to perform</i>	
9.	Assembled Shaft End Play	inches
10.	Air Gap Variation <10%

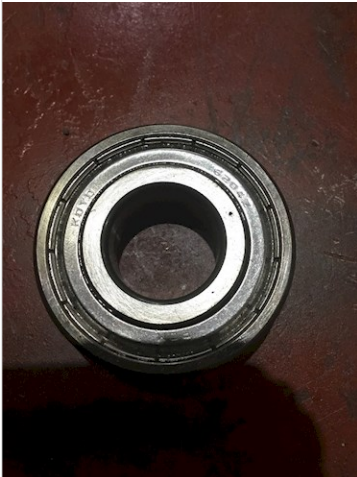
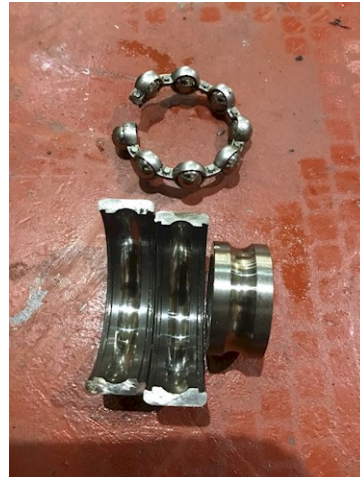
P99

33. Drive End Bearing Condition

replace

35. Opposite Drive End Bearing Number-

6204 Z

46.	Number of Rotor Bars	48
47.	Rotor Condition	pass
48.	List the Parts needed for the Repair Below <i>Rewind stator. Replace bearings: 6206Z & 6204Z</i> <i>Replace both capacitors and O-rings plus power cord grommet</i> <i>Inner seal: Carbon-Ceramic with viton elastomer OD 1.7575: ID 1.1250</i> <i>Outer seal: Tungsten with viton elastomer: OD 1.7575: ID 1.1250</i>

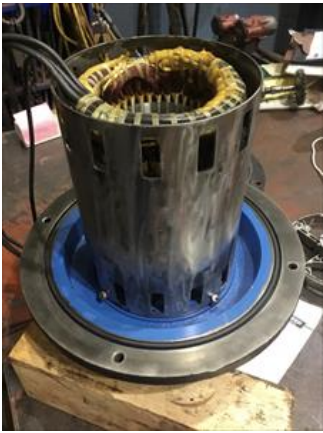
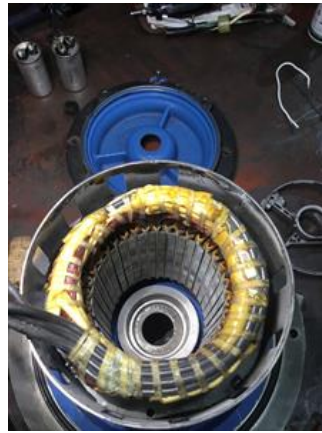
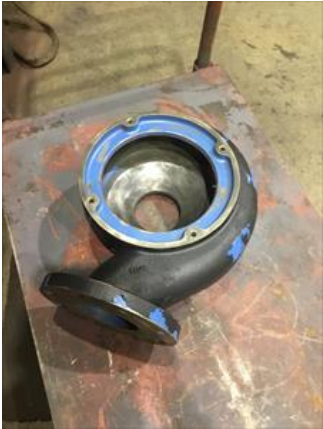
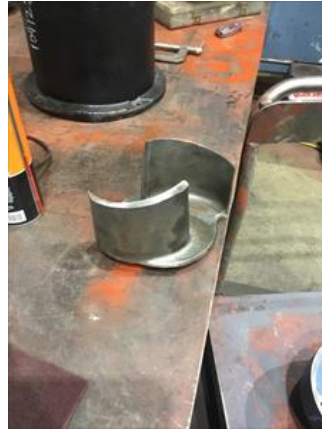
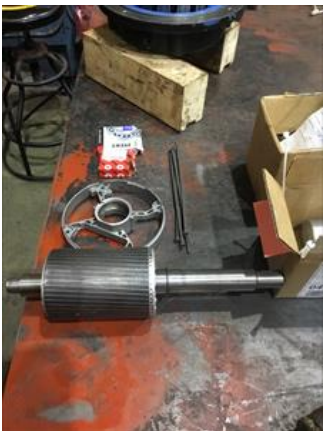
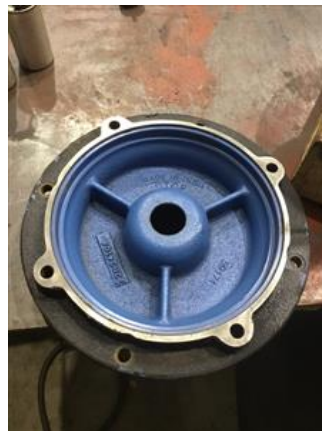
See pics below.			
87.	Photograph All Major Components prior to assembly	P17

67.	Failure locations <i>Windings</i> <i>D.E. housing fit</i>		
68.	Root cause of failure <i>Outer seal failure due to excessive debris, allowed water to penetrate the stator windings causing shorted windings.</i>		
Dynamic Balance Report

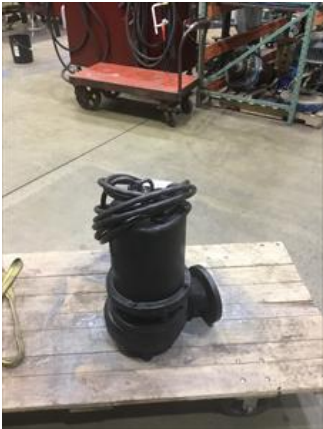
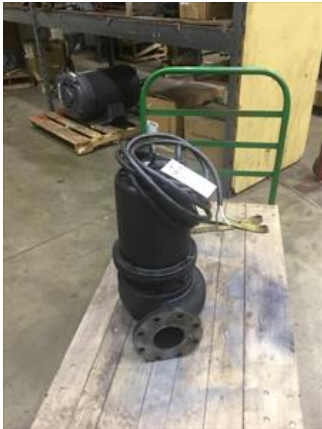
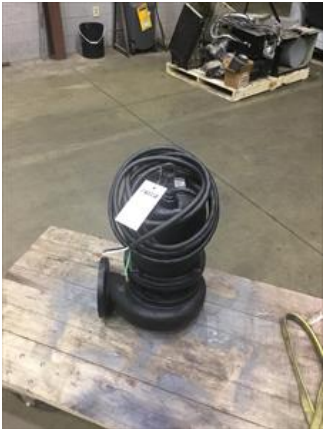
93.	Drive End Vibration Readings - Inches Per Second		
	Horizontal	Vertical	Axial
94.	Opposite Drive End Vibration Readings - Inches Per Second		
	Horizontal	Vertical	Axial
95.	Ambient Temperature - Fahrenheit		
96.	Drive End Bearing Temps - Fahrenheit		
	5 Minutes	10 Minutes	15 Minutes
97.	Opposite Drive End Bearing Temps - Fahrenheit		
	5 Minutes	10 Minutes	15 Minutes
98.	Document Final Condition with Pictures after paint		
	<div>
