AC Inspection as Found

Riceland Foods (11100-RLF)

AC Inspection - Rev. 2

Description: 50HP US 1770 RPM

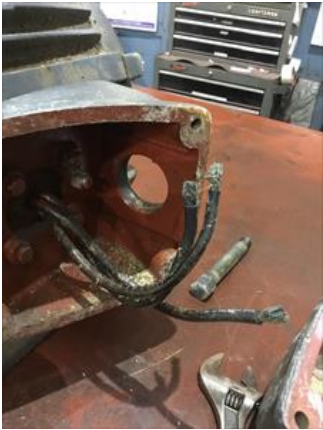
12.	Lead Length	10 Inches	
13.	Does it have Lugs?, If so what is the Stud Size?	(No) No	
14.	Lead Numbers	1-3	
15.	Frame Condition	pass	
16.	Fan Condition	(P) Pass	P115

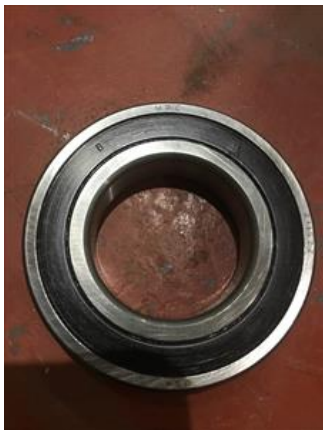
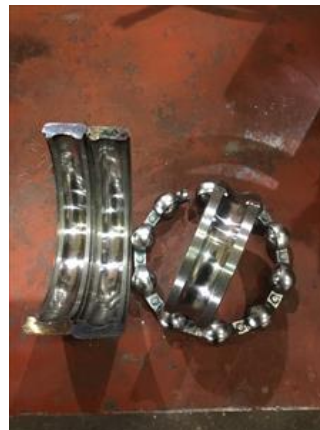
28. Drive End Bearing Qty.	1
29. Drive End Bearing Type	(Ball) Ball Bearing
30. Drive End Lubrication Type	(Grease) Grease Lubricated
31. Drive End Bearing Insulation or Grounding Device?	none
32. Drive End Wavy Washer/Snap-Ring Other Retention Device?	none
33. Drive End Bearing Condition	replace
34. Opposite Drive End Bearing Brand	MRC

45. Growler Test	(Pass) Pass	
46. Number of Rotor Bars	56	
47. Rotor Condition	pass	
48. List the Parts needed for the Repair Below	211 & 311 2RS bearings Remove multiple dents from fan cover and replace grease overload tube. Recondition motor	
49. Signature of Technician that Disassembled Motor	Terrence Holland

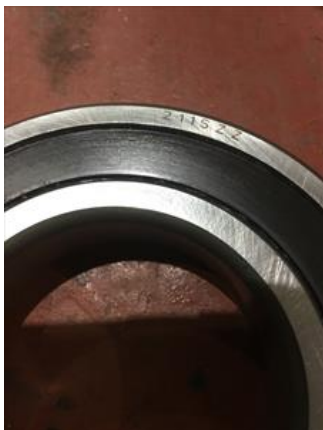
36. Opposite Drive End Bearing Qty.	1
37. Opposite Drive End Bearing Type	(Ball) Ball Bearing

38. Opposite Drive End Lubrication Type	(Grease) Grease Lubricated	
39. Opposite Drive End Bearing Insulation or Grounding Device?	none	
40. Opposite Drive End Wavy Washer/Snap-Ring Other Retention Device?	none	
41. Opposite Drive End Bearing Condition	replace	
42. Drive End Seal	USEM 344625	P120
<div style="display: flex; justify-content: space-around;">     </div>		
43. Opposite Drive End Seal	none	
Rotor Inspection		
44. Rotor Type/Material	(Squirrel Aluminum) Squirrel Cage Aluminum Die Cast	P3

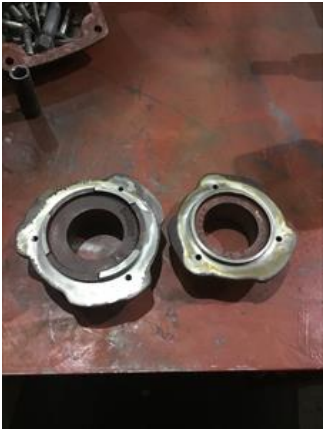
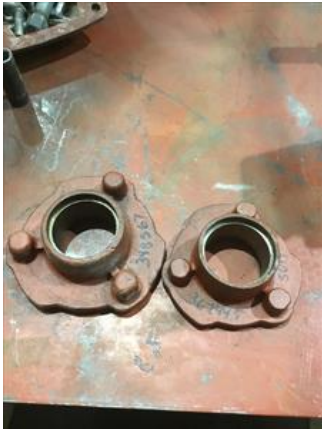
3.9375	3.9376	3.9376
62. Opposite Drive End - Endbell Bearing Fit Condition			(P) Pass
63. Bearing Cap Condition			P52
	Drive End Bearing Cap	Opposite Drive End Bearing Cap	
<div>
