AC Inspection as Found

Sage V Foods

AC Inspection - Rev. 2

Description: 25 HP SCHAEFFLER

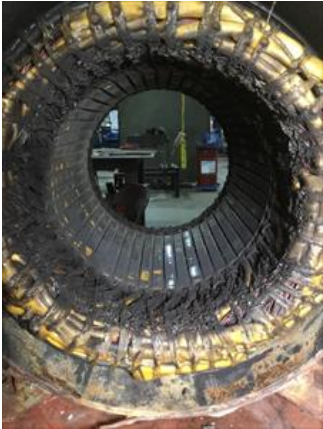
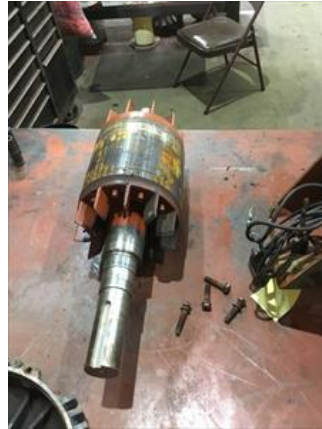
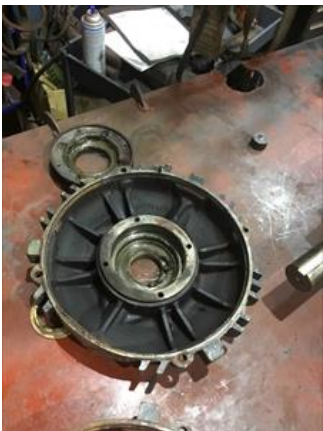
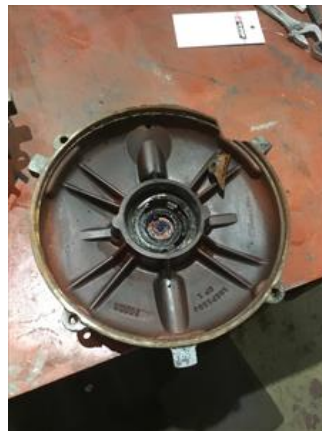
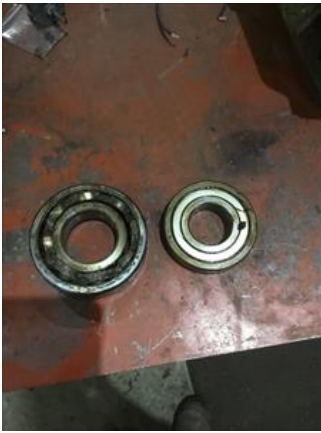
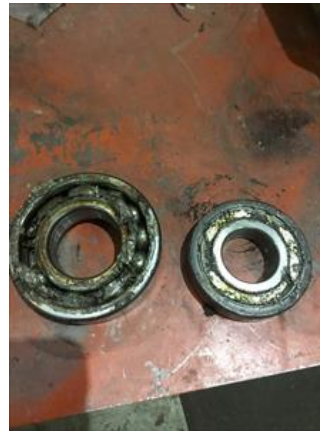
4. Describe the Overall Condition of the Equipment as Received

Dirty/rusted

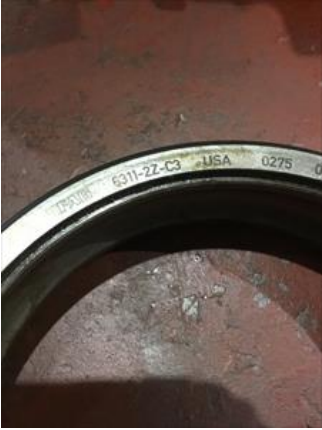
21.	Perform Surge Test	(NA) Not Applicable	
22.	Number of Stator Slots	48	
23.	Stator Condition	rewind	
24.	Stator Thermistors/Ohms		
25.	Stator Overloads/Ohms		
Mechanical Inspection			
26.	Drive End Bearing Brand	FAG	P12

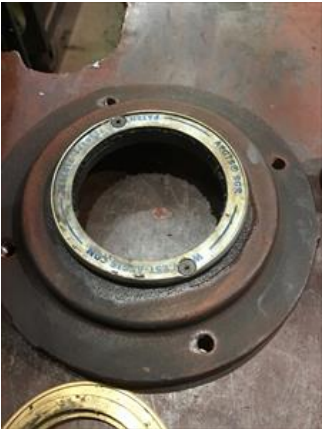
27.	Drive End Bearing Number-	6311 2Z/C3	
28.	Drive End Bearing Qty.	1	
29.	Drive End Bearing Type	(Ball) Ball Bearing	
30.	Drive End Lubrication Type	(Grease) Grease Lubricated	
31.	Drive End Bearing Insulation or Grounding Device?	Aegis ring	P64

33. Drive End Bearing Condition

water contaminated grease

6309&6311 2Z/C3 bearings.
Replace ODE housing with broken off ear.
Replace aegis ring: shaft measurement is 2.7140
Rewind stator and replace in pro seal on DE housing.

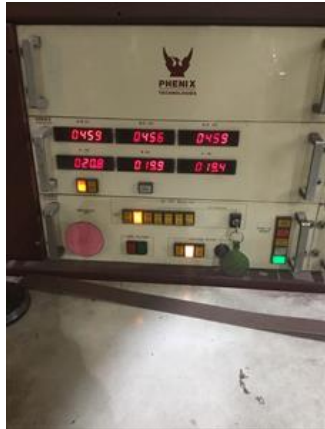
97.	Assembled Shaft Endplay	0 inches	
98.	Assembled Shaft Runout	0.002 inches	
99.	Test Run Voltage		
	Volts	Volts	Volts
	459	456	459

100.	Test Run Amperage		
	Amps	Amps	Amps
	20.8	19.9	19.4
101.	Drive End Vibration Readings - Inches Per Second		
	Horizontal	Vertical	Axial
	0.04	0.03	0.05
102.	Opposite Drive End Vibration Readings - Inches Per Second		
	Horizontal	Vertical	Axial
	0.03	0.01	0.070000000000000001
103.	Ambient Temperature - Fahrenheit		
104.	Drive End Bearing Temps - Fahrenheit		
	5 Minutes	10 Minutes	15 Minutes
105.	Opposite Drive End Bearing Temps - Fahrenheit		
	5 Minutes	10 Minutes	15 Minutes
106.	Document Final Condition with Pictures after paint	see below	
107.	Final Pics and QC Review	Terrence Holland
