## AC Inspection as Found

Riceland Foods  
1200 N Park Ave  
Stuttgart, AR 72160

### AC Inspection - Rev. 2

Description: 200 HP BALDOR

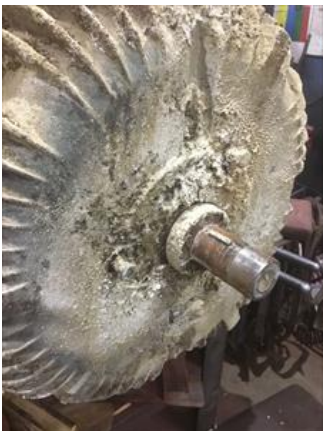
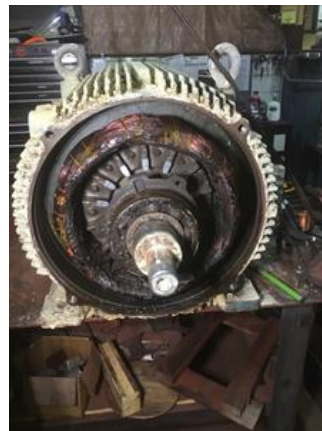
*ODE bearing cap bolts loose. (All of them.)*

Co sign RRW		
Root Cause of Failure			
67.	Failure locations		
	ODE bearing cap bolts. Both bearings have dirty grease.

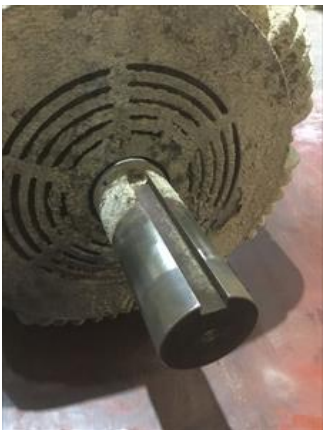
5.	Does Shaft Turn Freely?	(Y) Yes	
6.	Does the shaft require T.I.R in Lathe to identify additional repairs?	(No) No	
7.	Does Shaft Have Visible Damage?	(No) No	P26

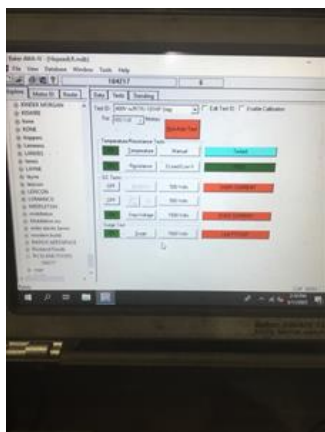
21. Perform Surge Test

(F) Fail

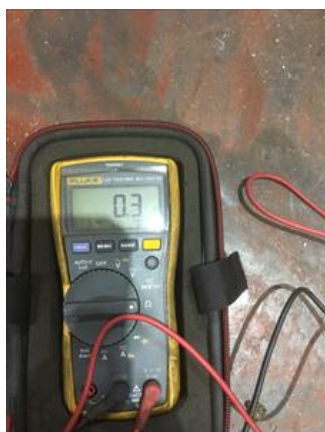
23. Stator Condition

rewind

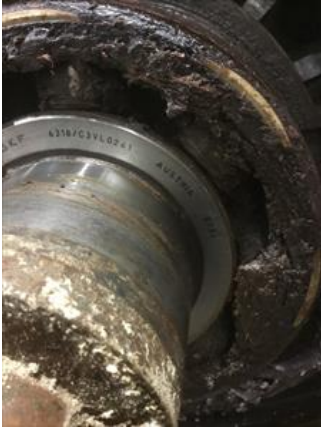
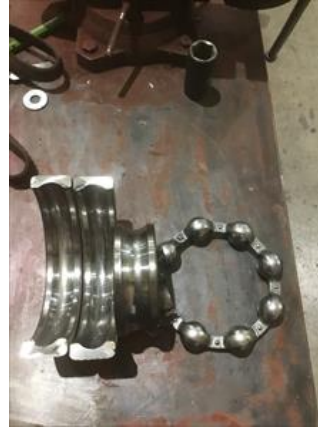
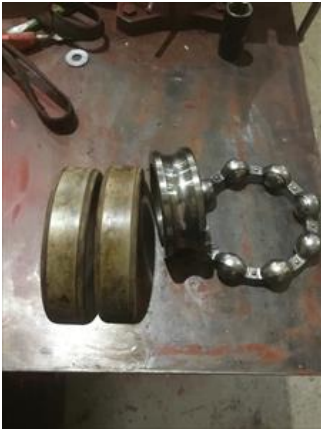
36. Opposite Drive End Bearing Qty.	1
37. Opposite Drive End Bearing Type	(Ball) Ball Bearing
38. Opposite Drive End Lubrication Type	(Grease) Grease Lubricated
39. Opposite Drive End Bearing Insulation or Grounding Device?	none
40. Opposite Drive End Wavy Washer/Snap-Ring Other Retention Device?	none
41. Opposite Drive End Bearing Condition	replace
<div></div> Contaminated grease.	
42. Drive End Seal	none
43. Opposite Drive End Seal	none

*D.E bearing #6318 C3 & ODE #6318/C3 VL0241 (ceramic)  
Sleeve both housing fits.  
Repair ODE air gap shaft surface.  
Recommend Aegis grounding ring on DE*

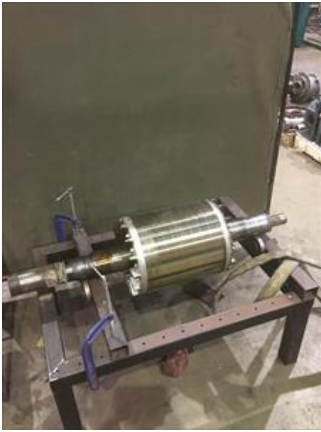
45. Growler Test

(Pass) Pass

47. Rotor Condition

pass

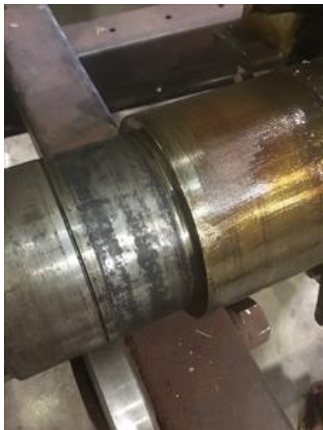
53.	Coupling Fit Closest to the end of the Shaft		
	0 Degrees	60 Degrees	120 Degrees
54.	Drive End Bearing Shaft Fit		
	0 Degrees	60 Degrees	120 Degrees
	3.5434	3.5433	3.5434
55.	Drive End Bearing Shaft Fit Condition		(P) Pass P81
