AC Inspection as Found
Arkansas Electric Coop. (11681)
17400 highway 365 south
Little Rock, AR 72206

AC Inspection - Rev. 2

Description: 7 1/2 AMETEK

Hi-Speed Job Number: 104252

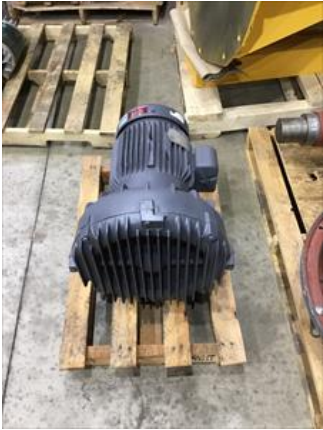
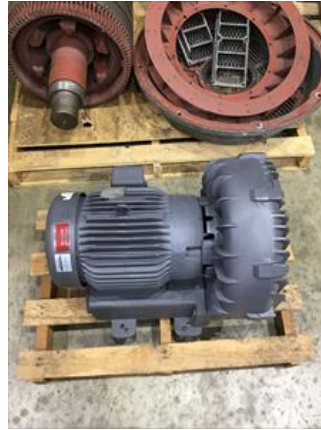
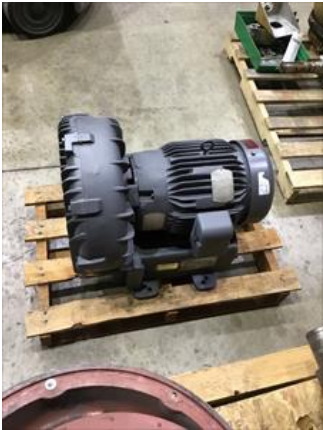
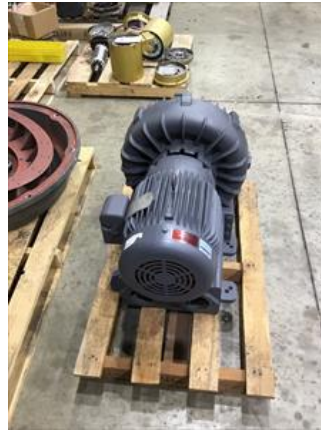
97.	Drive End Vibration Readings - Inches Per Second		
	Horizontal	Vertical	Axial
	0.04	0.04	0.05
98.	Opposite Drive End Vibration Readings - Inches Per Second		
	Horizontal	Vertical	Axial
	0.05	0.04	0.05
99.	Ambient Temperature - Fahrenheit		
100.	Drive End Bearing Temps - Fahrenheit		
	5 Minutes	10 Minutes	15 Minutes
101.	Opposite Drive End Bearing Temps - Fahrenheit		
	5 Minutes	10 Minutes	15 Minutes
102.	Document Final Condition with Pictures after paint
