**AC Inspection as Found**  
**FUTURE FUEL CHEMICAL**  
2800 GAP RD HWY 394 SO  
BATESVILLE, AR 72501

**AC Inspection - Rev. 2**

Location: LR MOTOR SHOP

Description: 50 HP U.S ELECTRIC

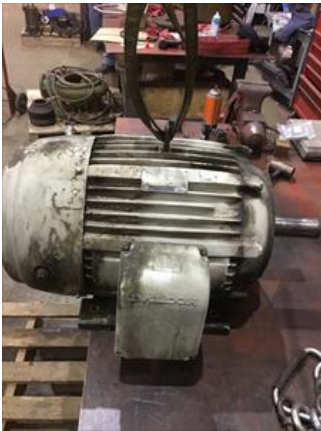
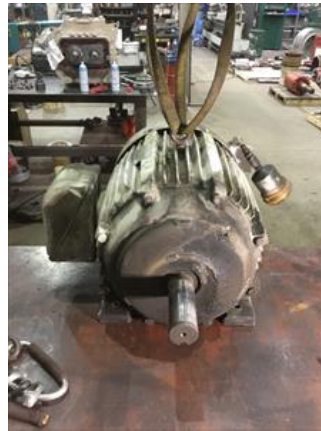
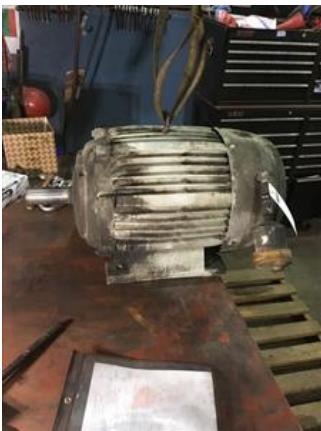
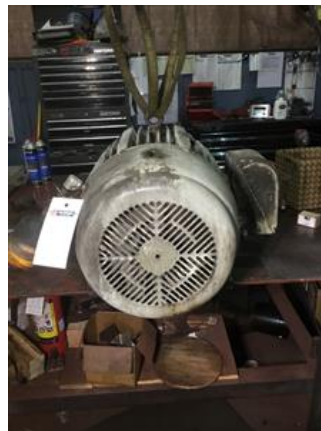
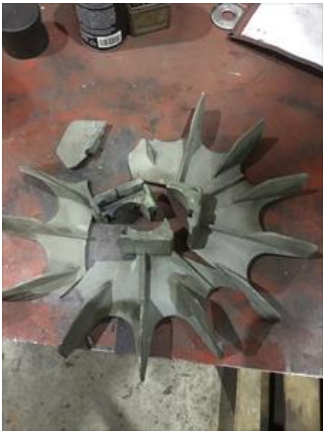
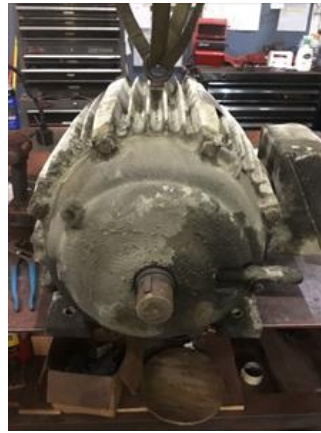
3. Photos of all six sides of the machine.

4. Describe the Overall Condition of the Equipment as Received  
*Serviceable*
