## AC Inspection as Found

### FUTURE FUEL CHEMICAL

#### AC Inspection - Rev. 2

Description: 75 HP BALDOR

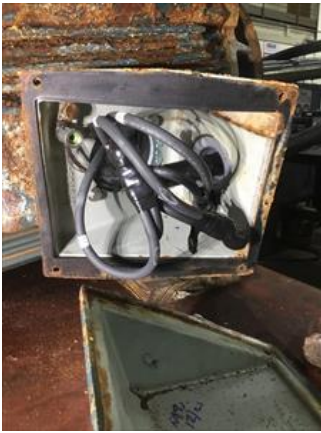
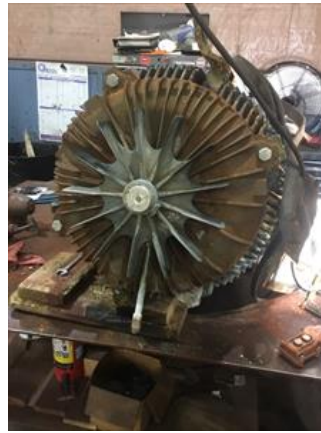
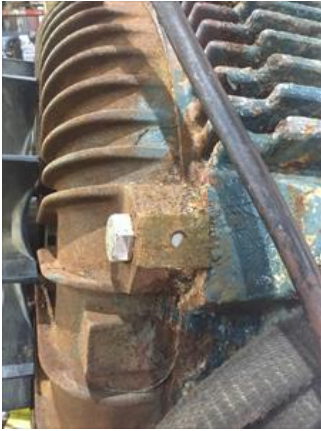
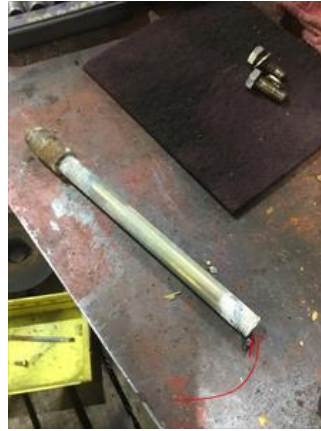
*Broken bolt*

*Part Broken off in housing.*

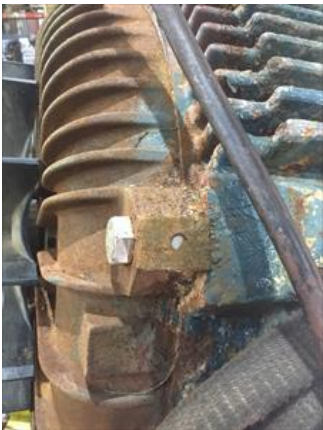
17. Does motor have internal fan?	(No) No	
18. Broken or Missing Components	p	P124
<div>Broken of fan cover mount bolt on ODE.</div>

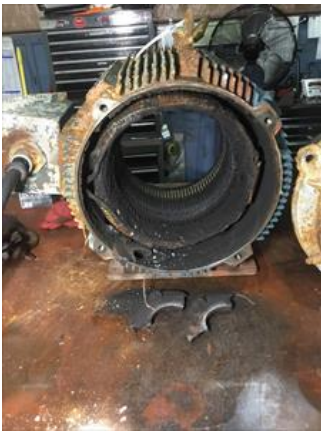
P57

## 21. Perform Surge Test

(F) Fail

| 48. List the Parts needed for the Repair Below<br><i>New shaft. Rewind stator &amp; major core repair.<br/> Replace broken DE bearing<br/> Sleeve for 7219 housing fit.<br/> 6313 and 7219 bearings.</i> | |

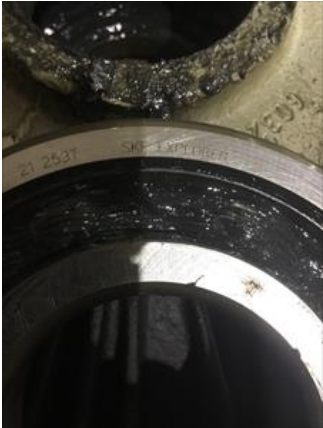
34. Opposite Drive End Bearing Brand	<b>SKF</b>	P92

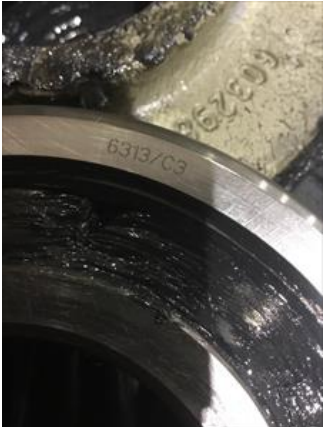
35. Opposite Drive End Bearing Number-	<b>6313 C3</b>	P99

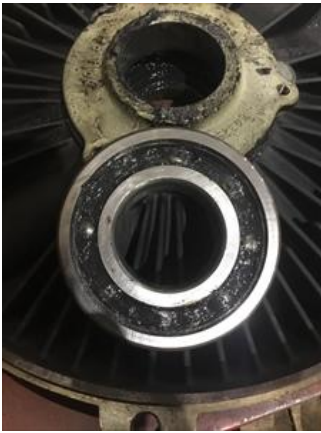
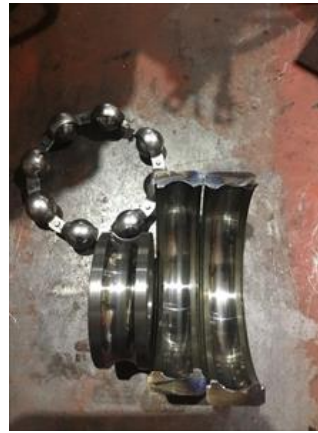
36. Opposite Drive End Bearing Qty.	<b>1</b>	
37. Opposite Drive End Bearing Type	<b>(Ball) Ball Bearing</b>	P106

| 41. Opposite Drive End Bearing Condition | replace |
| <div> <div></div> <i>Normal wear.</i> </div> | |
