AC Inspection as Found

American Kraft Paper

AC Inspection - Rev. 2

Description: 125 HP
NAMEPLATE NOT READABLE FOR SOME
SPECS

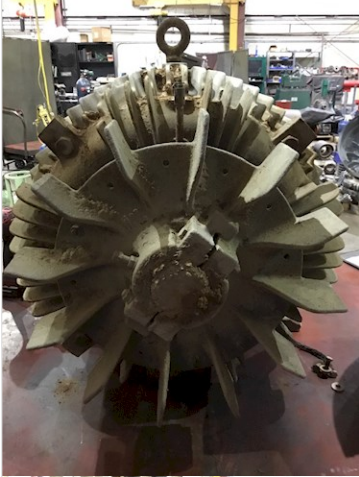
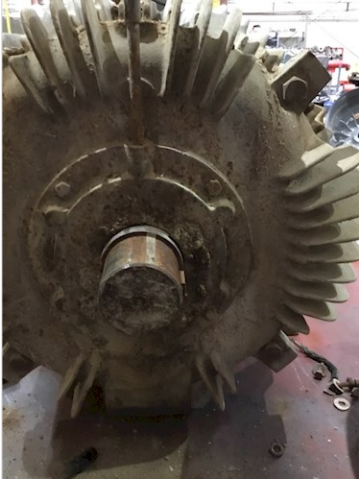
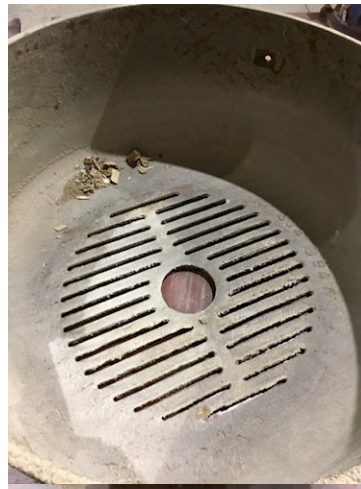
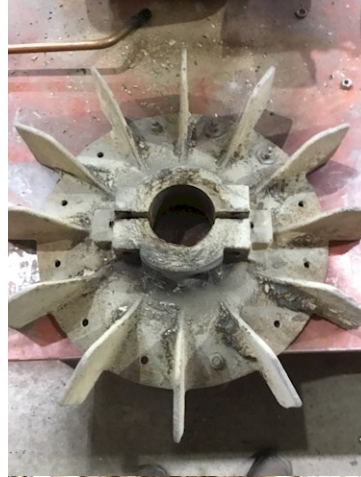
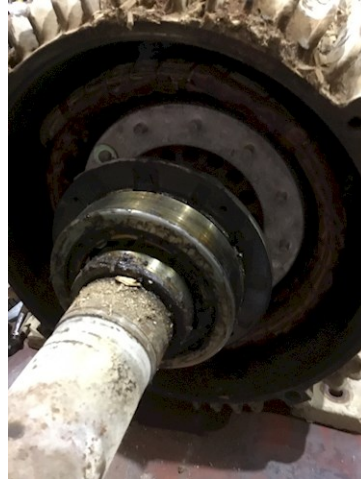
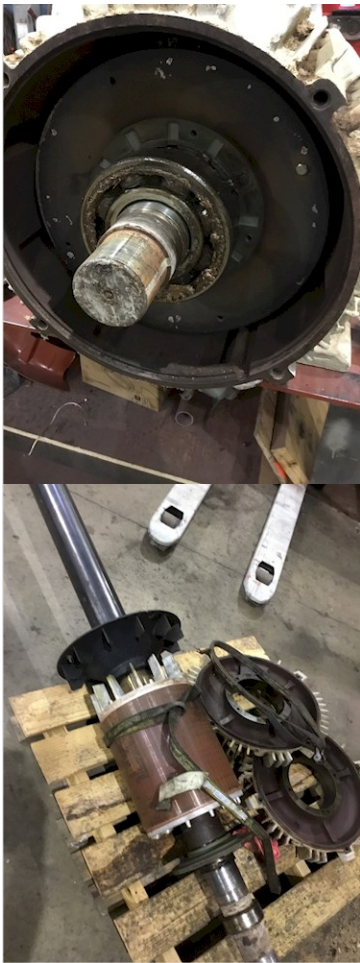
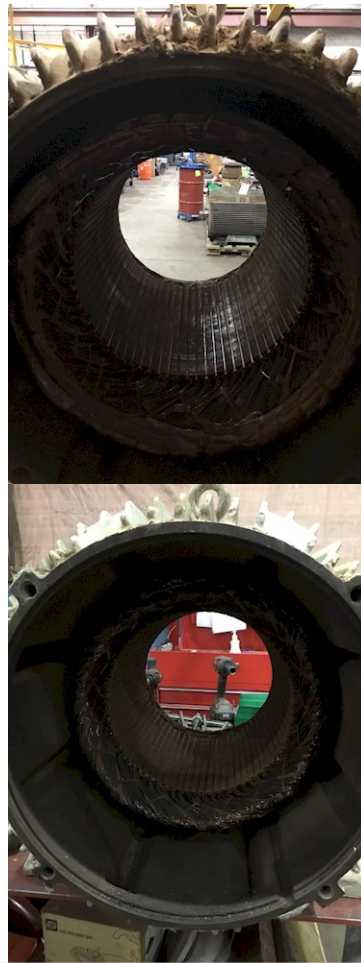
3.	Photos of all six sides of the machine.	
4.	Describe the Overall Condition of the Equipment as Received <i>Dirty</i>	
5.	Is this a UL Listed Motor	(No) No
