AC Inspection as Found
Green Bay Packaging, Pinecrest (11362)
3610 Hwy 64 East
Plummerville, AR 72127

AC Inspection - Rev. 2

Description: MOTOR -NO NAMEPLATE DATA

Hi-Speed Job Number: 104598

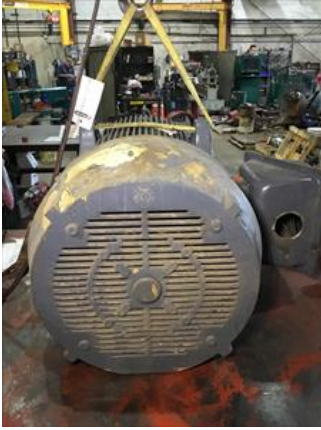
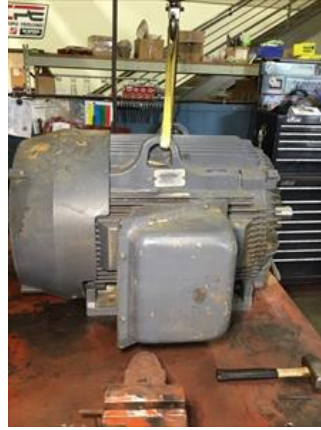
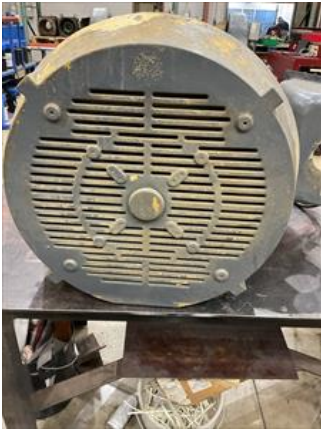
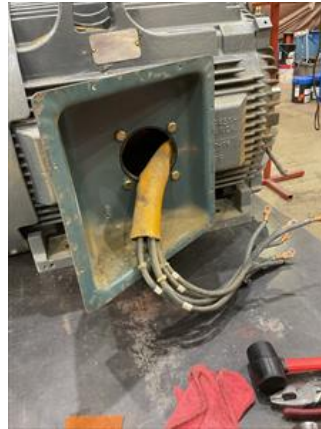
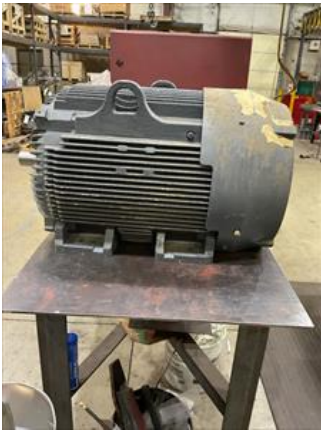
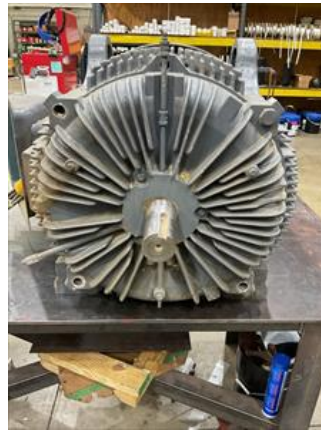
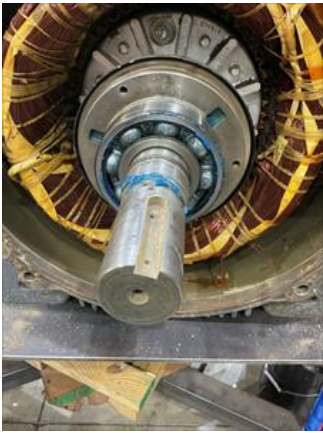
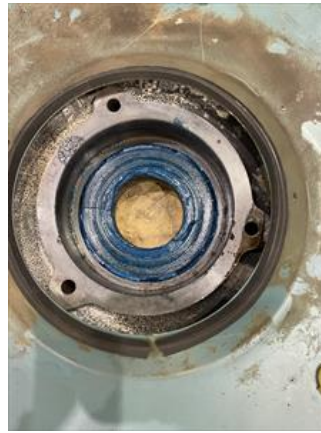
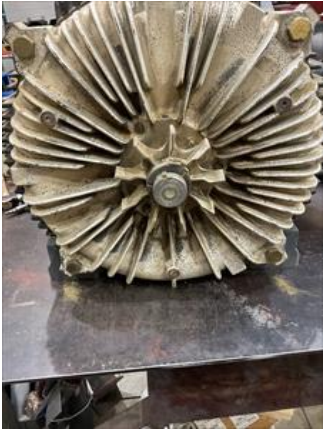
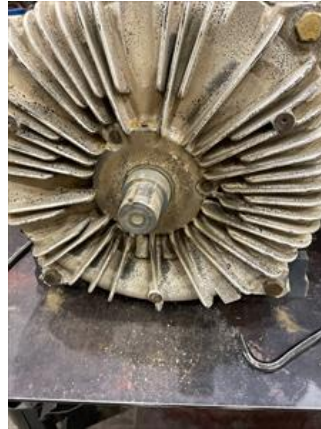
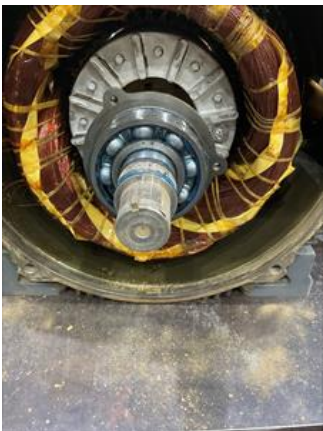
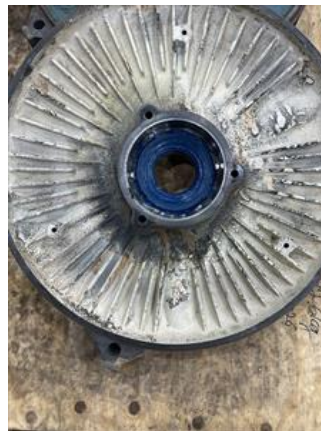
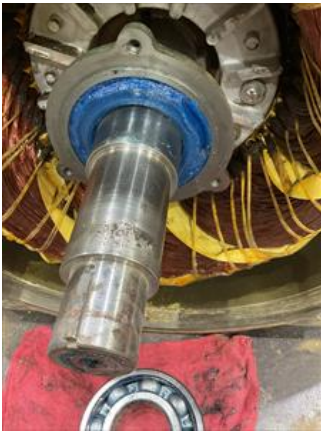
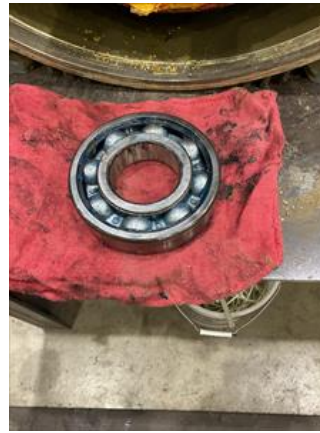
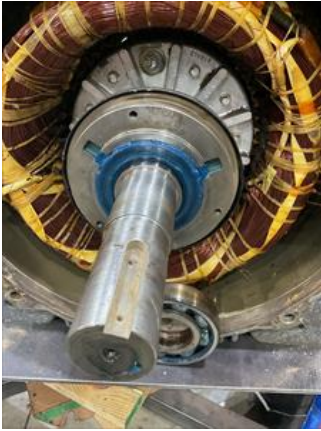
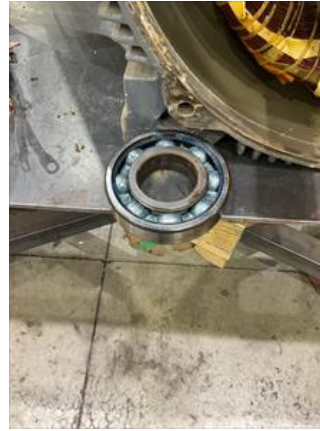
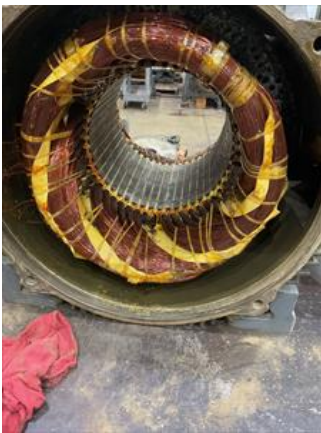
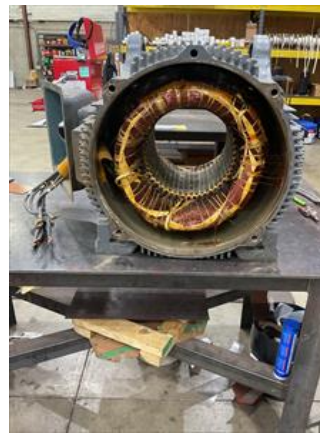
4.	Describe the Overall Condition of the Equipment as Received	
	<i>Serviceable</i>	
5.	Is this a UL Listed Motor	(No) No
6.	Is the motor water cooled or can be pressure checked before teardown	(No) No
Initial Mechanical/Electrical		
7.	Does Shaft Turn Freely?	(Y) Yes
8.	Does the shaft require T.I.R in Lathe to identify additional repairs?	(No) No
9.	Does Shaft Have Visible Damage?	(No) No
10.	Assembled Shaft Runout	0.003 Inches
11.	Assembled Shaft End Play	0 inches
12.	Air Gap Variation <10%

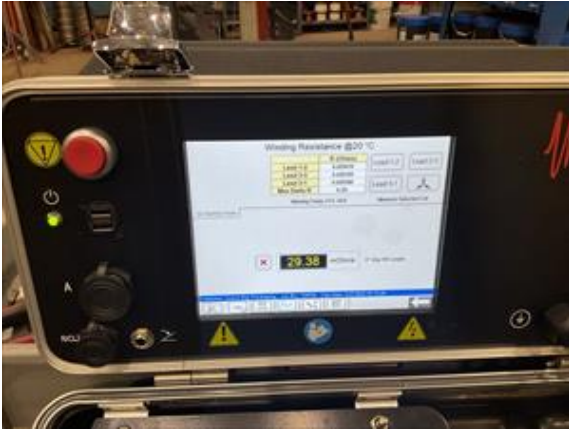
1-2	1-3	2-3
1-2 0.029410	1-3 0.9380	2-3 0.29350

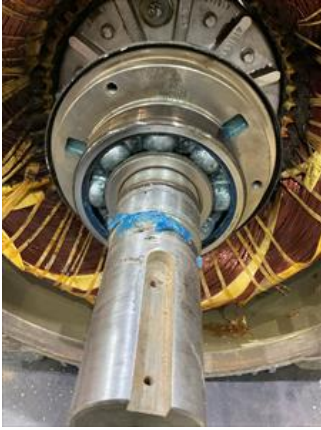
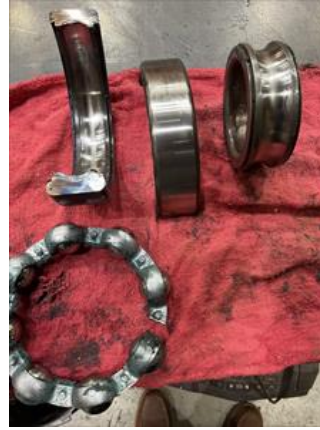
29.	Drive End Bearing Brand	SKF
30.	Drive End Bearing Number-	6313zz
31.	Drive End Bearing Qty.	1
32.	Drive End Bearing Type	(Ball) Ball Bearing
33.	Drive End Lubrication Type	(Grease) Grease Lubricated
34.	Drive End Bearing Insulation or Grounding Device?	
35.	Drive End Wavy Washer/Snap-Ring Other Retention Device?

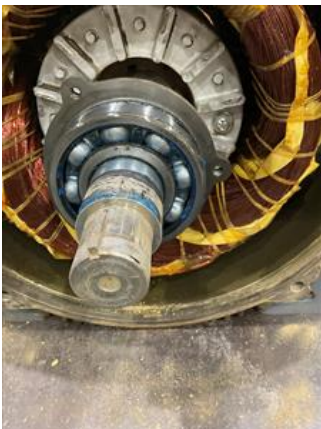
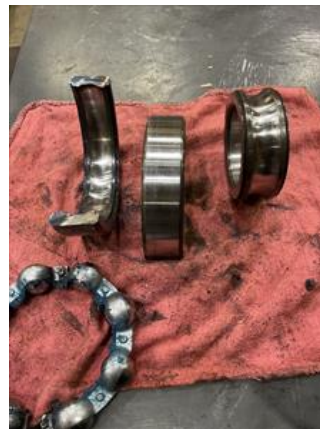
37. Opposite Drive End Bearing Brand	SKF
38. Opposite Drive End Bearing Number-	6313zz
39. Opposite Drive End Bearing Qty.	1
40. Opposite Drive End Bearing Type	(Ball) Ball Bearing
41. Opposite Drive End Lubrication Type	(Grease) Grease Lubricated
42. Opposite Drive End Bearing Insulation or Grounding Device?	
43. Opposite Drive End Wavy Washer/Snap-Ring Other Retention Device?	
<input checked="" type="checkbox"/> <i>Wavy washer</i>	
44. Opposite Drive End Bearing Condition
