**AC Inspection as Found**  
**Saint Jean Industries, Inc. (11653)**  
424 Industrial Park Road  
Heber Springs, AR 72543

**AC Inspection - Rev. 2**

**Location:** LR MOTOR SHOP

**Description:** 300 HP NEMA

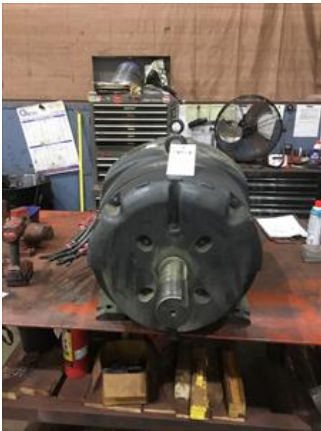
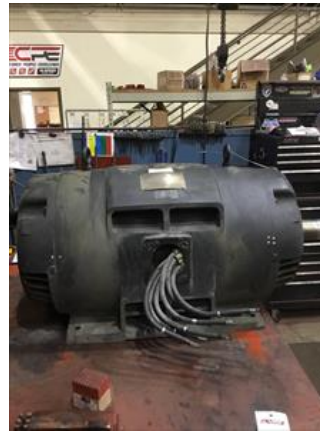
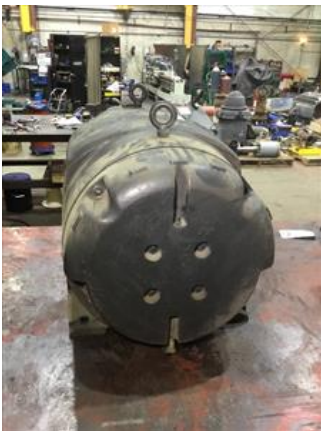
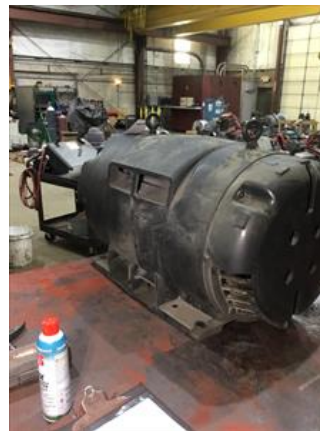
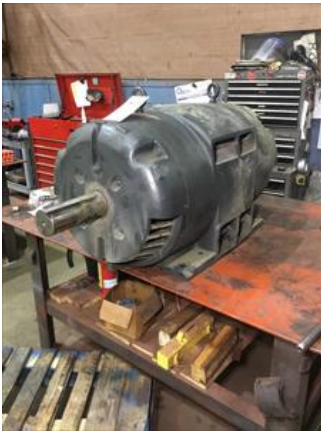
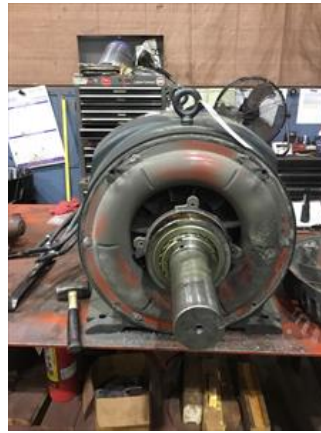
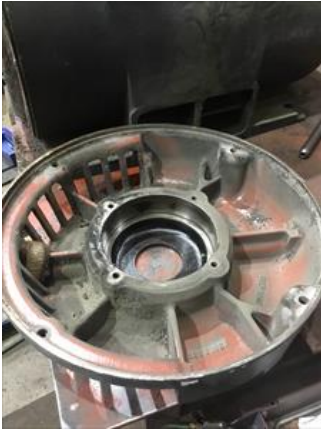
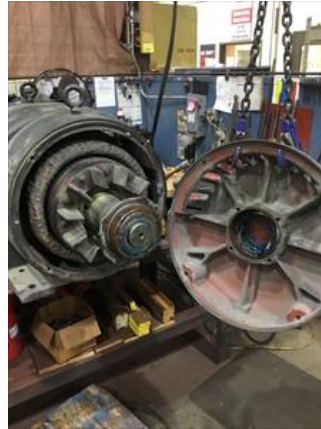
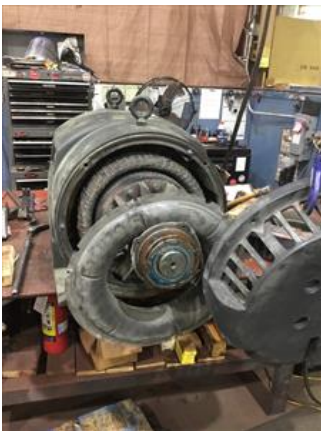
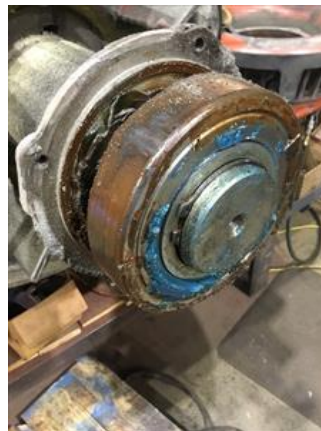
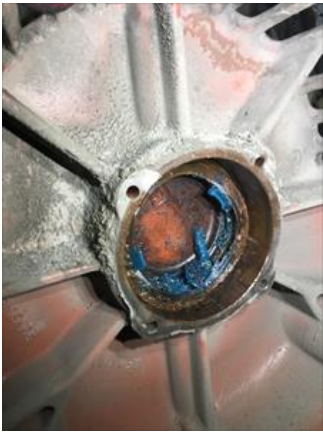
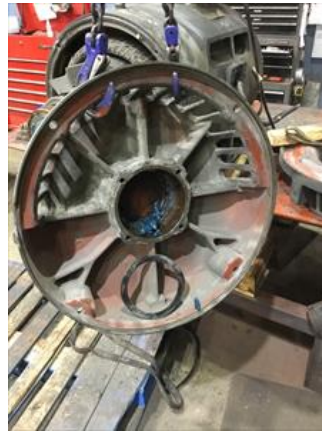
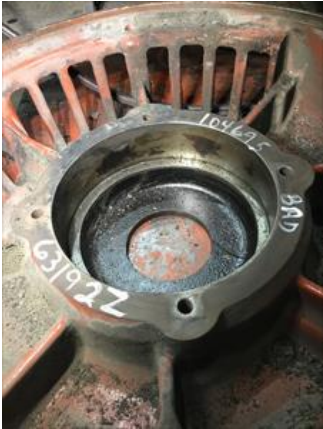
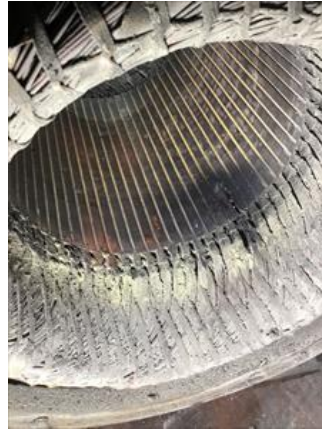
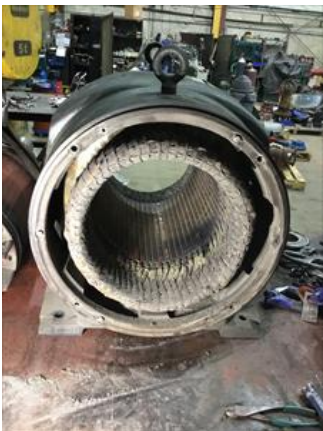
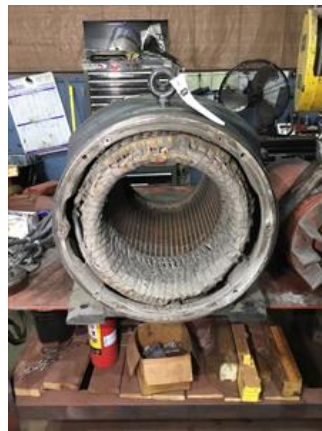
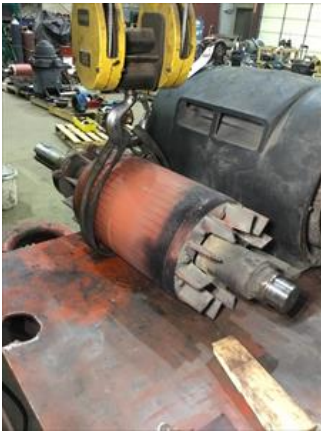
P45

3. Photos of all six sides of the machine.

4. Describe the Overall Condition of the Equipment as Received <i>Serviceable</i>		
5. Is this a UL Listed Motor	(No) No	
6. Is the motor water cooled or can be pressure checked before teardown	(No) No	
<b>Initial Mechanical/Electrical</b>		
7. Does Shaft Turn Freely?	(Y) Yes	
8. Does the shaft require T.I.R in Lathe to identify additional repairs?	(No) No	
9. Does Shaft Have Visible Damage?	(No) No	P26
10. Assembled Shaft Runout	0.001 Inches	
11. Assembled Shaft End Play	0 inches	
12. Air Gap Variation <10%

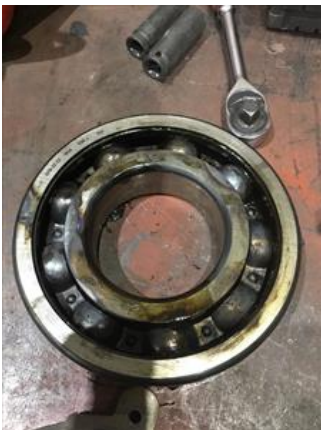
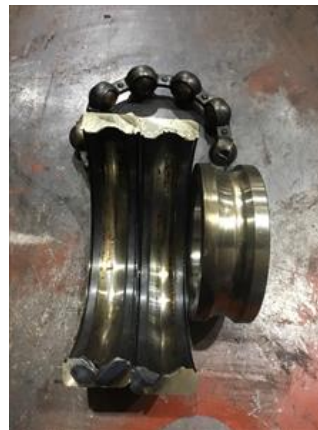
P51

36. Drive End Bearing Condition	<b>worn</b>	
37. Opposite Drive End Bearing Brand	<b>Fag</b>	
38. Opposite Drive End Bearing Number-	<b>6314 2Z/C3</b>	P101

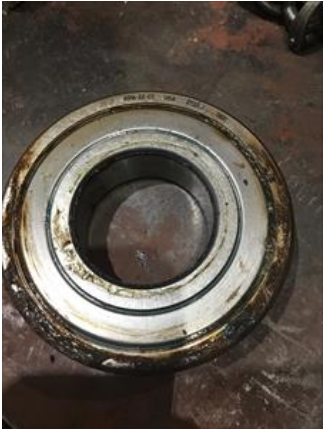
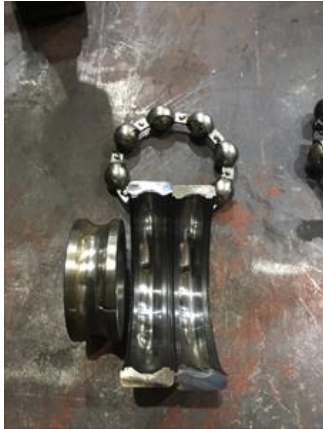
41. Opposite Drive End Lubrication Type	<b>(Grease) Grease Lubricated</b>	
42. Opposite Drive End Bearing Insulation or Grounding Device?	<b>none</b>	
43. Opposite Drive End Wavy Washer/Snap-Ring Other Retention Device?	<b>wavy washer</b>	
44. Opposite Drive End Bearing Condition	<b>worn</b>	
45. Drive End Seal	<b>none</b>	
46. Opposite Drive End Seal	<b>none</b>	
<b>Rotor Inspection</b>

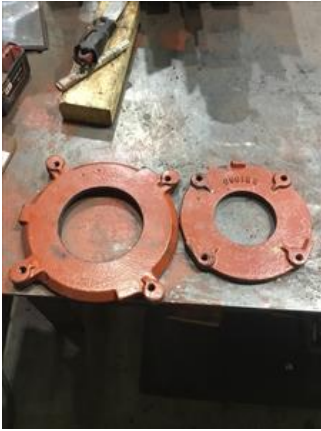
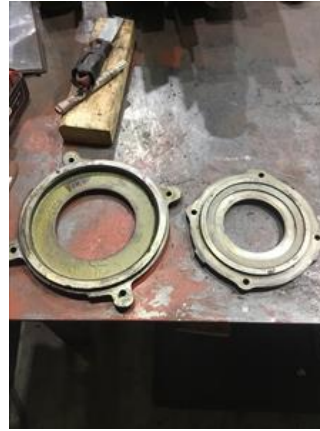
<div>61. Shaft Air Seal Fits</div> <div> <div>Drive End Air Seal</div> <div>Opposite Drive End Air Seal</div> </div>	<div>Mechanical Fits- Bearing Housings</div> <div>62. Drive End - Endbell Bearing Fit</div> <div> <div>0 Degrees</div> <div>60 Degrees</div> <div>120 Degrees</div> </div> <div>Bad</div>		
<div>63. Drive End - Endbell Bearing Fit Condition</div> <div>Excessive wear. See photo below</div> <div>

</div>	<div>(F) Fail</div> <div>P15</div>		
<div>64. Opposite Drive End - Endbell Bearing Fit</div> <div> <div>0 Degrees</div> <div>60 Degrees</div> <div>120 Degrees</div> </div> <div>Bad</div>	<div>65. Opposite Drive End - Endbell Bearing Fit Condition</div> <div>Excessive wear. See photo below.</div> <div>

</div>		
<div>(F) Fail</div> <div>P39</div>
