## AC Inspection as Found

American Kraft Paper

### AC Inspection - Rev. 2

Description: 350 HP GENERAL ELECTRIC

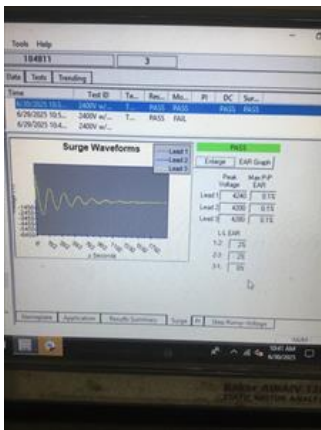
## 25. Perform Surge Test

I(μA)	0.3396
Resist	12075
At 40°C	3803
Surge Status	PASS No Test
Peak Volt(V) L1	4240
Peak Volt(V) L2	4200
Peak Volt(V) L3	4280
Max P-P EAR[...	0.1/0.1/0.1
EAR 1-2/2-3/...	2/2/0
