AC Inspection as Found

Sage V Foods

AC Inspection - Rev. 2

Description: .90 KW BECKER

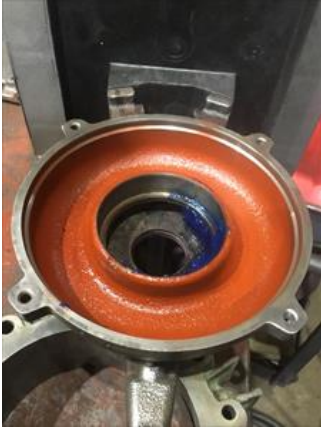
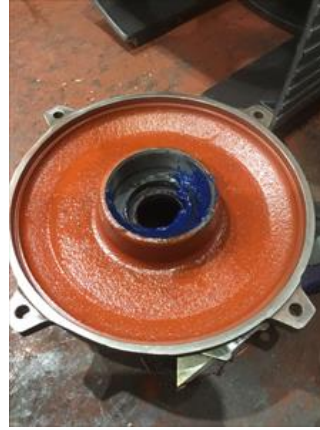
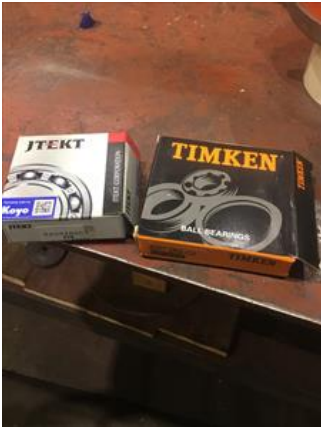
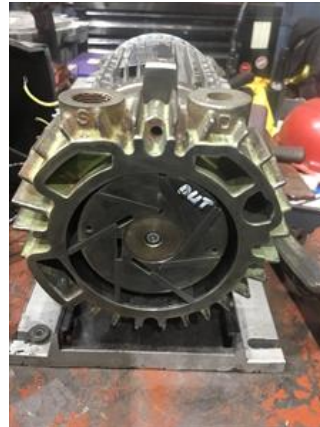
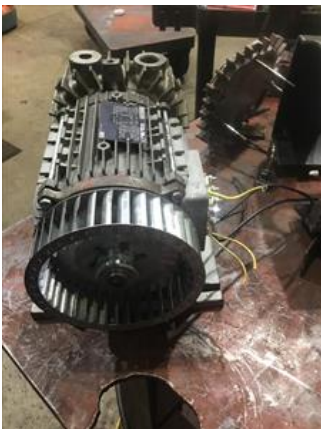
Root Cause of Failure		
70.	Failure locations	
	Pump end	
71.	Root cause of failure	
	Rust in pump end	
Dynamic Balance Report

49.	Number of Rotor Bars	28	
50.	Rotor Condition	acceptable	
51.	List the Parts needed for the Repair Below <i>6207 2RS</i> <i>6205 2RS</i> <i>Filter 90950500</i> <i>Pump Vanes 7971570 BG 21 BECKER WN 124-162</i> <i>Wash and bake</i>
