AC Inspection as Found
ARKANSAS INDUSTRIAL MACHINERY
3804 N. NONA ST
NORTH LITTLE ROCK, AR 72118

AC Inspection - Rev. 2

Location: LR MOTOR SHOP

Description: 200 HP QUINCY COMPRESSOR
PREVENTATIVE MAINTENANCE

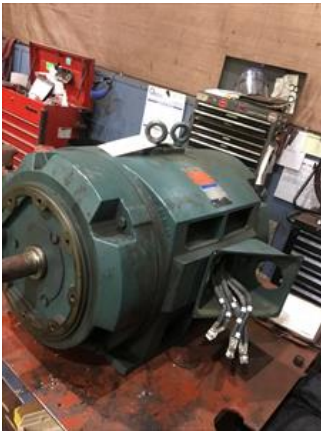
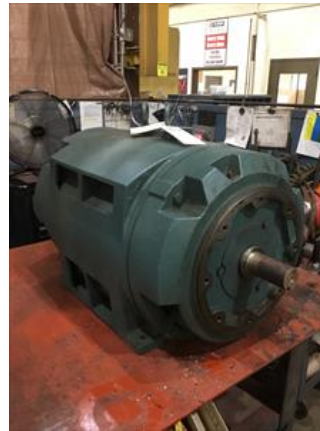
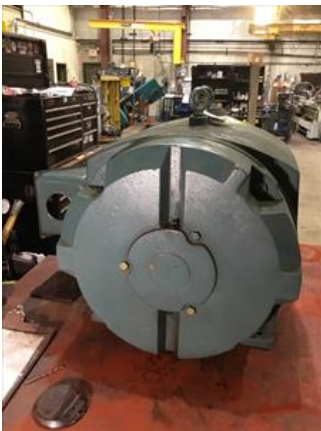
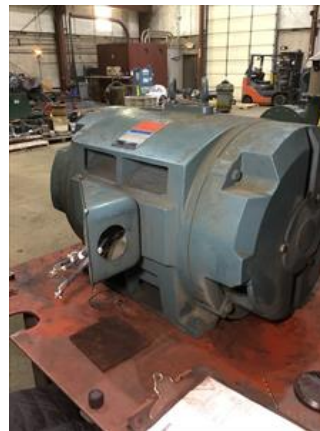
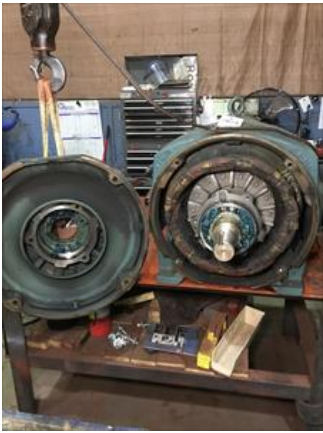
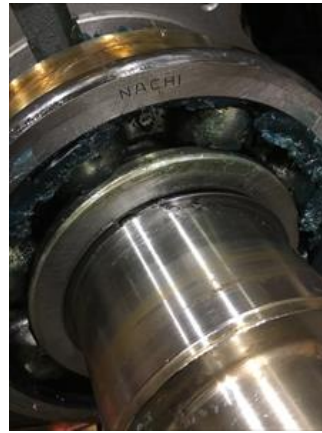
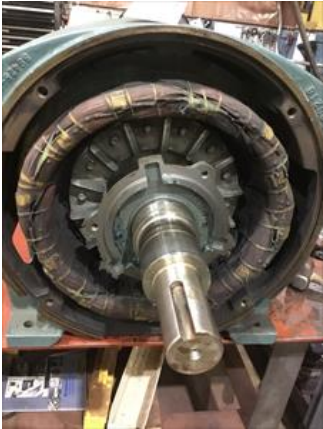
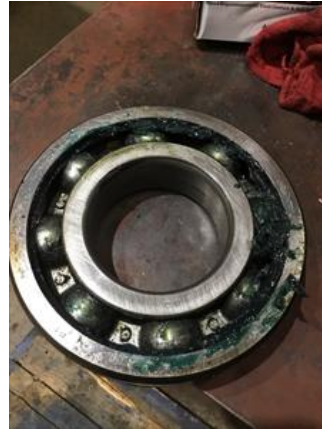
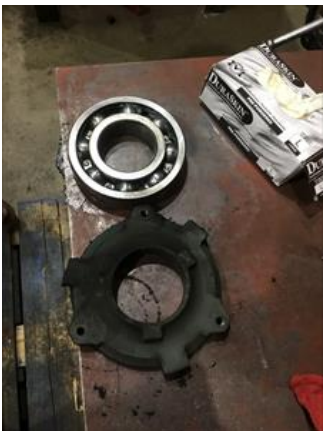
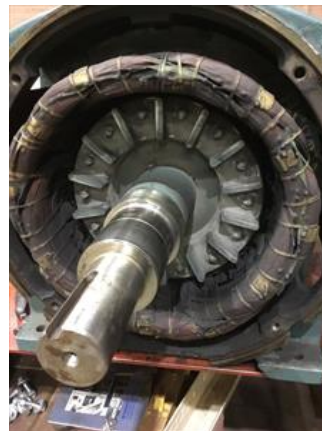
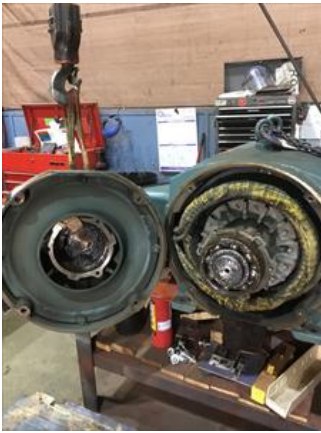
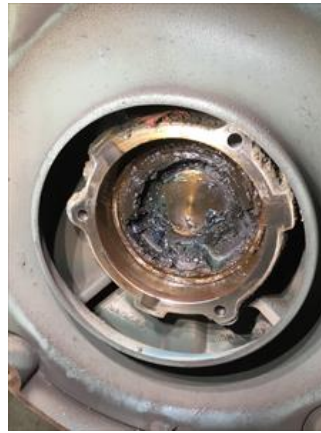
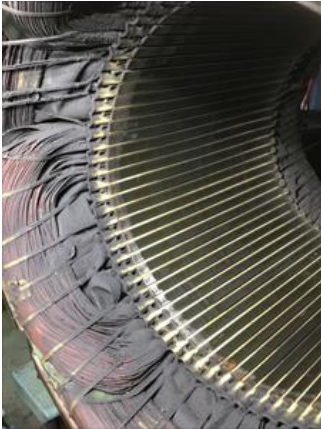
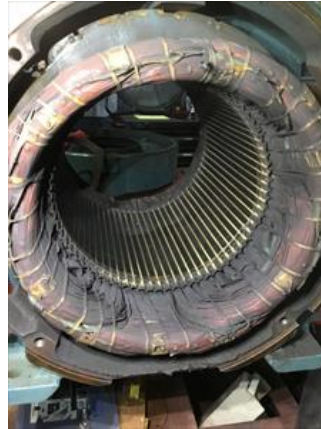
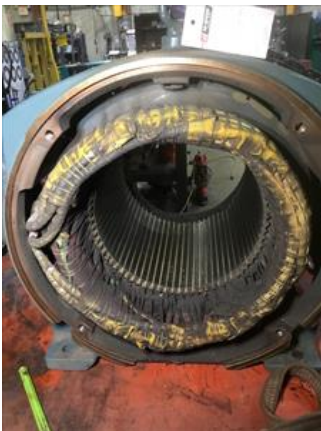
3. Photos of all six sides of the machine.

4.	Describe the Overall Condition of the Equipment as Received	
	<i>Serviceable</i>	
5.	Is this a UL Listed Motor	(NO) NO
6.	Is the motor water cooled or can be pressure checked before teardown	(NO) NO
Initial Mechanical/Electrical		<input type="checkbox"/>
7.	Does Shaft Turn Freely?	(Y) Yes
8.	Does the shaft require T.I.R in Lathe to identify additional repairs?	(NO) NO

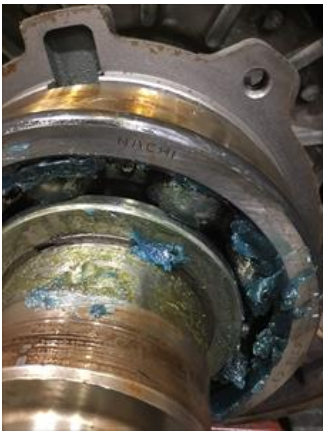
31. Drive End Bearing Qty.	1
32. Drive End Bearing Type	(Ball) Ball Bearing
33. Drive End Lubrication Type	(Grease) Grease Lubricated
34. Drive End Bearing Insulation or Grounding Device?	none
35. Drive End Wavy Washer/Snap-Ring Other Retention Device?	snap ring
36. Drive End Bearing Condition	replace

Contaminated grease.	
37. Opposite Drive End Bearing Brand	nachi

51. List the Parts needed for the Repair Below 2) 6318 2Z/C3 bearings 1) 318 sleeve for ODE housing fit			
52. Signature of Technician that Disassembled Motor	Terrence Holland

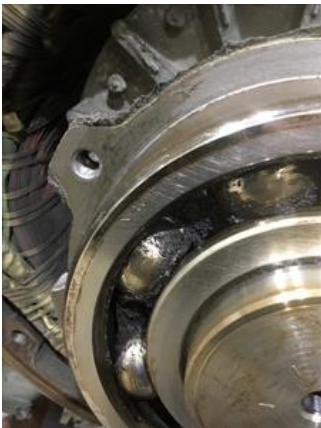
39.	Opposite Drive End Bearing Qty.	1	
40.	Opposite Drive End Bearing Type	(Ball) Ball Bearing	
41.	Opposite Drive End Lubrication Type	(Grease) Grease Lubricated	
42.	Opposite Drive End Bearing Insulation or Grounding Device?		
43.	Opposite Drive End Wavy Washer/Snap-Ring Other Retention Device?	wavy washer	P115

44.	Opposite Drive End Bearing Condition	replace
	Contaminated grease	
45.	Drive End Seal	
46.	Opposite Drive End Seal

Fail

Excessive wear. Lip worn in housing.
