Hi-Speed Industrial Service
7030 Ryburn Dr
Millington, Tn 38053
901-873-5300

AC Inspection as Found

REMURIAE

Location: MLMR
Serial Number: LSFT322U039
Description: 500 HP AC

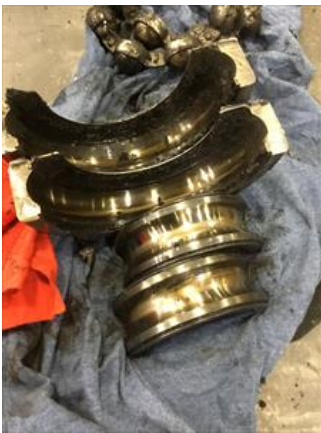
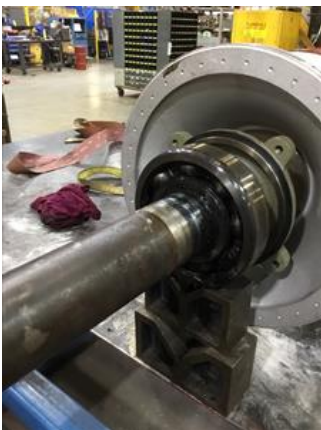
33. Drive End Bearing Number-	6315 zC3
34. Drive End Bearing Qty.	1
35. Drive End Bearing Type	(Ball) Ball Bearing
36. Drive End Lubrication Type	(Grease) Grease Lubricated
37. Drive End Bearing Insulation or Grounding Device?	None
38. Drive End Wavy Washer/Snap-Ring Other Retention Device?	None
39. Drive End Bearing Condition	fluted

Passed all electrical tests. Shaft is bent and requires repair. Stator passed all electrical tests. Shaft is bent and requires repair as well as machine work to both end bells. Drive end bearing shows electrical fluting.? Recommend adding aegis ring to drive end and insulated bearing on opposite drive end.
