Hi-Speed Industrial Service
7030 Ryburn Dr
Millington, Tn 38053
901-873-5300

AC Inspection as Found
MOTOR - KTG USA
400 Mahannah
Memphis, TN 38107

AC Inspection - Rev. 2

Location: MLMR
Serial Number: Q2 G14T0326NPI
Description: 100HP AC

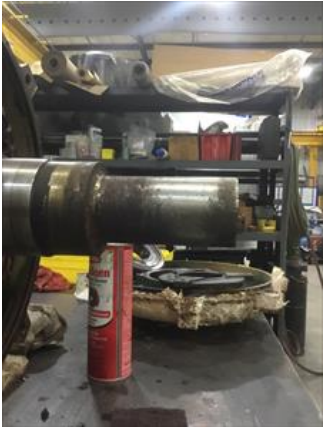
Mechanical Fits- Rotor			
50.	Shaft Runout	0.001 inches	
51.	Rotor Runout		
	Drive End Bearing Fit	Rotor Body	Opposite Drive End Bearing
	0.001	0.001	0.001
52.	Coupling Fit Closest to Bearing Housing		
	0 Degrees	90 Degrees	120 Degrees
	2.125	2.125	2.125

53.	Coupling Fit Closest to the end of the Shaft		
	0 Degrees	60 Degrees	120 Degrees
	2.125	2.125	2.125
