AC Inspection as Found
UNITED SOLUTIONS
 1052 INDUSTRIAL PARK RD
 SARDIS, MS 38666

AC Inspection - Rev. 2

Hi-Speed Job Number:	154620
Manufacturer:	Other
HP/kW:	115 (kW)
RPM:	2500 (RPM)
Voltage:	Other
Current:	205 (Amps)
Phase:	Three
Hz:	125 (Hz)
# of Leads:	3
J-box Included:	Complete
Coupling/Sheave:	None
Date Received:	02/03/2025
Bearing RTDs:	No
Stator RTDs:	Yes
Repair Stage:	Teardown Inspection
Heaters:	No
Winding Type :	Random Wound
Bearing Type:	Rolling Element

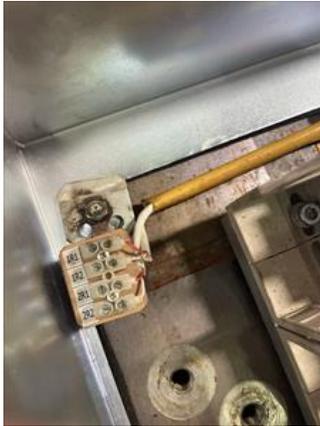
16. Frame Condition	Good
17. Fan Condition	(N) NA
18. Does motor have internal fan?	(No) No
19. Broken or Missing Components	none

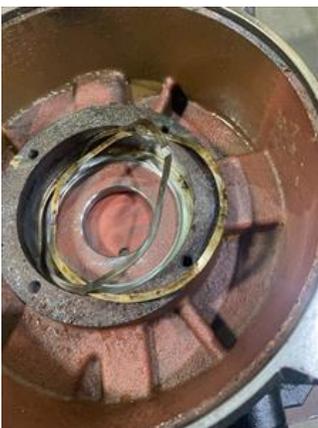
34. Drive End Bearing Condition	good	
35. Opposite Drive End Bearing Brand	Fag	
36. Opposite Drive End Bearing Number-	6311-2RSR-C3	P39

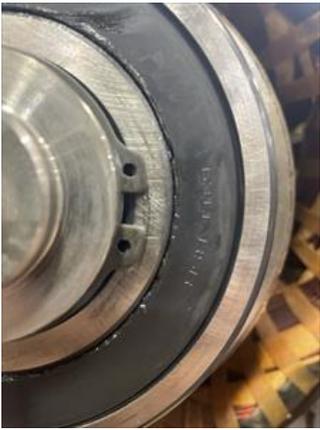
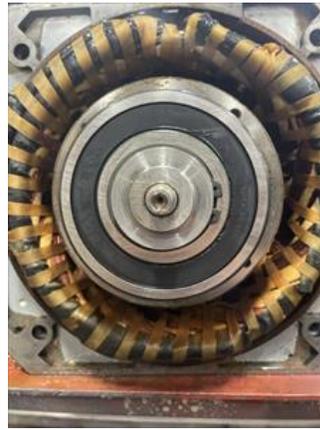
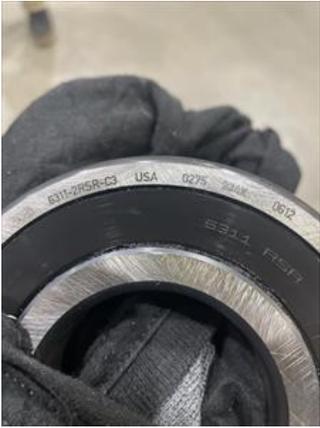
Sealed bearing

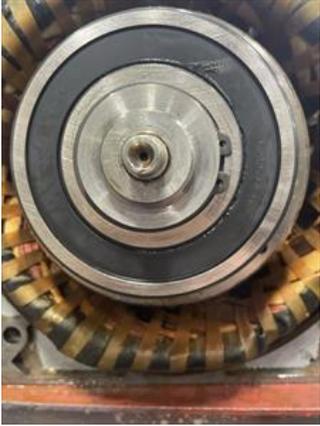
42. Opposite Drive End Bearing Condition	good	
43. Drive End Seal	none	
44. Opposite Drive End Seal	none	
Rotor Inspection		
45. Rotor Type/Material	(Aluminum Bar) Aluminum Barred Rotor
