Hi-Speed Industrial Service
7030 Ryburn Dr
Millington, Tn 38053
901-873-5300

AC Inspection as Found

USG Interiors
850 No Broadway
Greenville, MS 38701

Location: Millington Motorshop
Serial Number: S9027482-001005 AM
Description: 100 HP AC

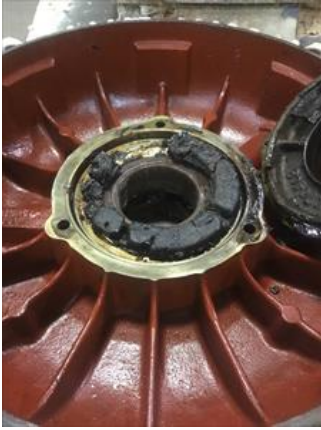
27. Drive End Bearing Number-	6316 C3
28. Drive End Bearing Qty.	1
29. Drive End Bearing Type	(Ball) Ball Bearing
30. Drive End Lubrication Type	(Grease) Grease Lubricated
31. Drive End Bearing Insulation or Grounding Device?	None
32. Drive End Wavy Washer/Snap-Ring Other Retention Device?	None
33. Drive End Bearing Condition	Destroyed to remove from end bell
34. Opposite Drive End Bearing Brand	SKF
35. Opposite Drive End Bearing Number-	6316 C3
36. Opposite Drive End Bearing Qty.	1
37. Opposite Drive End Bearing Type	(Ball) Ball Bearing
38. Opposite Drive End Lubrication Type	(Grease) Grease Lubricated
39. Opposite Drive End Bearing Insulation or Grounding Device?	None
40. Opposite Drive End Wavy Washer/Snap-Ring Other Retention Device?	Wavy Washer
41. Opposite Drive End Bearing Condition	normal wear
42. Drive End Seal	None
43. Opposite Drive End Seal	Nine
