AC Inspection as Found

Big River Steel (004767)

AC Inspection - Rev. 2

Location: Melt Shop

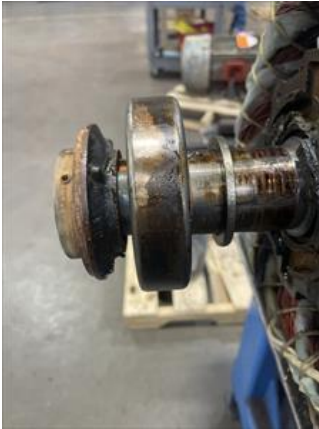
P3

3. Photos of all six sides of the machine.

4. Describe the Overall Condition of the Equipment as Received
Motor failed winding resistance and meg so it is in need of a rewind

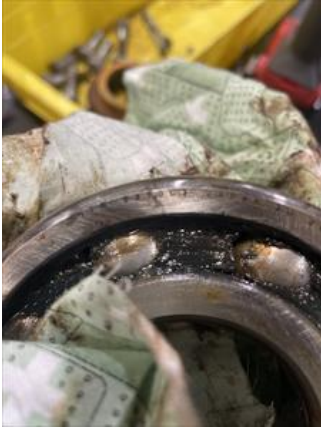
33.	Drive End Bearing Condition	good	
34.	Opposite Drive End Bearing Brand	nin

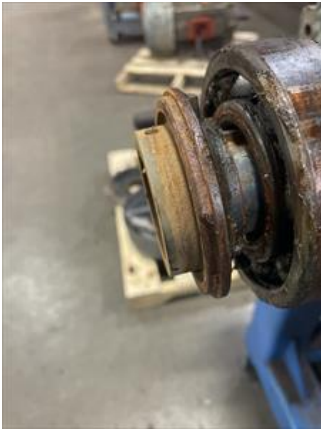
36. Opposite Drive End Bearing Qty.	1
37. Opposite Drive End Bearing Type	(Ball) Ball Bearing
38. Opposite Drive End Lubrication Type	(Grease) Grease Lubricated
39. Opposite Drive End Bearing Insulation or Grounding Device?	none
40. Opposite Drive End Wavy Washer/Snap-Ring Other Retention Device?	lock collar

41. Opposite Drive End Bearing Condition	good
42. Drive End Seal	none
43. Opposite Drive End Seal	none
