**AC Inspection as Found**  
**MARS FOOD (0001269)**  
1098 N. Broadway  
Greenville, MS 38701

**AC Inspection - Rev. 2**

Description: 11KW AC

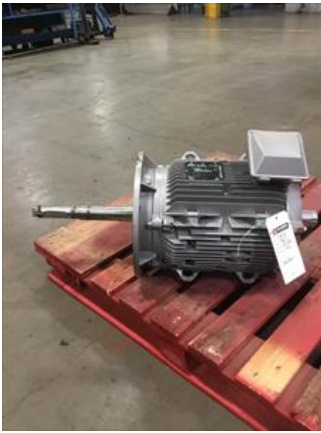
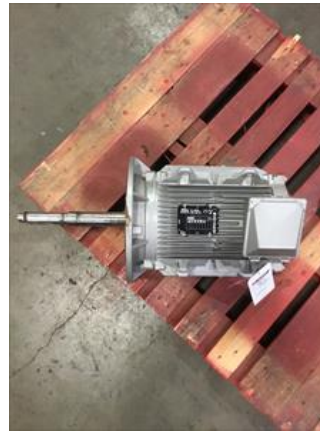
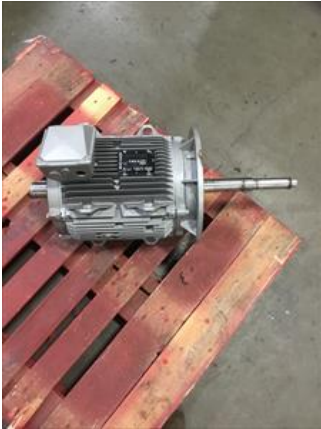
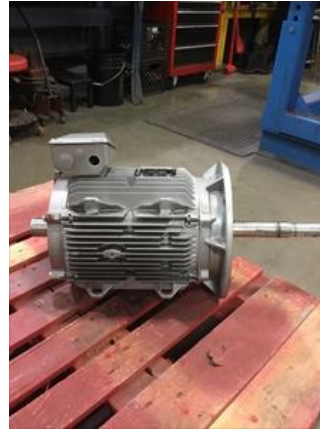
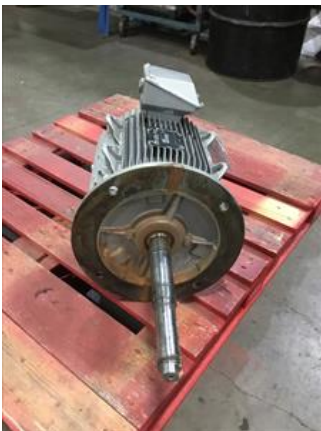
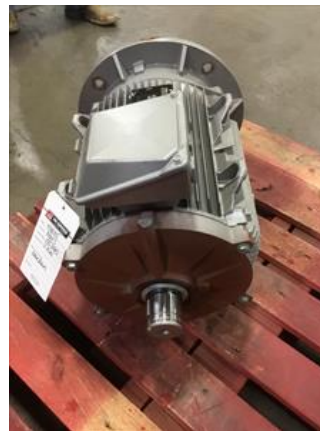
| 3. Photos of all six sides of the machine. | P3 |

4. Describe the Overall Condition of the Equipment as Received		
<i>Stator passed all electrical tests. Drive end bearing failed. Needs bore and bushing installed in opposite drive end and damaged end of shaft filed.</i>		
<input checked="" type="radio"/>	5. Is this a UL Listed Motor	(No) No
<input checked="" type="radio"/>	6. Is the motor water cooled or can be pressure checked before teardown	(No) No
<b>Initial Mechanical/Electrical</b>		<input type="checkbox"/>
<input checked="" type="radio"/>	7. Does Shaft Turn Freely?	(N) No
<input checked="" type="radio"/>	8. Does the shaft require T.I.R in Lathe to identify additional repairs?	(No) No

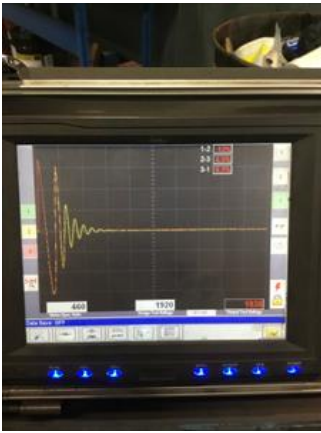
25. Number of Stator Slots	48	
26. Stator Condition	Pass	P26
<div>

<i>Stator had moisture present. Stator was dried out and retested.</i> </div>

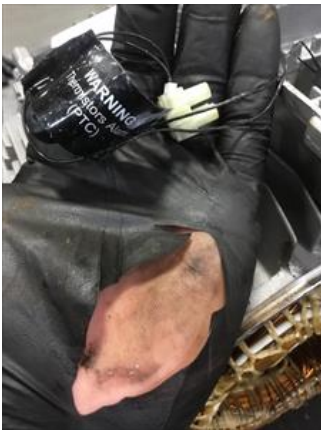
27. Stator Thermistors/Ohms	230	P27
-----------------------------	-----	-----

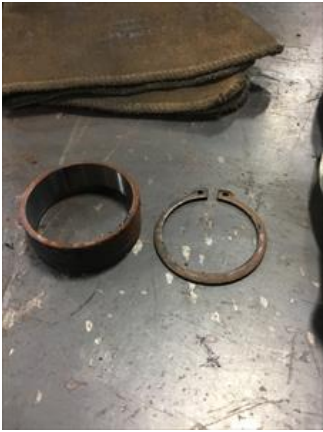
34. Drive End Bearing Insulation or Grounding Device?	None	
35. Drive End Wavy Washer/Snap-Ring Other Retention Device?	Snap Ring and seal sleeve	P35

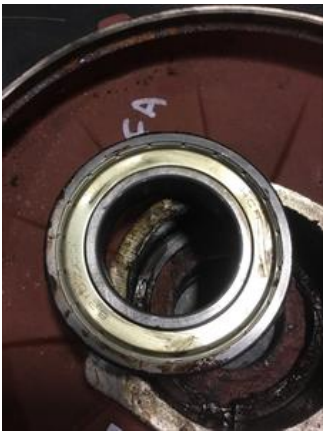
37. Opposite Drive End Bearing Brand	HCH	P37

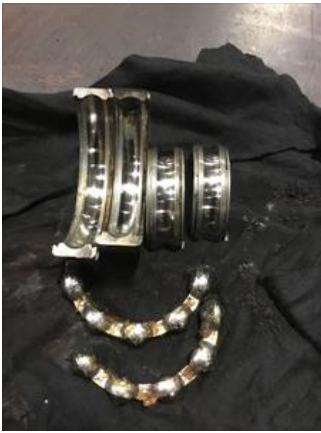
38. Opposite Drive End Bearing Number-	6210 2RS C3	
39. Opposite Drive End Bearing Qty.	1	
40. Opposite Drive End Bearing Type	(Ball) Ball Bearing	
41. Opposite Drive End Lubrication Type	(Grease) Grease Lubricated	
42. Opposite Drive End Bearing Insulation or Grounding Device?	None	
43. Opposite Drive End Wavy Washer/Snap-Ring Other Retention Device?	Wavy Washer	
44. Opposite Drive End Bearing Condition	Normal wear	P44

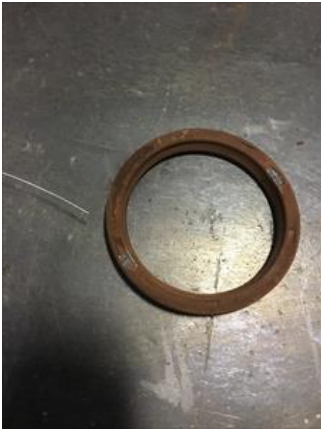
P45

45. Drive End Seal

50 62 7

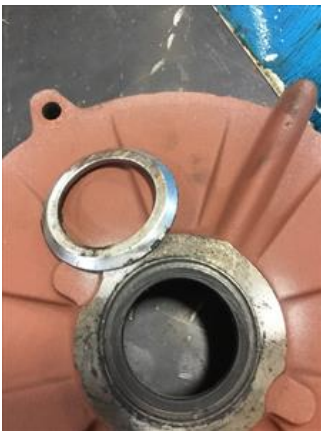
P46

46. Opposite Drive End Seal

VA50

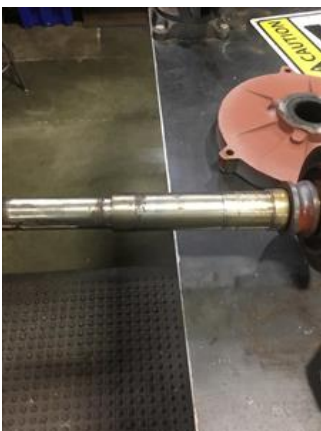
P55

55. Coupling Fit Closest to Bearing Housing

0 Degrees	90 Degrees	120 Degrees
<b>1.378</b>	<b>1.378</b>	<b>1.378</b>
