NuVasive
Memphis, TN
March 2025 Infrared Survey Report

On March 13, 2025, all electrical breaker panels, transformers, disconnects in the entire facility along with the main switch distribution panels outside were scanned using a

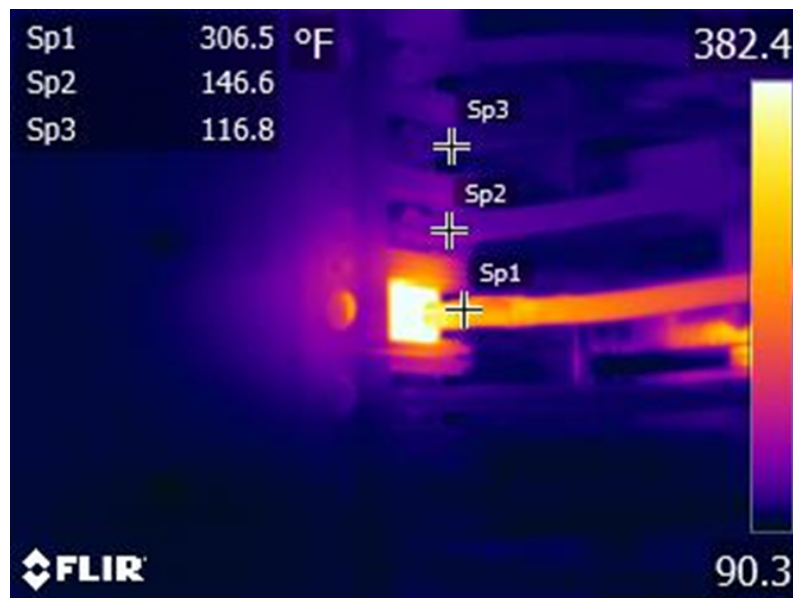
IR image shows no heat on far left fuse circuit. Amp load was checked while on site by Gephart tech. We found zero current on the far left fuse. There is a balanced load on the other two fuses. This may or may not be an issue. We recommend further investigation to determine why no load exists on this circuit.
