## AC Recondition As Found

### Sage V Foods

#### AC Recondition - Rev. 2

Description: 50HP Baldor 1800RPM 326TDZ

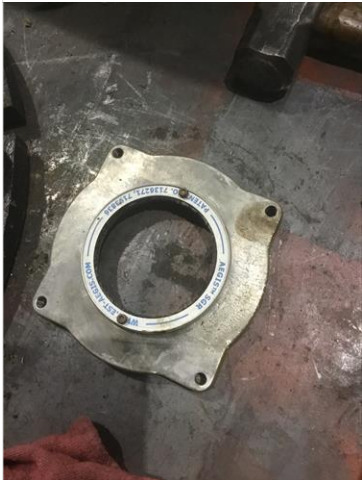
<b>Mechanical Inspection</b>			
18. Drive End Bearing Number-	6312		
19. Drive End Bearing Qty.	1		
20. Drive End Bearing Type	(Ball) Ball Bearing		
21. Drive End Lubrication Type	(Grease) Grease Lubricated		
22. Drive End Bearing Insulation or Grounding Device?	Aegis

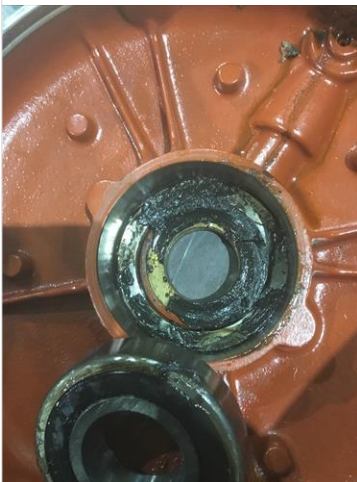
25. Opposite Drive End Bearing Number-	<b>6311</b>
26. Opposite Drive End Bearing Qty.	<b>1</b>
27. Opposite Drive End Bearing Type	<b>(Ball) Ball Bearing</b>
28. Opposite Drive End Lubrication Type	<b>(Grease) Grease Lubricated</b>
29. Opposite Drive End Bearing Insulation or Grounding Device?	<b>no</b>
30. Opposite Drive End Wavy Washer/Snap-Ring Other Retention Device?	<b>wavy washer</b>

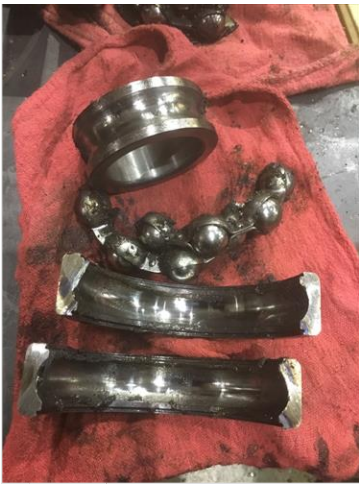
P32

32. Drive End Seal

Inpro

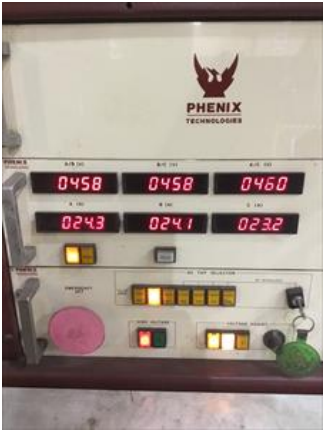
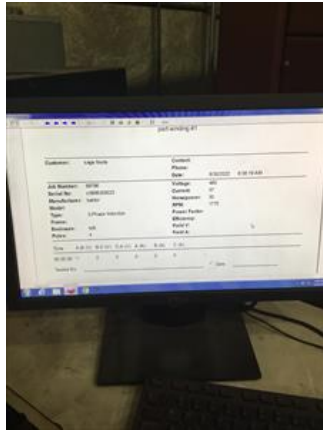
85.	Final Insulation Resistance Test		
86.	Assembled Shaft Endplay		
87.	Assembled Shaft Runout		
88.	Test Run Voltage		
	Volts	Volts	Volts
89.	Test Run Amperage		
	Amps	Amps	Amps
90.	Drive End Vibration Readings - Inches Per Second		
	Horizontal	Vertical	Axial
91.	Opposite Drive End Vibration Readings - Inches Per Second		
	Horizontal	Vertical	Axial
92.	Ambient Temperature - Fahrenheit		
93.	Drive End Bearing Temps - Fahrenheit		
	5 Minutes	10 Minutes	15 Minutes
94.	Opposite Drive End Bearing Temps - Fahrenheit		
	5 Minutes	10 Minutes	15 Minutes
95.	Final Test Run Sign-off		
96.	Document Final Condition with Pictures after paint

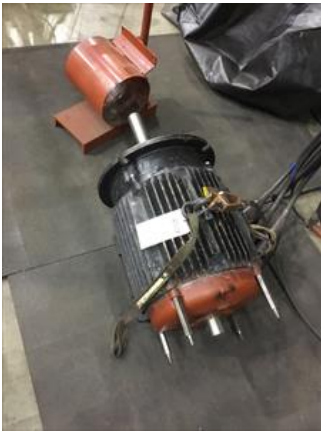
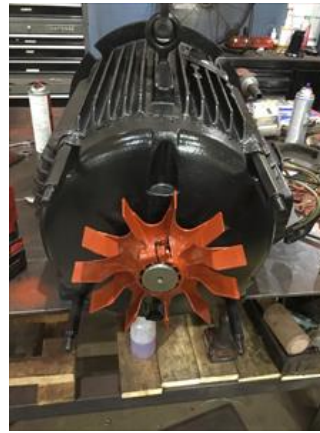
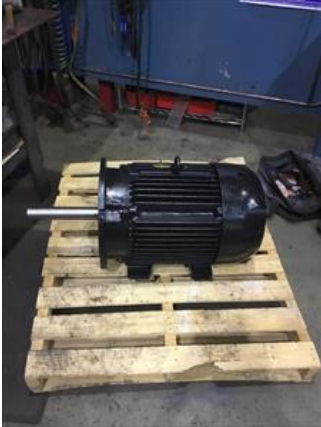
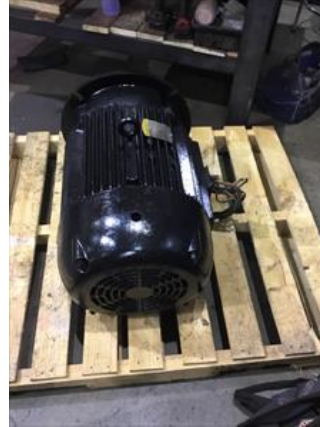
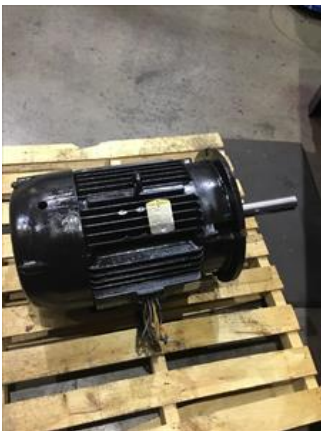
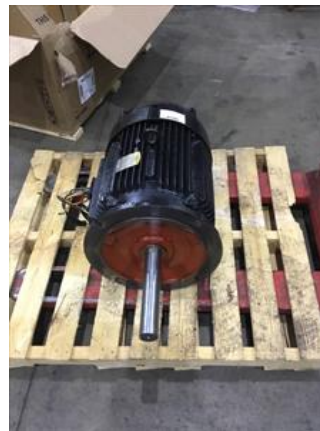
P2200
97.	Final Pics and QC Review		<b>Terrence. Holland</b>
