AC Recondition As Found

Sage V Foods

AC Recondition - Rev. 2

Location: MOTOR SHOP LR
Serial Number: C0906200018
Description: 50HP Baldor 1800RPM 326TDZ

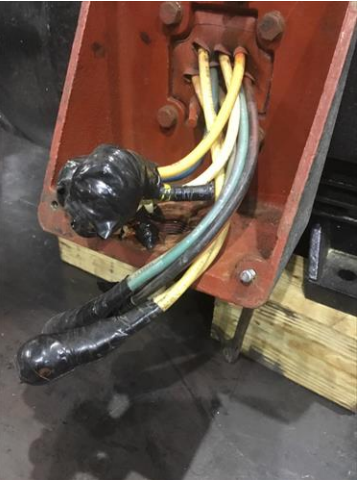
3. Describe the Overall Condition of the Equipment as Received
Shaft excessively bent...greater than 2.987

<i>Bent key way. Chunk missing out of shaft.</i>		
7.	Assembled Shaft Runout	2.987 Inches	
8.	Assembled Shaft End Play	0 inches	
9.	Air Gap Variation <10%		
10.	Lead Condition	(P) Pass	P31

55.	End Bell Air Seal Fits		
	Drive End Air Seal	Opposite Drive End Air Seal	
56.	List Machine Work Needed Below <i>New shaft.</i>		
57.	Technician		Terrence. Holland

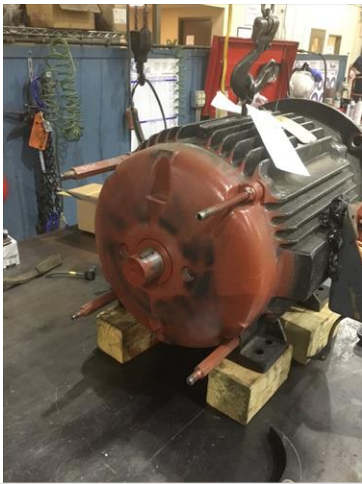
P56

in pro seals worn

35. Rotor Type/Material	(Squirrel Aluminum) Squirrel Cage Aluminum Die Cast
36. Growler Test	(Pass) Pass
37. Number of Rotor Bars	40
38. Rotor Condition	fail. shaftbent
39. List the Parts needed for the Repair Below <i>In pro seal,</i>	
40. Signature of Technician that Disassembled Motor	Terrence. Holland

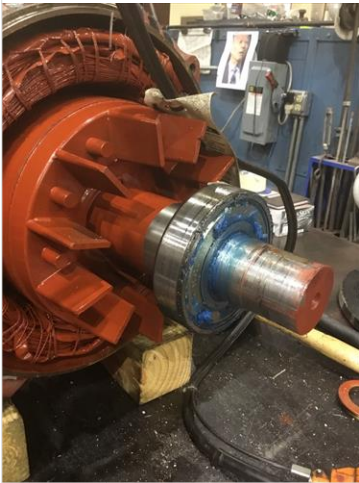
P55

32. Opposite Drive End Bearing Condition

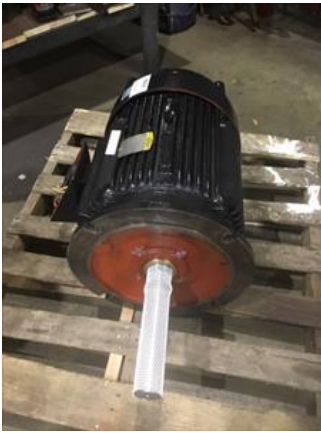
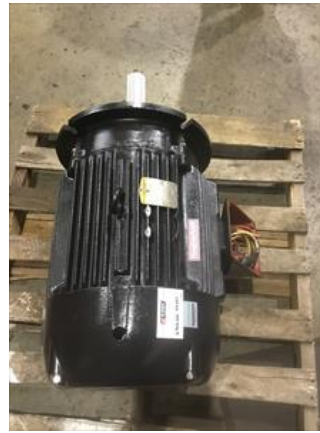
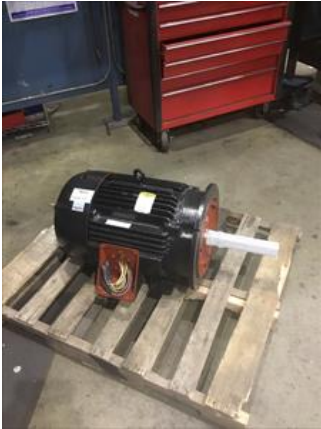
P2200

97. Document Final Condition with Pictures after paint
