AC Recondition As Found

Kroger

AC Recondition - Rev. 2

Description: 6HP ILG INDUSTRIES 900RPM 32
FRAME

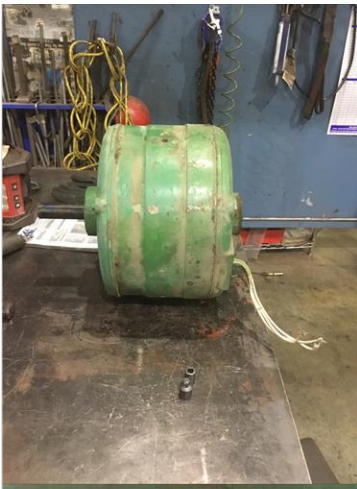
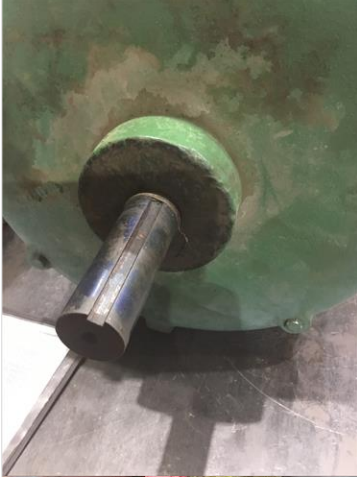
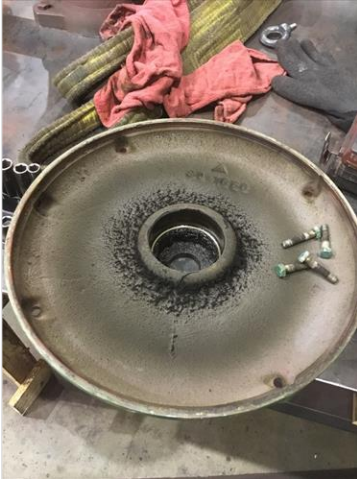
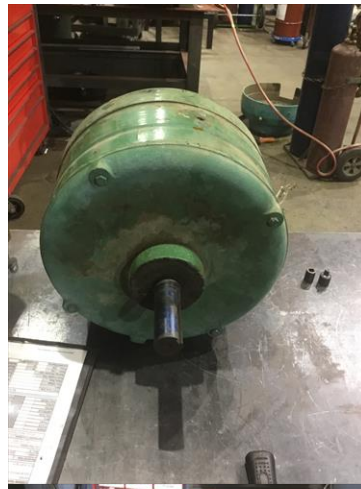
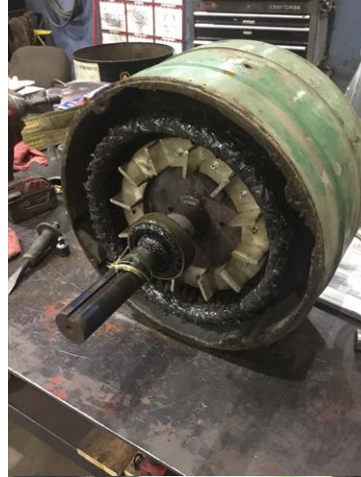
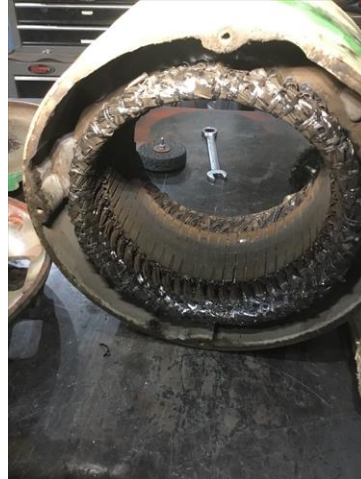
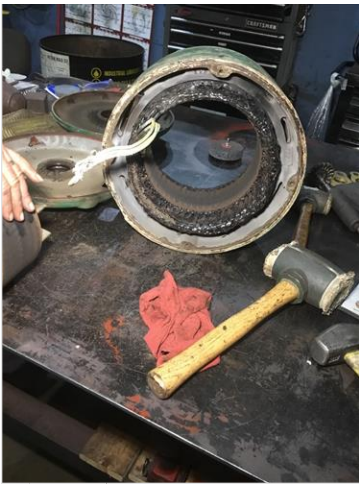
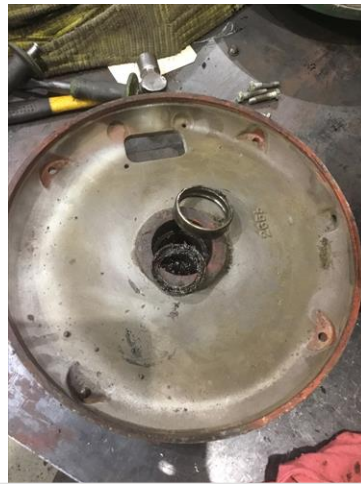
4. Photos of all six sides of the machine.

3. Describe the Overall Condition of the Equipment as Received

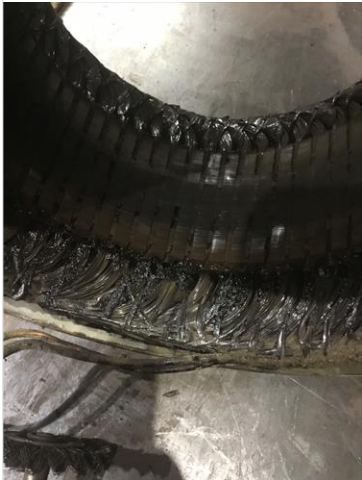
15.	Insulation Resistance/Megger	Megohms	
16.	Winding Resistance		
	1-2	1-3	2-3
17.	Perform Surge Test	(NA) Not Applicable	P32

18.	Stator Condition	good	
Mechanical Inspection

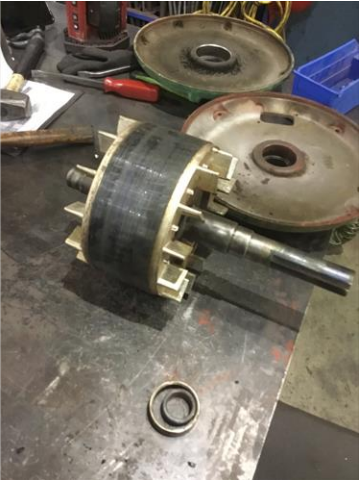
</div>			
35.	Rotor Type/Material	(Squirrel Aluminum) Squirrel Cage Aluminum Die Cast	P3
<div style="display: flex; justify-content: space-around;">

</div>			
36.	Growler Test	(Pass) Pass	
37.	Number of Rotor Bars		
38.	Rotor Condition	good	
39.	List the Parts needed for the Repair Below		
40.	Signature of Technician that Disassembled Motor	Terrence. Holland
