# **Job Information**

Job #:	94779				Date:	October 4, 2018
Priority:	_	Authorized OT:	No	Authorized by:

Manufacturer:	Siemens	Enclosure :	Totally Enclosed Fan Cooled
Serial#:	E120818165472300 6	Model#:	1LA9166-4KA99- ZT00
Service Factor:		Frame:	
Horsepower/kW:	30 kW	Rated RPM:	4170
Rated Amps:	70	Rated Voltage:	370
Phase:	3	Cycles:	60
Special design:	No

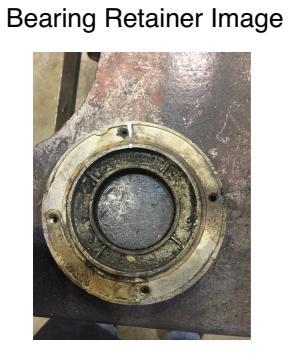
Bearings DE:	Worn	Bearings DE make:	SKF
Insulated:	No	Bearing DE Size:	NU208 EC
Bearings ODE:	Worn	Bearings ODE make:	SKF
Bearing Type:	Roller	Bearing ODE Size:	6209 ZZ
Bearings Retainer:	Yes	Thermal Protection:	No
Retainer condition:	Good	Thermal Protection Type:	_

ODE bearing failed, ODE bearing journal is bad, windings grounded

ODE bearing failed from lack of lubrication. ODE has no grease zert to add grease to lube the bearing
