December 6, 2022

Infrared Thermography Report

Arcosa Marine Fiberglass Plant

Caruthersville, MO

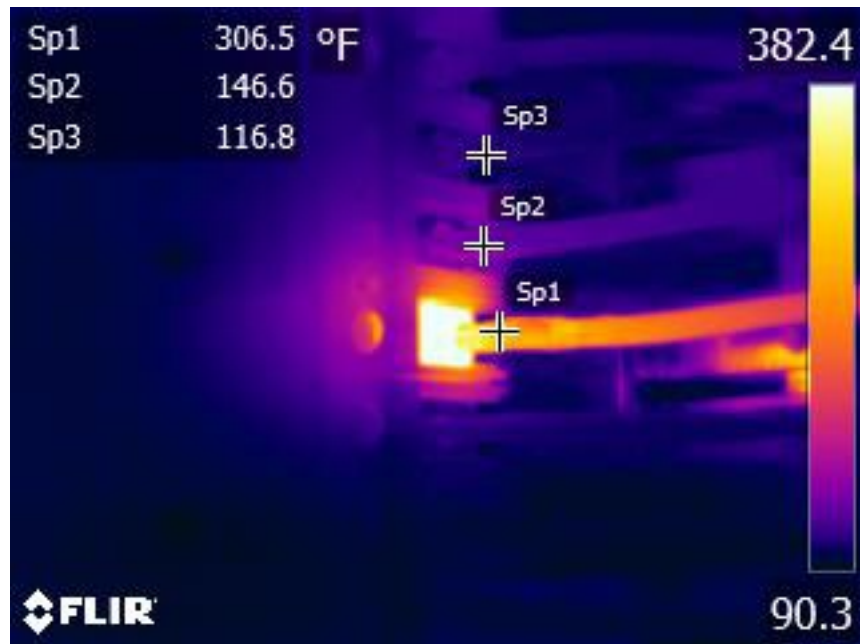
Component	B Phase Fuse Clip/Fuse
Equipment/Bucket ID	South Dust Collection System (Trim Area)

Fault	Loose fuse clip/Fuse connection
Defect Rating	CLASS I

Recommendations
B phase fuse/fuse clip appears to have an issue. Check fuse clip and fuse ensuring that there is a tight/clean connection.
