# QualiTest IR Radiometric Survey Report

Chemours  
HCN

| Job Number | 141407 |
| Survey Date | 12/17-18/19 |

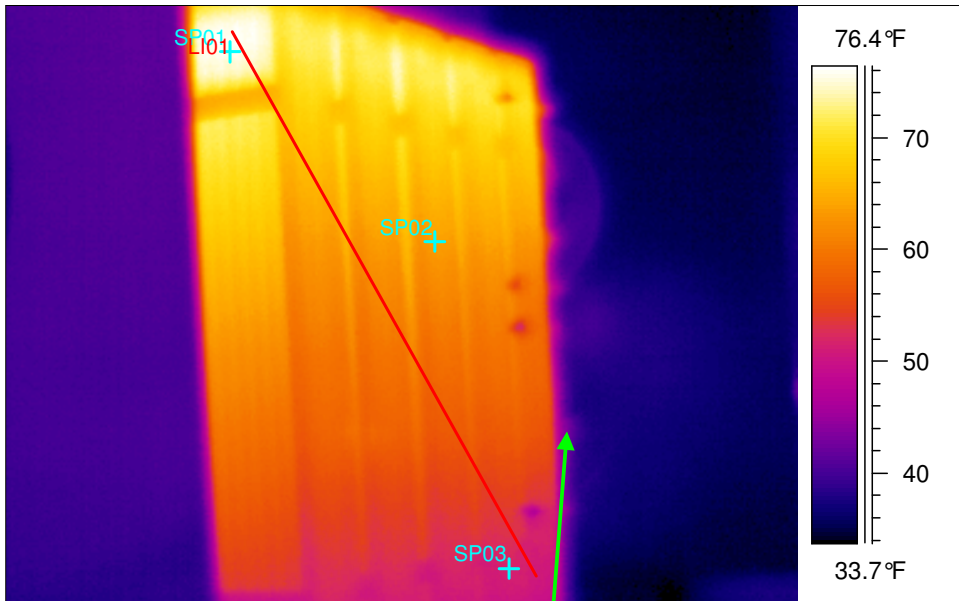
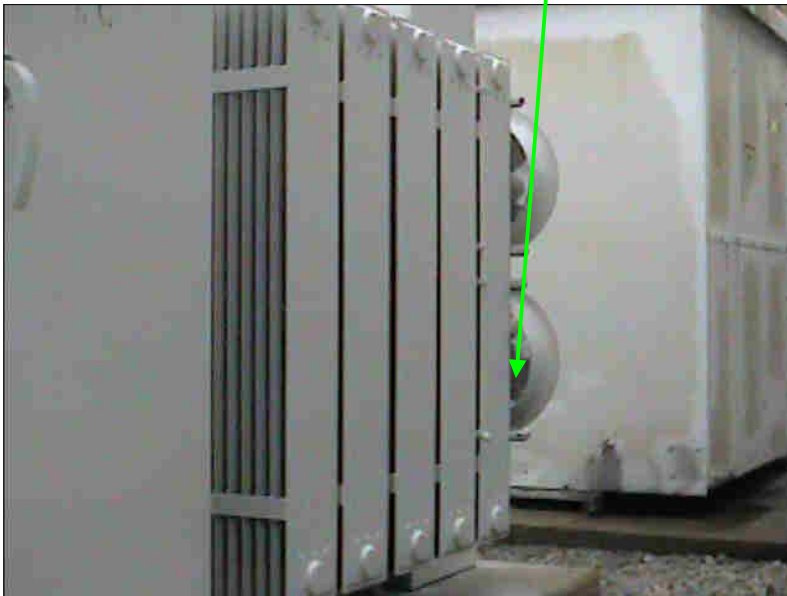
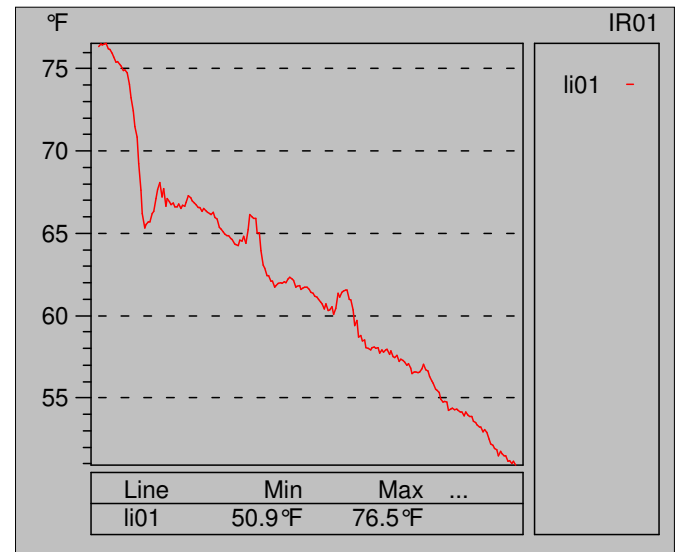
| Component | Equipment/Bucket ID | Plant/Area | Date |
|---|---|---|---|
| South Radiator | SUB 247 | HCN | 12-26-19 |

| <b>Fault</b> | None |
| <b>Defect Rating</b> | NA |

Operating normally, no issues.

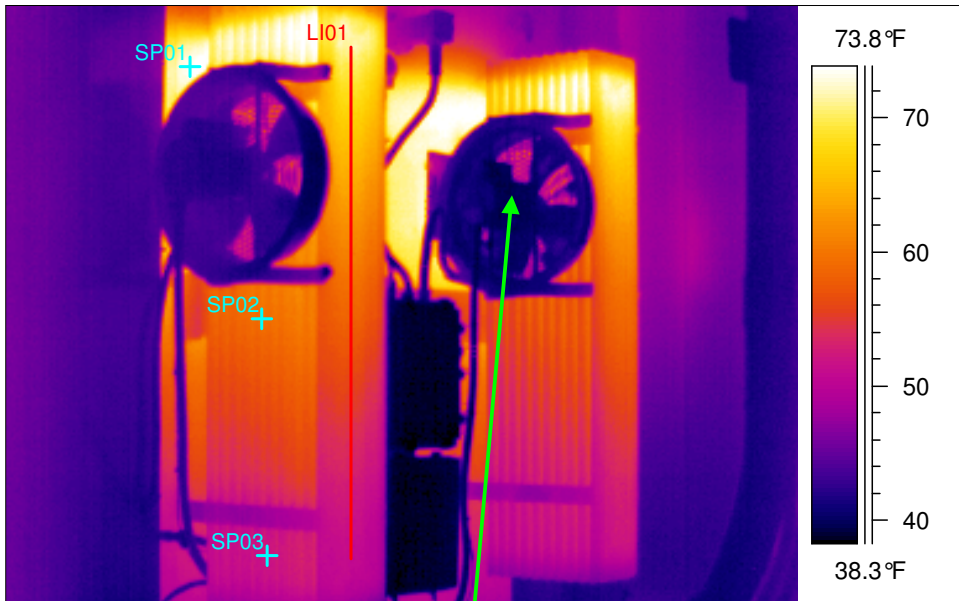
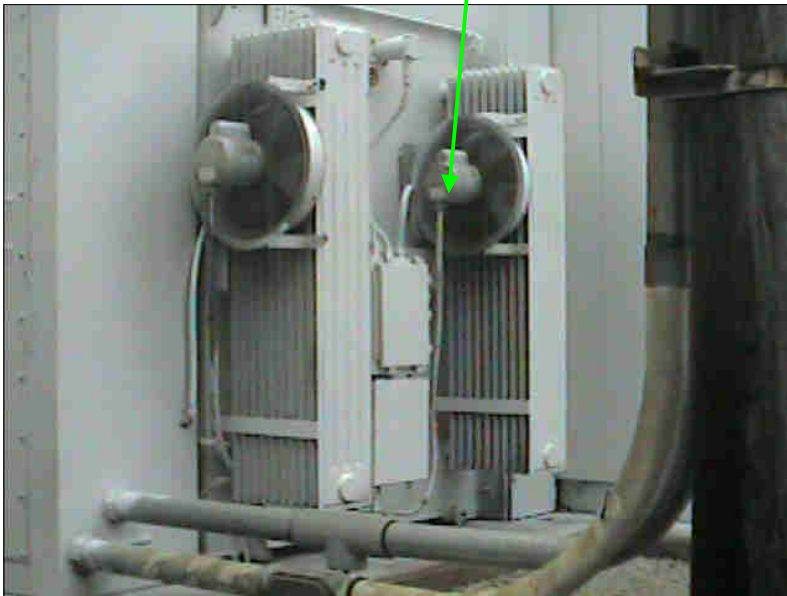
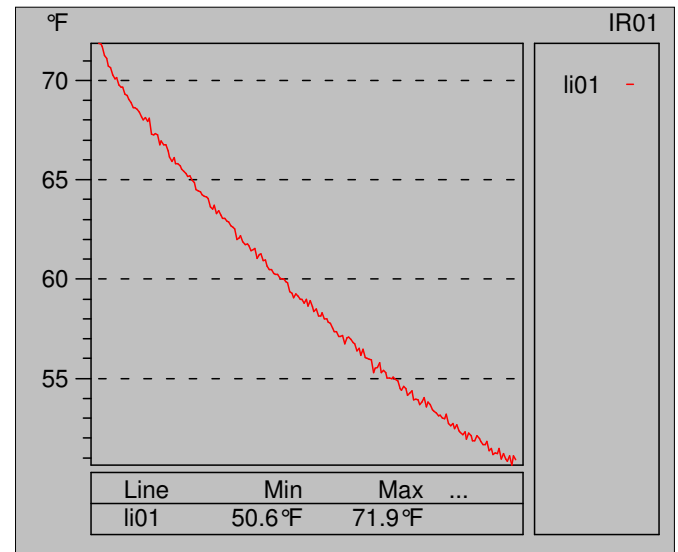
| Component | Equipment/Bucket ID | Plant/Area | Date |
|---|---|---|---|
| North Radiator | SUB 247 | HCN | 12-26-19 |

| <b>Fault</b> | None |
| <b>Defect Rating</b> | NA |

Operating normally, no issues.

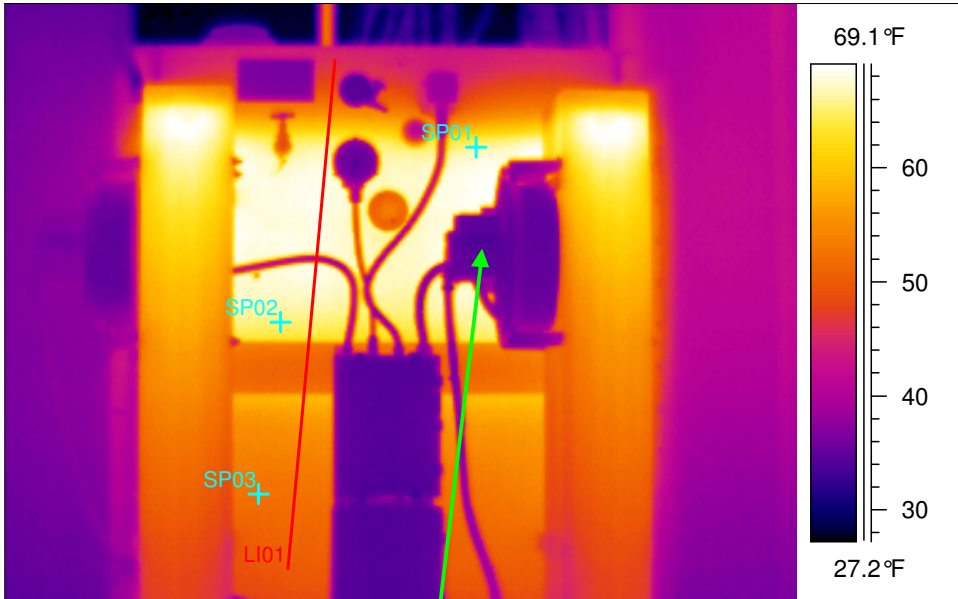
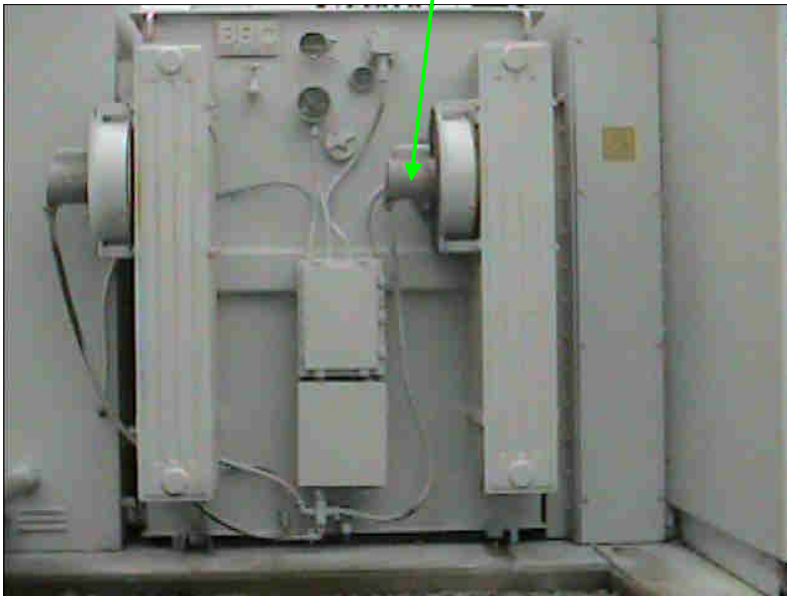
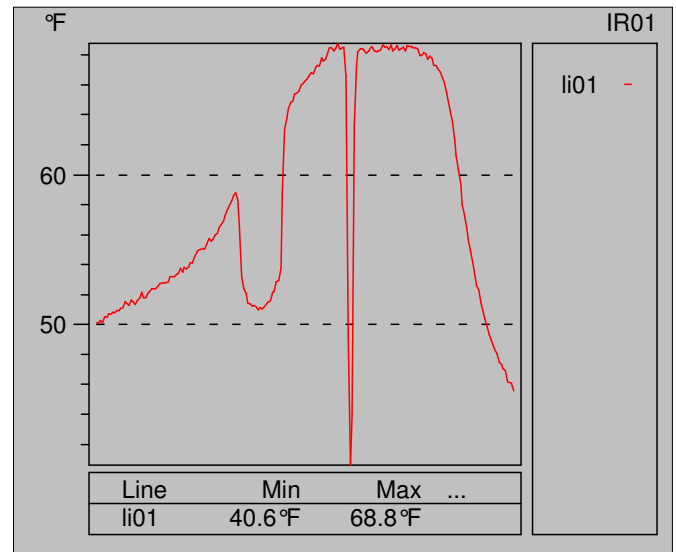
| Component | Equipment/Bucket ID | Plant/Area | Date |
|---|---|---|---|
| Body | SUB 247 | HCN | 12-26-19 |

| <b>Fault</b> | None |
| <b>Defect Rating</b> | NA |

Operating normally, no issues.  
Check fluid anyway.

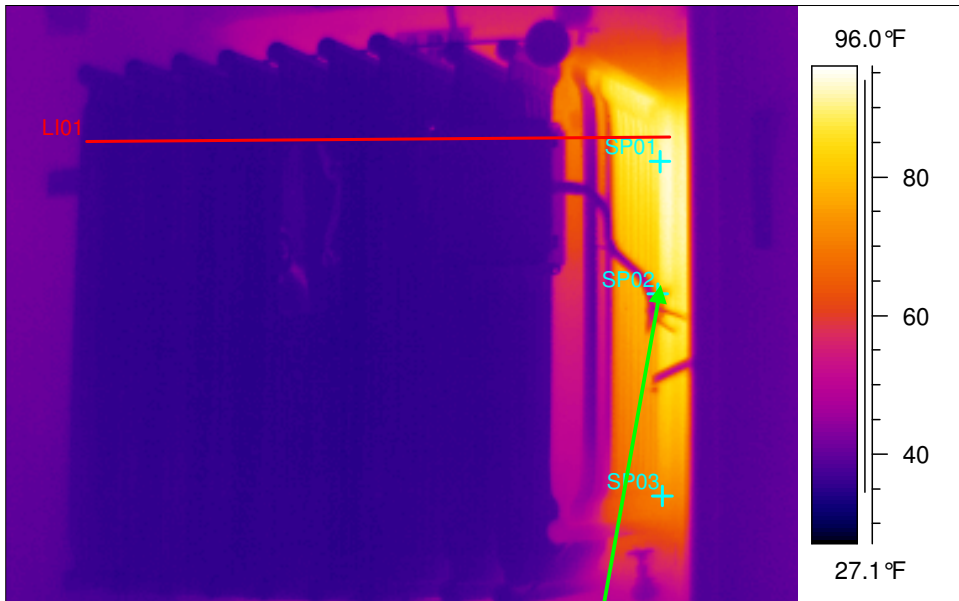
| Component | Equipment/Bucket ID | Plant/Area | Date |
|---|---|---|---|
| North Radiator | SUB 260 | HCN | 12-26-19 |

| <b>Defect Rating</b> | Class 2 |

Suspect low fluid level. Check coolant; add or replace as necessary. Possible blockage in cooling fins.

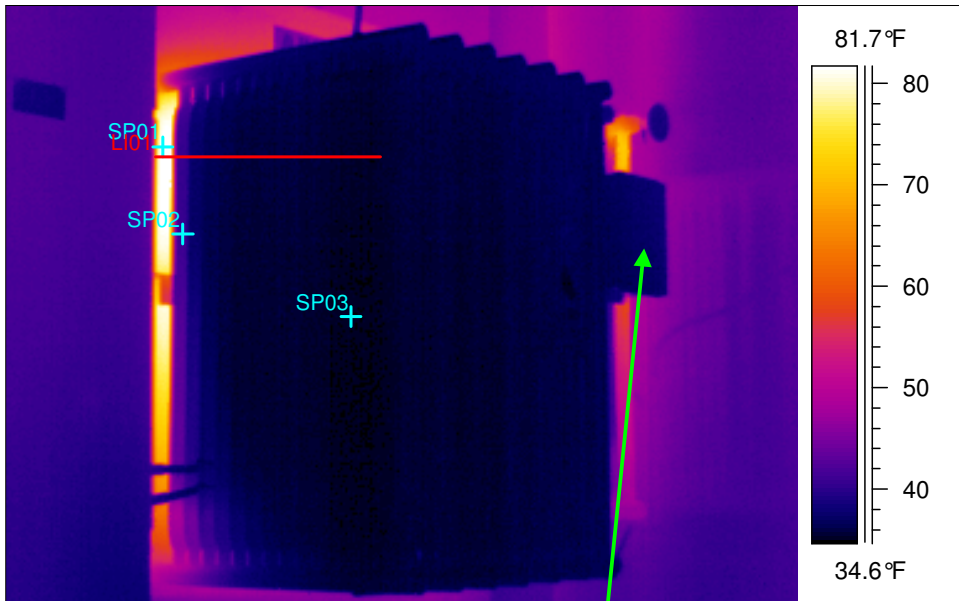
| Component | Equipment/Bucket ID | Plant/Area | Date |
|---|---|---|---|
| North Radiator (E view) | SUB 260 | HCN | 12-26-19 |

| <b>Defect Rating</b> | Class 2 |

Suspect low coolant level. Check coolant; add or replace as necessary. Possible blockage in coolant fins.

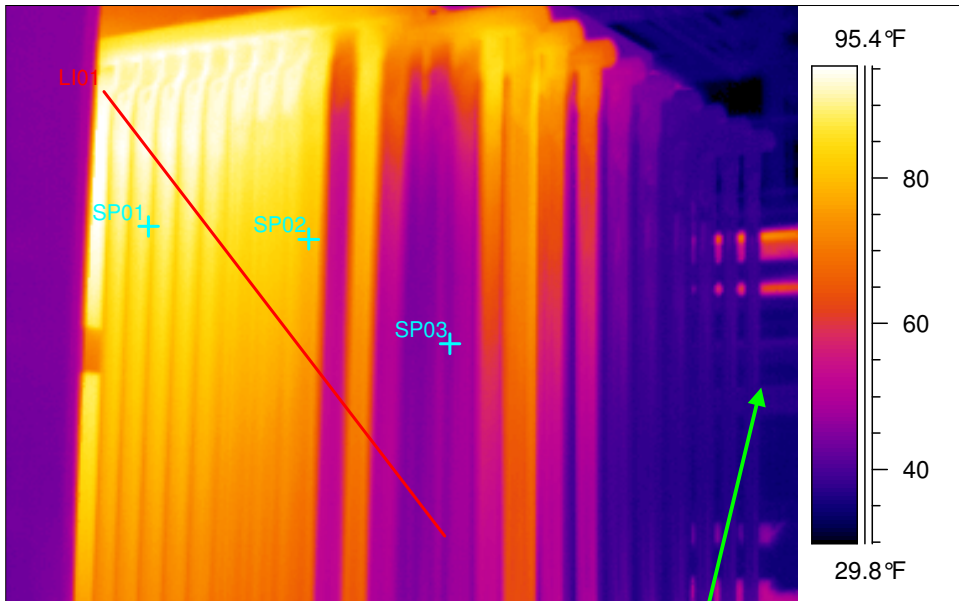
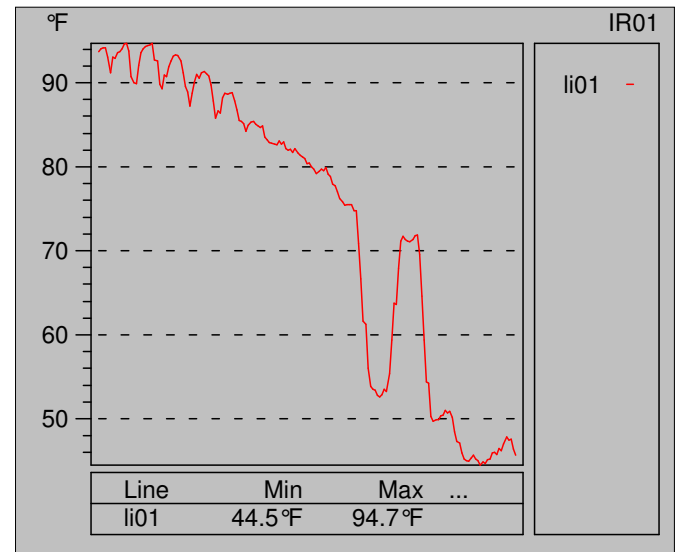
| Component | Equipment/Bucket ID | Plant/Area | Date |
|---|---|---|---|
| South Radaitor (West) | SUB 260 | HCN | 12-26-19 |

| <b>Fault</b> | Cooling Issue |
| <b>Defect Rating</b> | Class 2 |

Possible blocked fins and low coolant. At the next opportunity check coolant level and inspect fins for defects. This West view shows more operating fins than the East view.

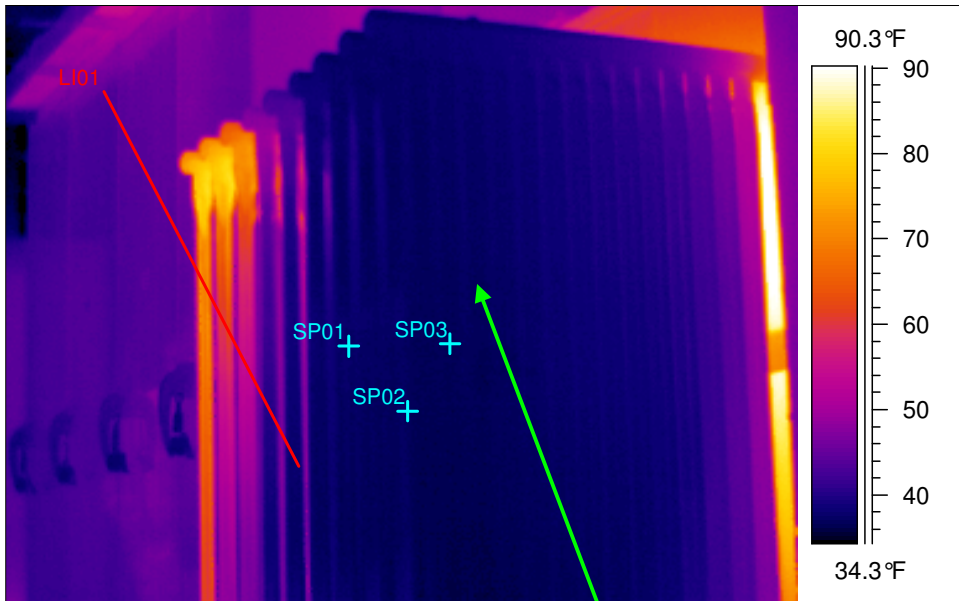
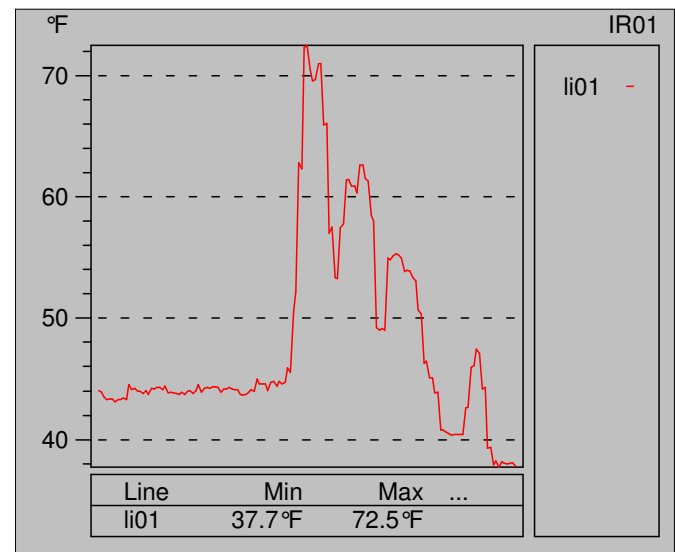
| Component | Equipment/Bucket ID | Plant/Area | Date |
|---|---|---|---|
| South Radiator (East) | Sub 260 | HCN | 12-26-19 |

| <b>Fault</b> | Cooling Issue |
| <b>Defect Rating</b> | Class 2 |

Possible blocked fins and low coolant level. At the next opportunity check coolant level and inspect fins for defects. This East view show less properly functioning fins than the West view.

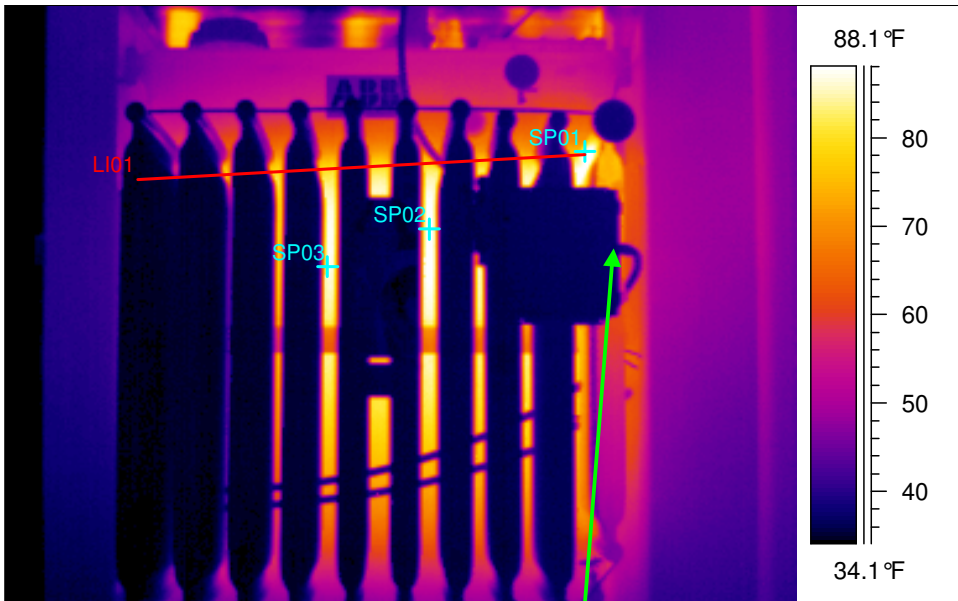
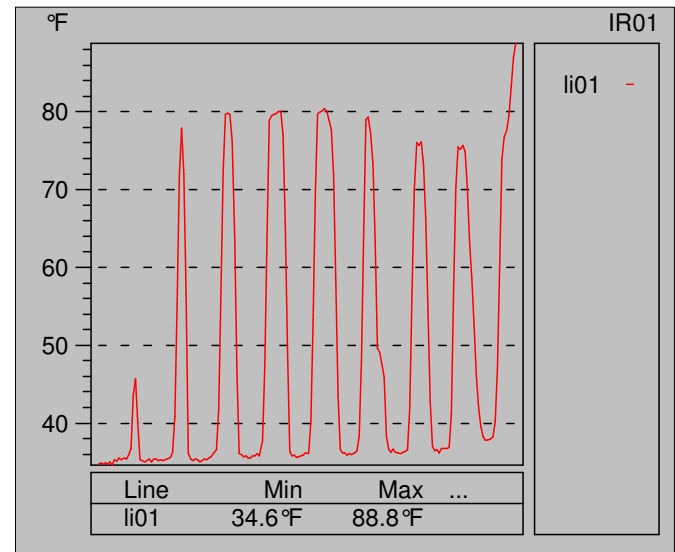
| Component | Equipment/Bucket ID | Plant/Area | Date |
|---|---|---|---|
| South Radiator NBody | SUB 260 | HCN | 12-26-19 |

| <b>Fault</b> | Cooling Issue |
| <b>Defect Rating</b> | Class 2 |

Possible blocked fins and low coolant levels. At the next opportunity check coolant level and inspect fins for possible defects. This North body view shows the possibility of low levels.

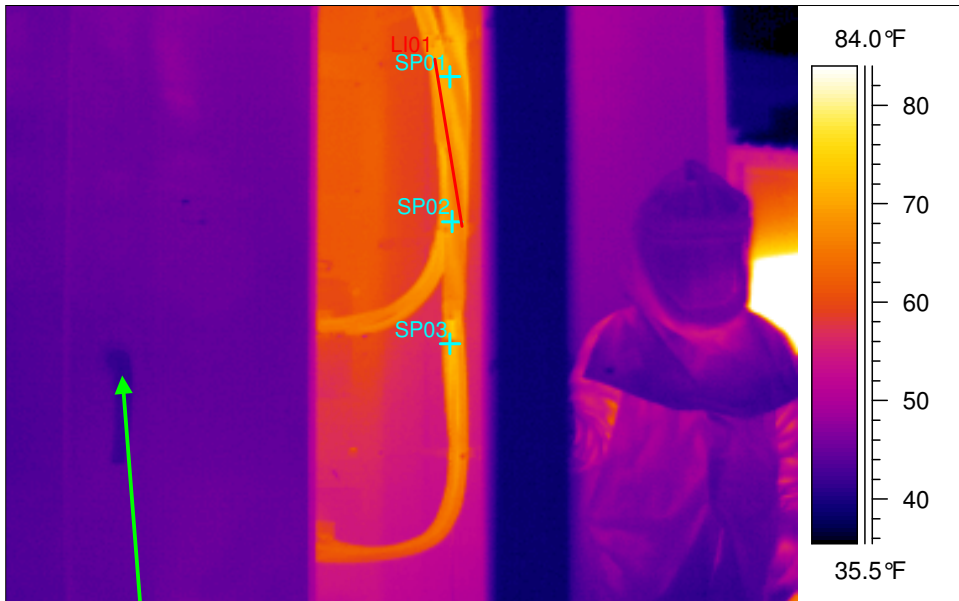
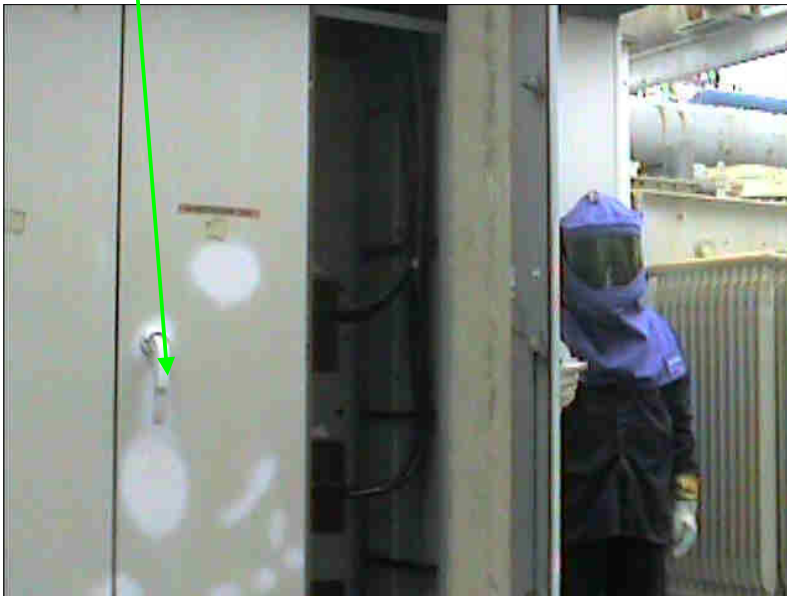
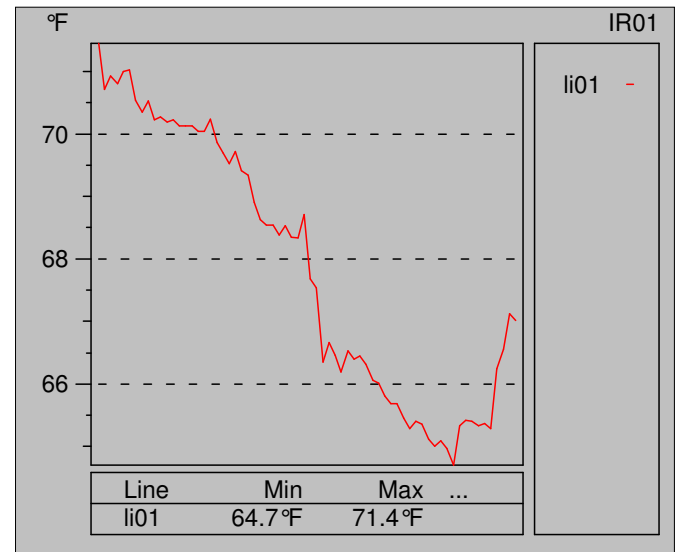
| Component | Equipment/Bucket ID | Plant/Area | Date |
|---|---|---|---|
| East Middle Panel | SUB 260 | HCN | 12-26-19 |

| <b>Fault</b> | None |

Operating normally, no issues.

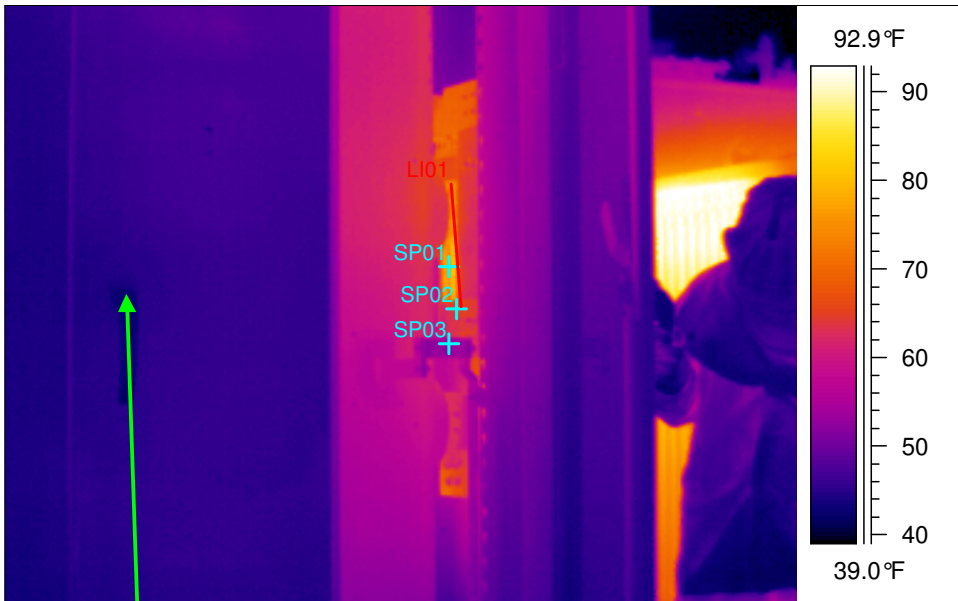
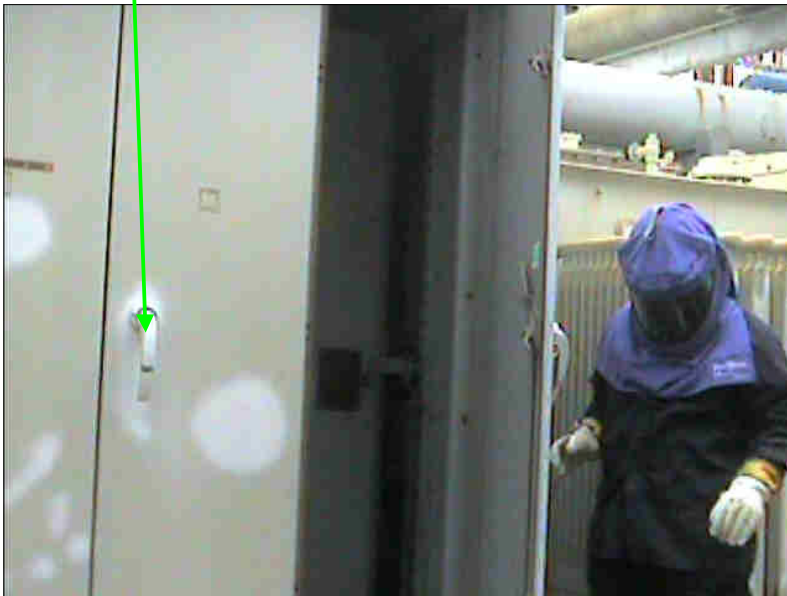
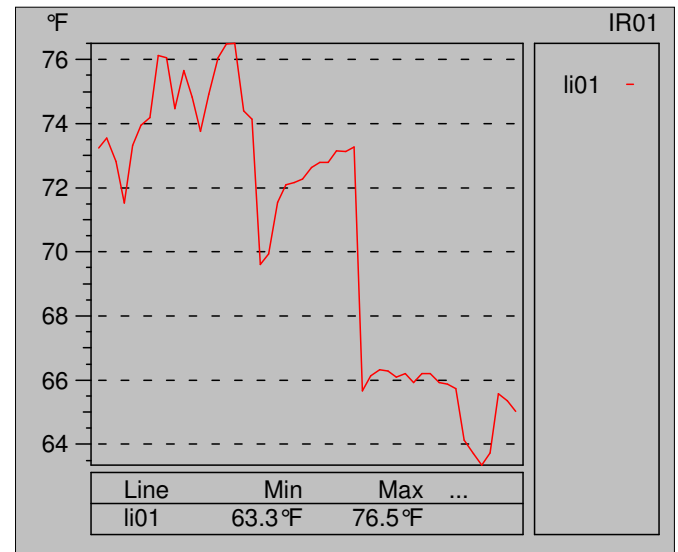
| Component | Equipment/Bucket ID | Plant/Area | Date |
|---|---|---|---|
| East Panel | SUB 260 | HCN | 12-26-19 |

| <b>Fault</b> | None |

Operating normally, no issues.

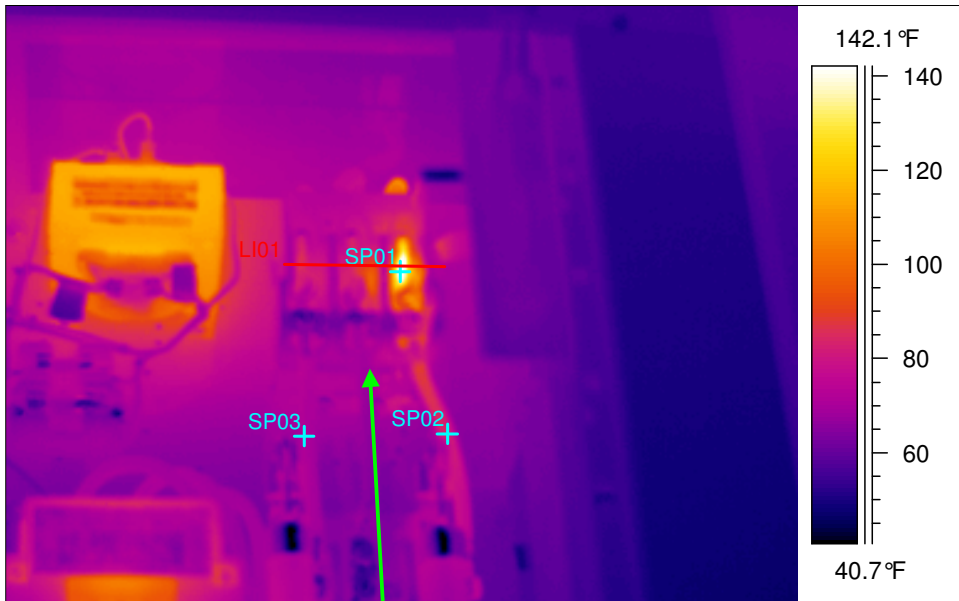
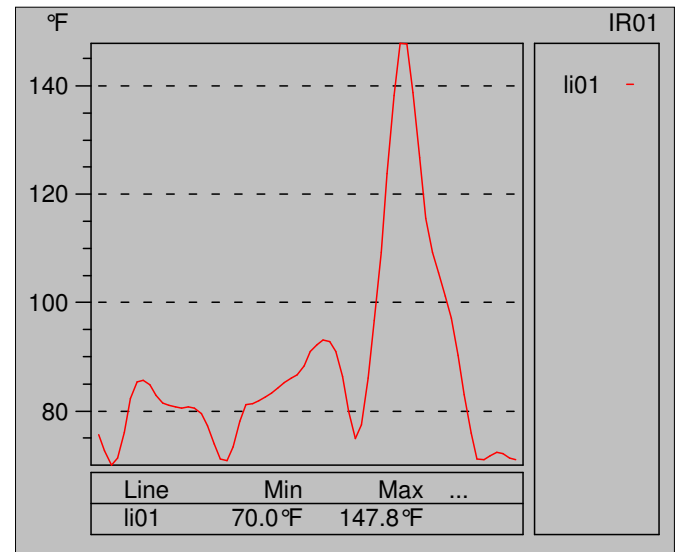
| Component | Equipment/Bucket ID | Plant/Area | Date |
|---|---|---|---|
| Comb. Air Blower | MCC 10 | HCN | 12-26-19 |

| <b>Fault</b> | Poor Contact at Switch |
| <b>Defect Rating</b> | Class 2 |

C phase shows what appears to be poor contact at the switch. Recommend inspection, repair and replace at the next opportunity.

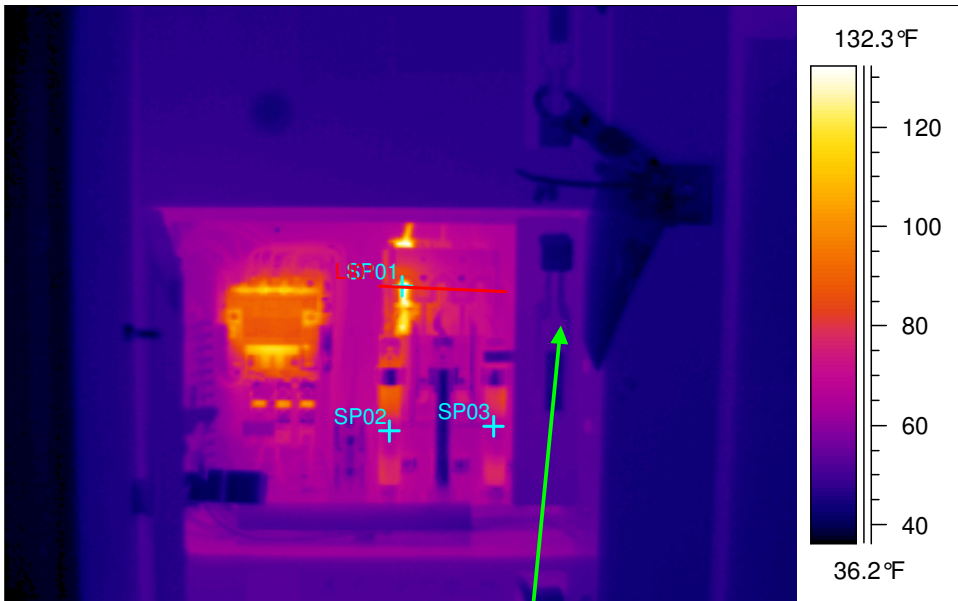
| Component | Equipment/Bucket ID | Plant/Area | Date |
|---|---|---|---|
| Methanol Pump | MCC B | HCN STO, TK. | 12-26-19 |

| <b>Defect Rating</b> | Class 2 |

A phase appears to have poor contact at the switch. Recommend inspecting and repair/replace at the next opportunity.

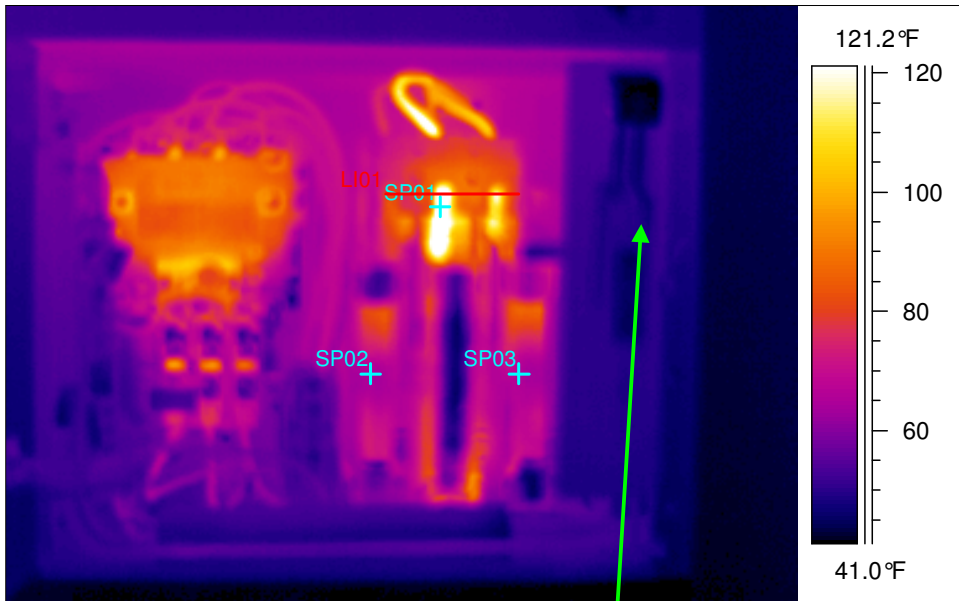
| Component | Equipment/Bucket ID | Plant/Area | Date |
|---|---|---|---|
| TK TRANS. PUMP | MCC B | HCN STO. TK. | 12-26-19 |

| <b>Defect Rating</b> | Class 2 |

Phase B is showing poor contact at the top of the switch. Recommend repairing/replacing at the next opportunity.

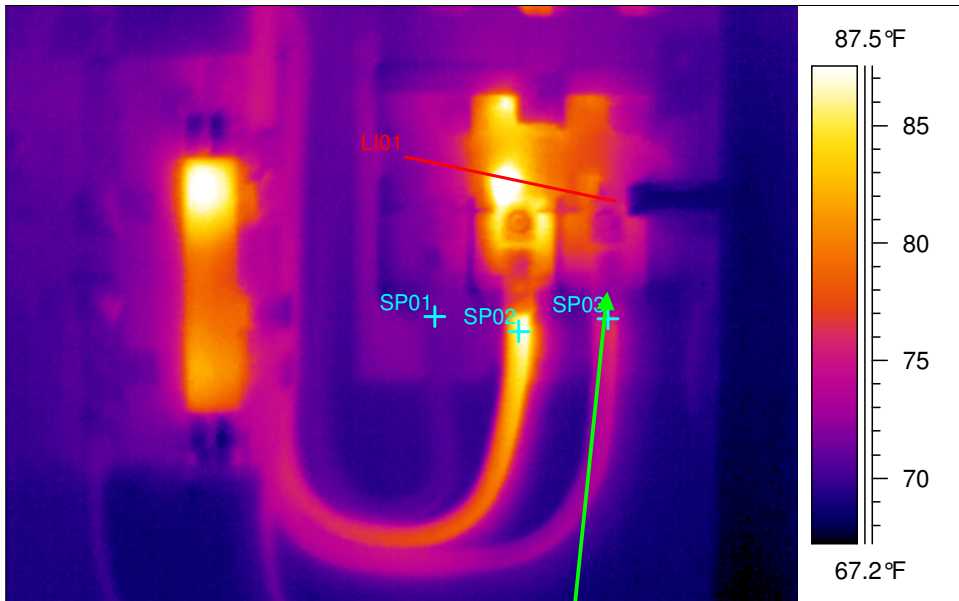
| Component | Equipment/Bucket ID | Plant/Area | Date |
|---|---|---|---|
| Switch | DH-2 | HCN BLD. 800 | 12-26-19 |

| <b>Defect Rating</b> | Class 1 |

B phase is showing a possible poor connection causing increased tempature. Recommend inspecting and repairing in the near future.

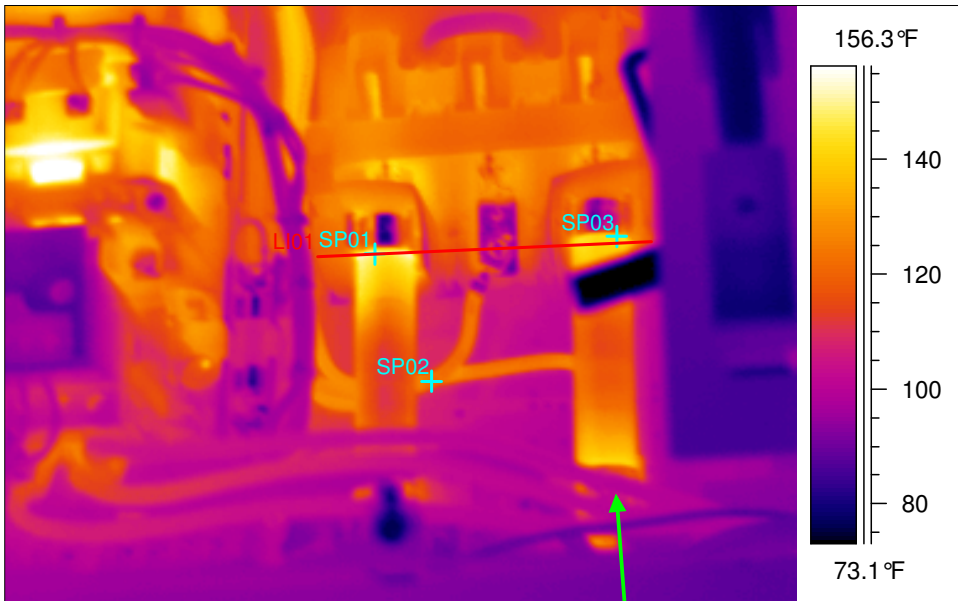
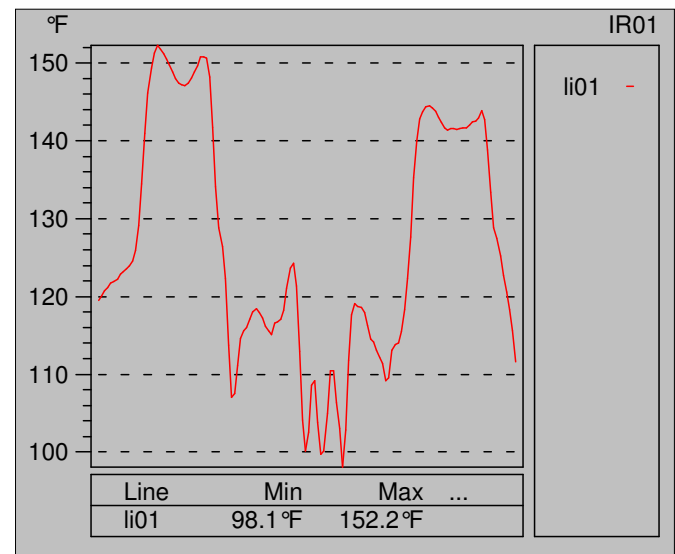
| Component | Equipment/Bucket ID | Plant/Area | Date |
|---|---|---|---|
| Top Feed Pmp.EP44A | MCC1 NH3 | HCN ECR | 12-26-19 |

| <b>Fault</b> | Poor connection at fuse clips |
| <b>Defect Rating</b> | Class 1 |

Showing an increased temperature at top of both fuse clips. Recommend inspection. Clean, repair and replace at the next opportunity.

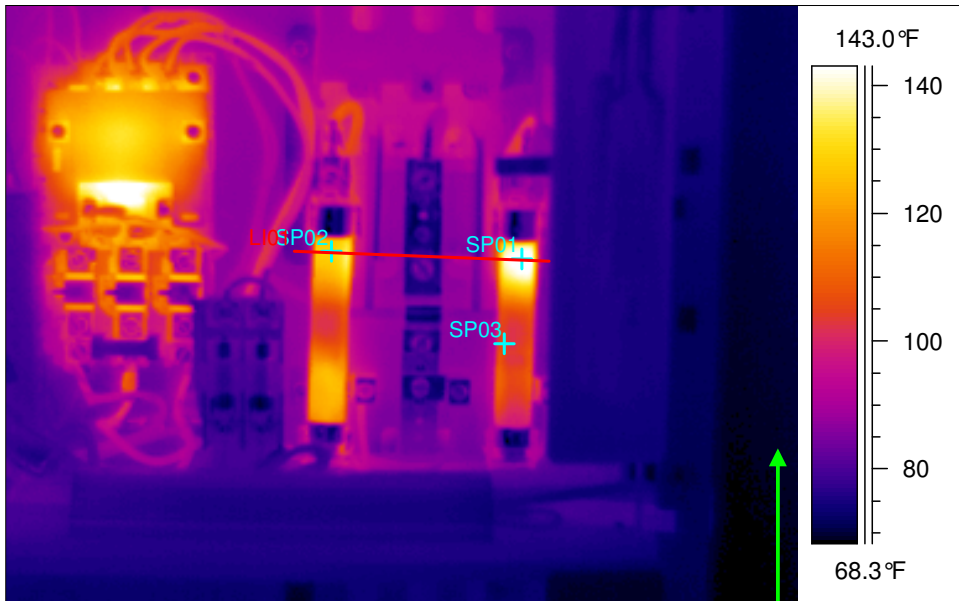
| Component | Equipment/Bucket ID | Plant/Area | Date |
|---|---|---|---|
| EP 930D | MCC 1 | HCN Trade Waste | 12-26-19 |

| <b>Defect Rating</b> | Class 1 |

Possible poor connection at fuse clips. Recommend inspection, cleaning, and possibly replacing in the near future.

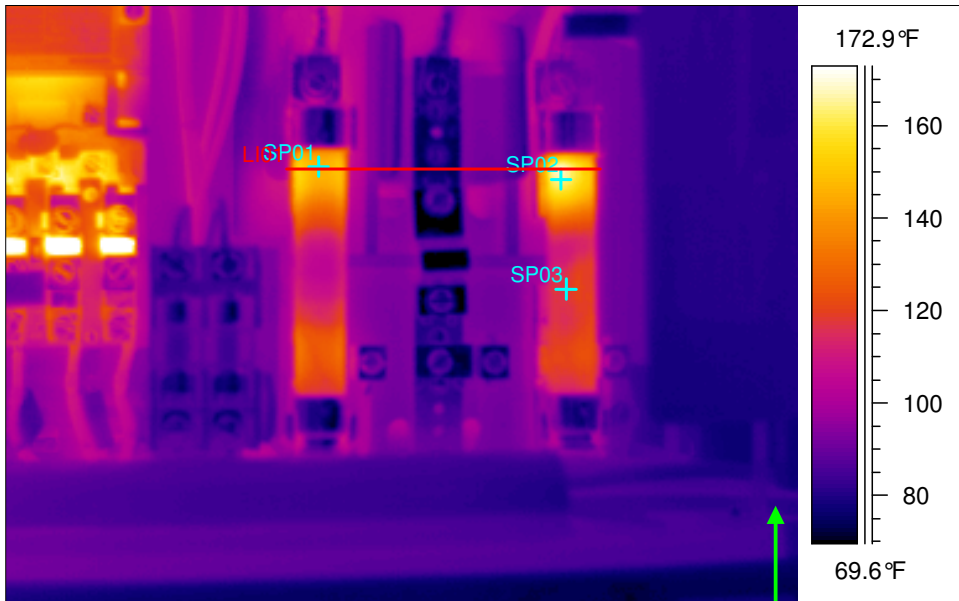
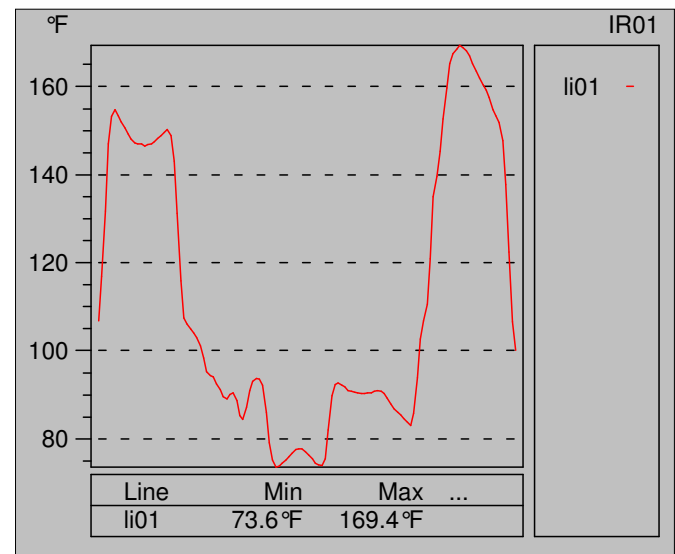
| Component | Equipment/Bucket ID | Plant/Area | Date |
|---|---|---|---|
| EP 930C | MCC1 | HCN Trade Waste | 12-26-19 |

| <b>Fault</b> | Connection at fuse clips |
| <b>Defect Rating</b> | Class 2 |

Possible poor connection at fuse clips. Recommend inspection. Clean, repair and replace at the next opportunity.

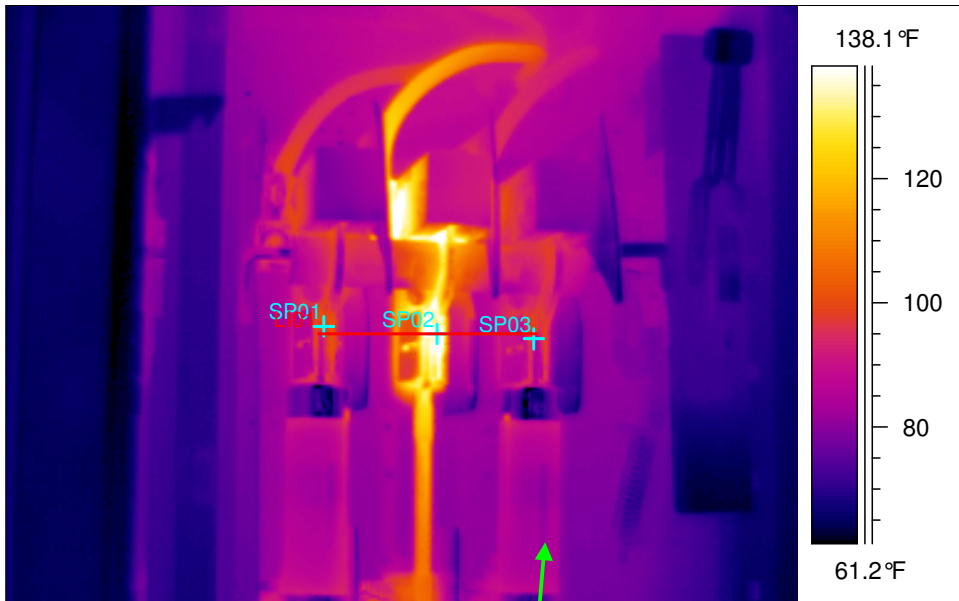
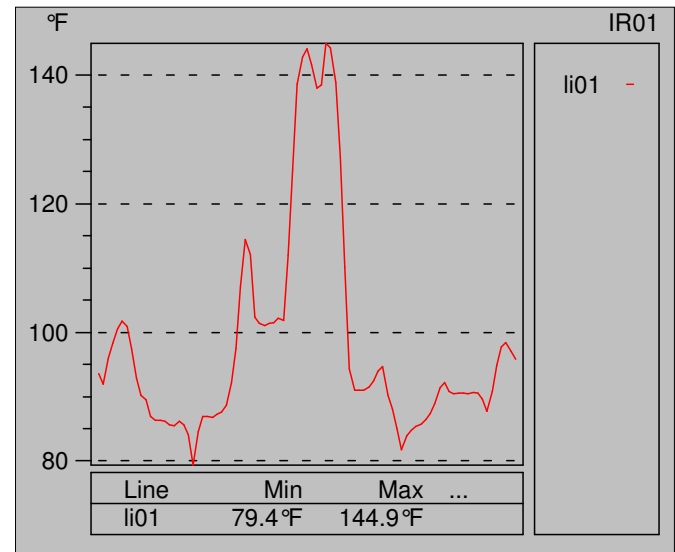
| Component | Equipment/Bucket ID | Plant/Area | Date |
|---|---|---|---|
| #1 Lift pump | MCC1 ECF | HCN | 12-26-19 |

| <b>Fault</b> | Bad Connection |
| <b>Defect Rating</b> | Class 2 |

Poor contact at switch in B phase. Recommend cleaning and inspecting. Repairing/replacing at the next opportunity. Make sure all connections are tight after maintenance.

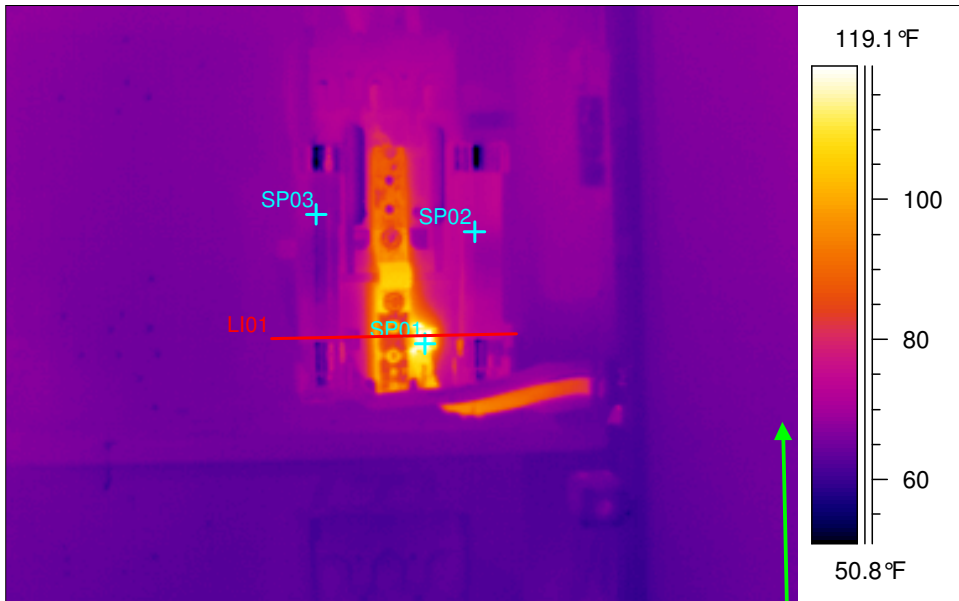
| Component | Equipment/Bucket ID | Plant/Area | Date |
|---|---|---|---|
| Heat Trace Disc. | MCC 1 ECF | HCN | 12-26-19 |

| <b>Defect Rating</b> | Class 1 |

Poor contact at switch in B phase. Recommend inspecting and cleaning, repairing/replacing in the near future.

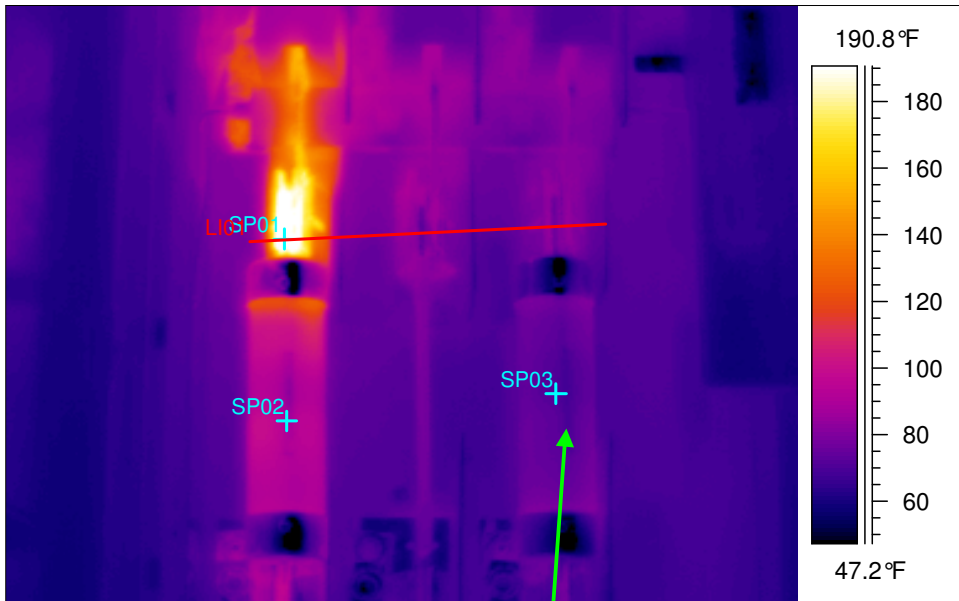
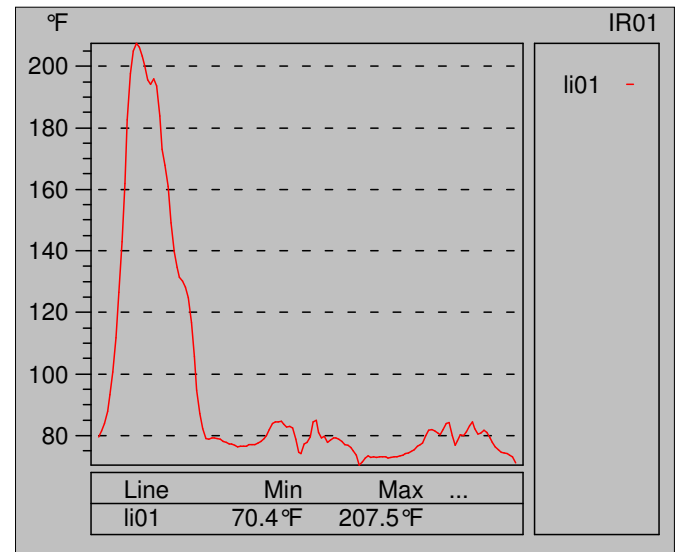
| Component | Equipment/Bucket ID | Plant/Area | Date |
|---|---|---|---|
| 2nd Neut. TK Agi. | MCC 1 ECF | HCN | 12-26-19 |

| <b>Fault</b> | Bad Switch Connection |
| <b>Defect Rating</b> | Class 3 |

Bad connection at the switch in A phase. Excessive heat. Recomend cleaning, inspecting, and repairing/replacing ASAP.

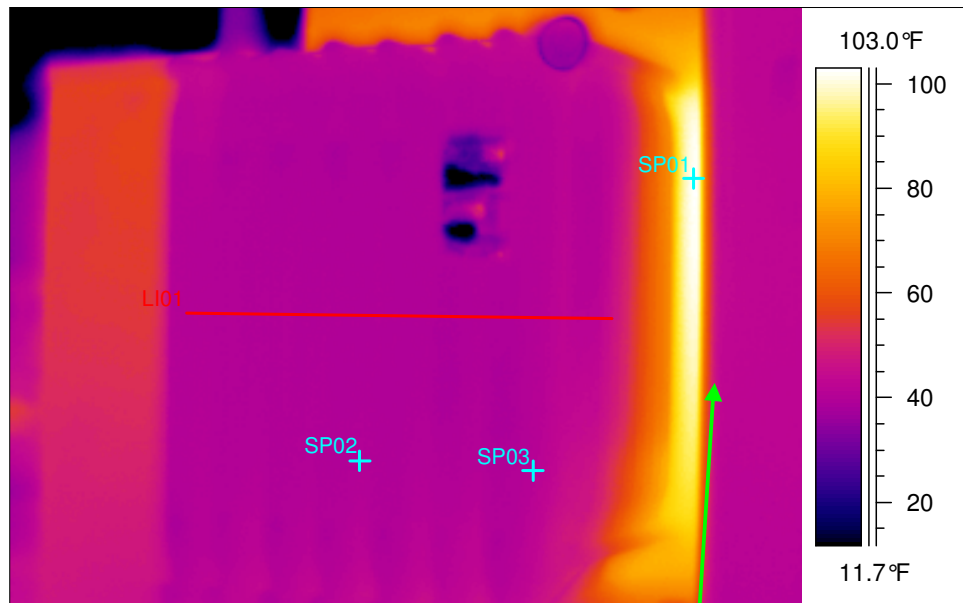
| Component | Equipment/Bucket ID | Plant/Area | Date |
|---|---|---|---|
| North Radiator | SUB 257 | HCN | 12-26-19 |

| <b>Defect Rating</b> | Class 2 |

Level appears to be below top tubes of radiator. Recommend checking coolant level.

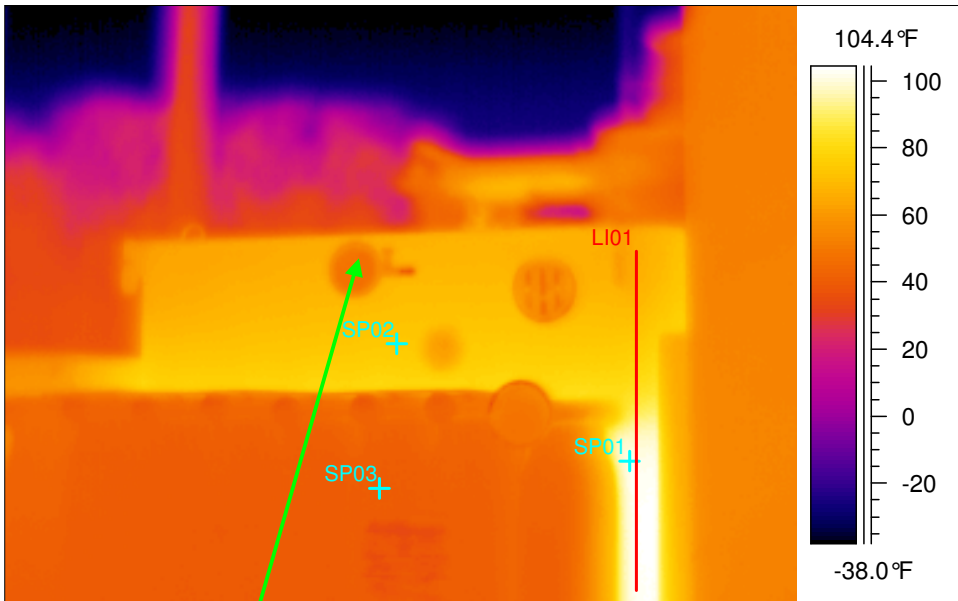
| Component | Equipment/Bucket ID | Plant/Area | Date |
|---|---|---|---|
| North Trans Body | SUB 257 | HCN | 12-26-19 |

| <b>Defect Rating</b> | Class 2 |

Level appears to be slightly low at bottom of top tubes. Recommend checking coolant level.

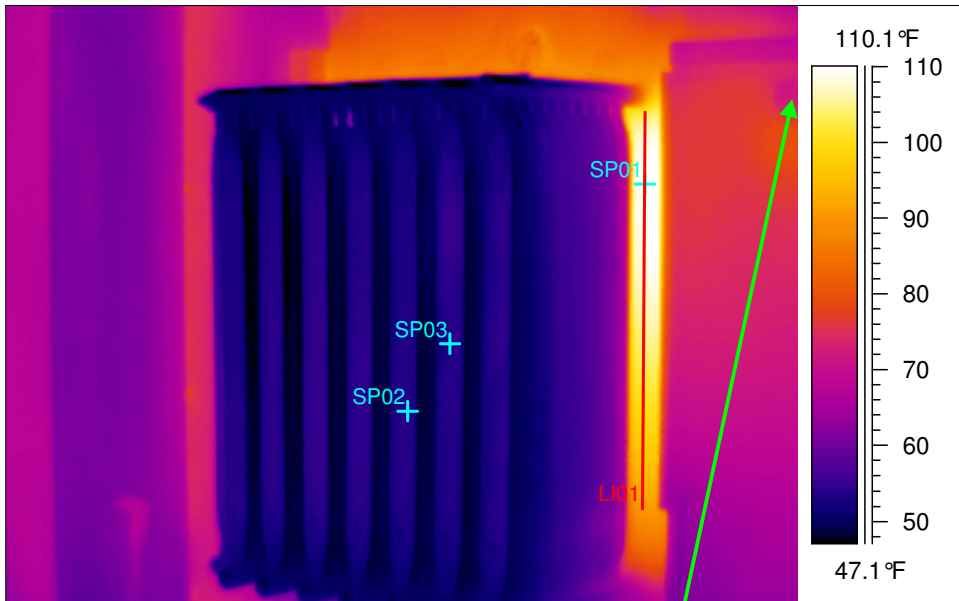
| Component | Equipment/Bucket ID | Plant/Area | Date |
|---|---|---|---|
| South Radiator | SUB 257 | HCN | 12-26-19 |

| <b>Defect Rating</b> | Class 3 |

Coolant level appears to be low. Recommend checking coolant level ASAP.
