# QualiTest IR Radiometric Survey Report

Chemours  
HCN

| Job Number | 141407 |
| Survey Date | 12/17-18/19 |

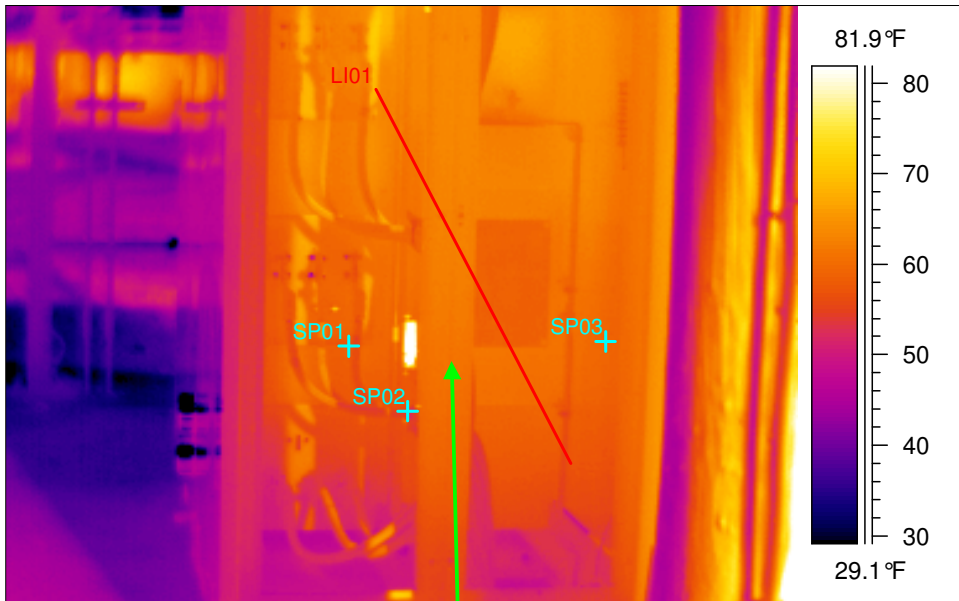
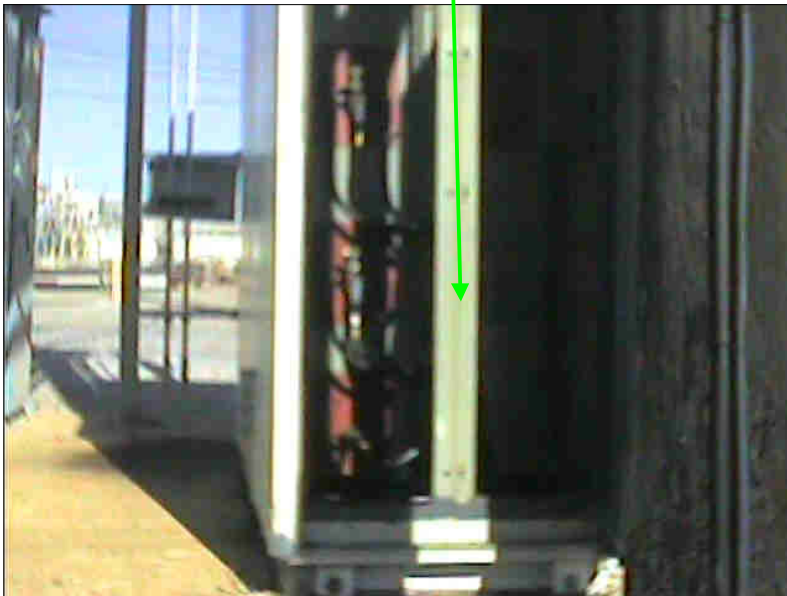
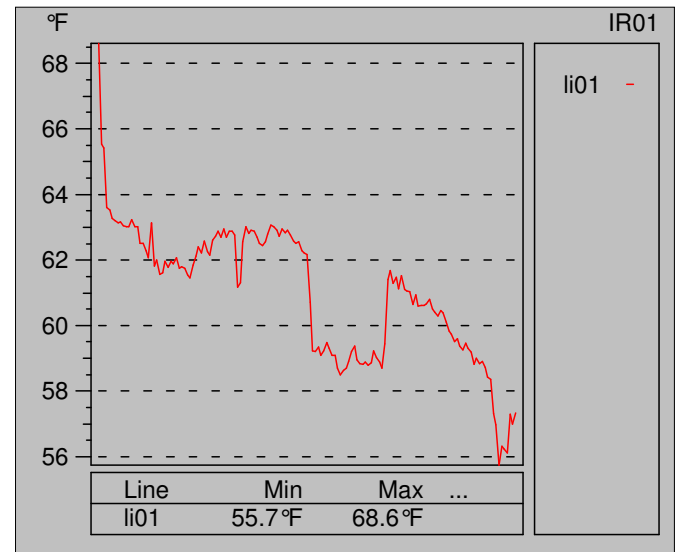
| Component | Equipment/Bucket ID | Plant/Area | Date |
|---|---|---|---|
| Electrical Pannel | SUB 257 | HCN | 12-26-19 |

| <b>Fault</b> | None |
| <b>Defect Rating</b> | NA |

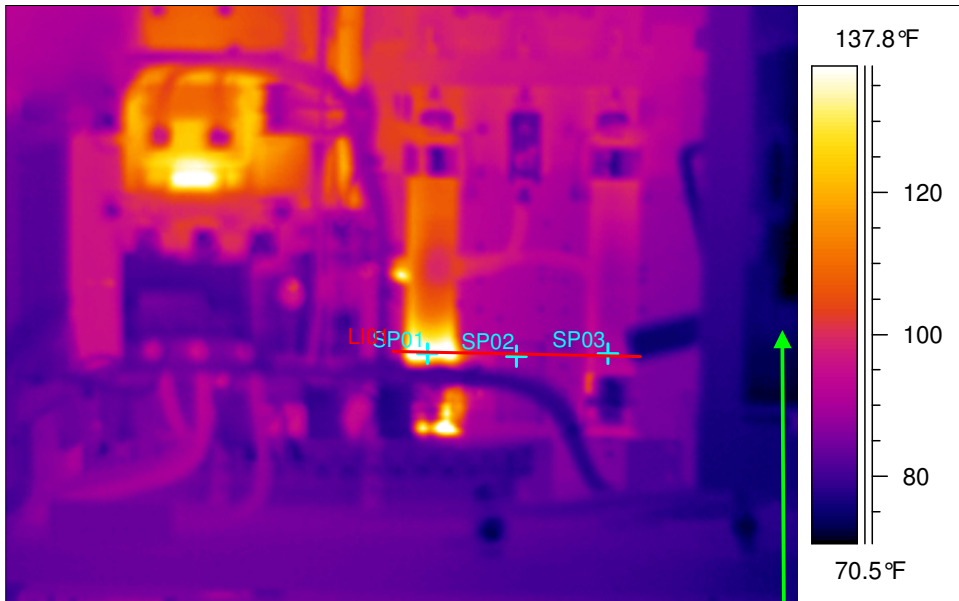
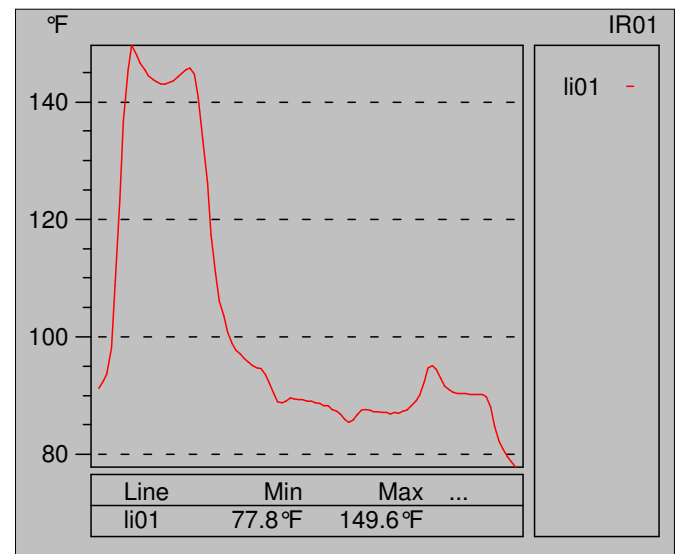
| Component | Equipment/Bucket ID | Plant/Area | Date |
|---|---|---|---|
| Abs. Mid Feed Pmp. | EP-44D | HCN | 12-26-19 |

| <b>Fault</b> | Bad Fuse Connection |
| <b>Defect Rating</b> | Class 2 |

Connection at A phase lower fuse clip appears to be bad. Recommend inspecting, cleaning, and repairing/replacing at the next opportunity.

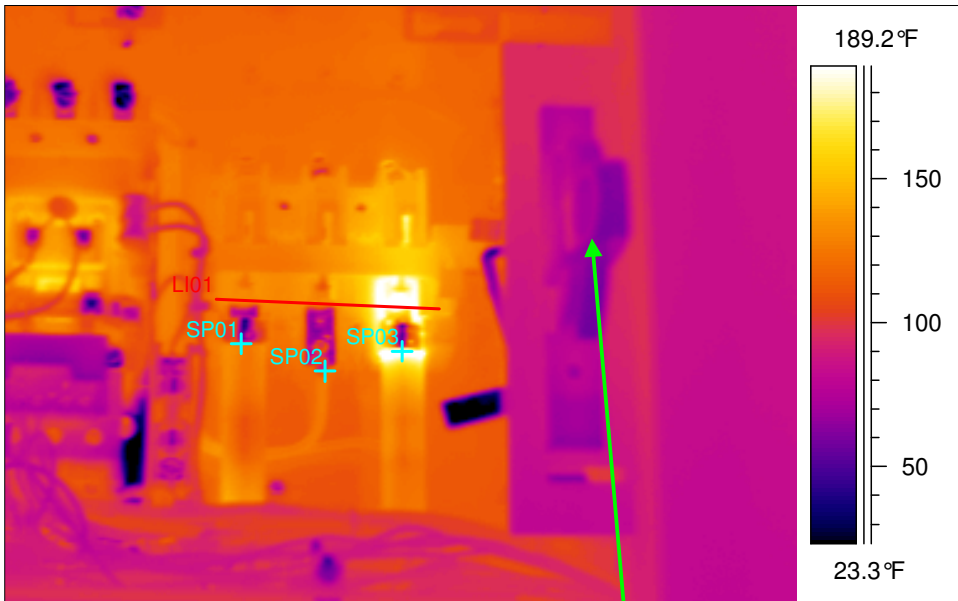
| Component | Equipment/Bucket ID | Plant/Area | Date |
|---|---|---|---|
| E HCN Circ. Pump | MCC E | HCN Tank Farm | 12-26-19 |

| <b>Defect Rating</b> | Class 3 |

Excessive heat in C phase switch. Recommend inspecting, cleaning, repairing/replacing ASAP

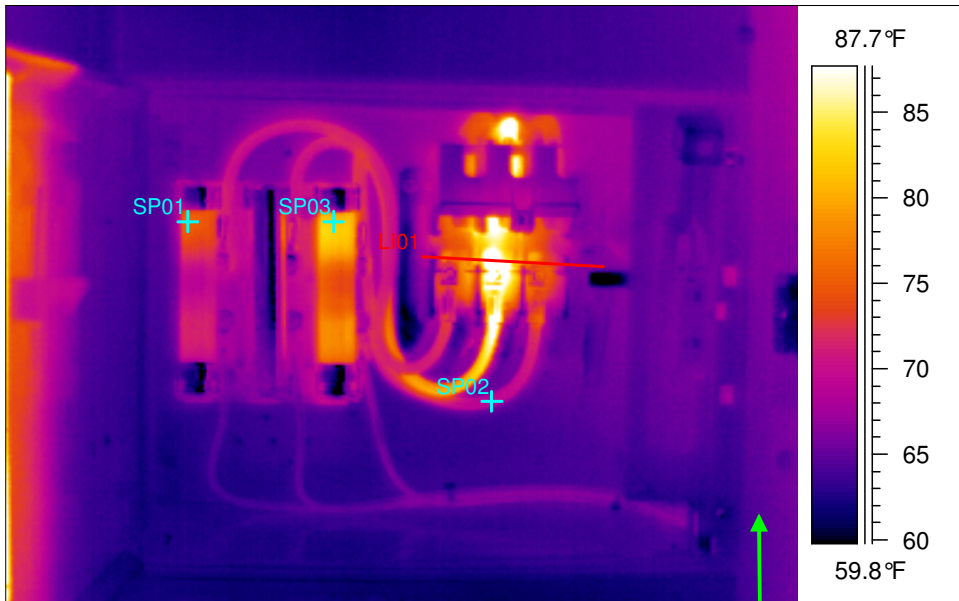
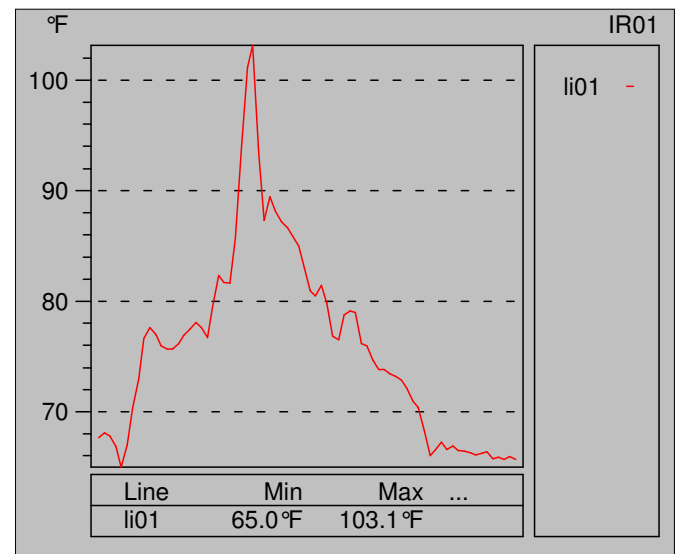
| Component | Equipment/Bucket ID | Plant/Area | Date |
|---|---|---|---|
| Lighting Trans. | MCC 501A | HCN TK. Farm | 12-26-19 |

| <b>Fault</b> | Poor Connection |
| <b>Defect Rating</b> | Class 1 |

Minor heat increase in B phase switch. Showing a 25 degree Delta. Recommend inspecting, cleaning; repair or replace as necessary in the near future.

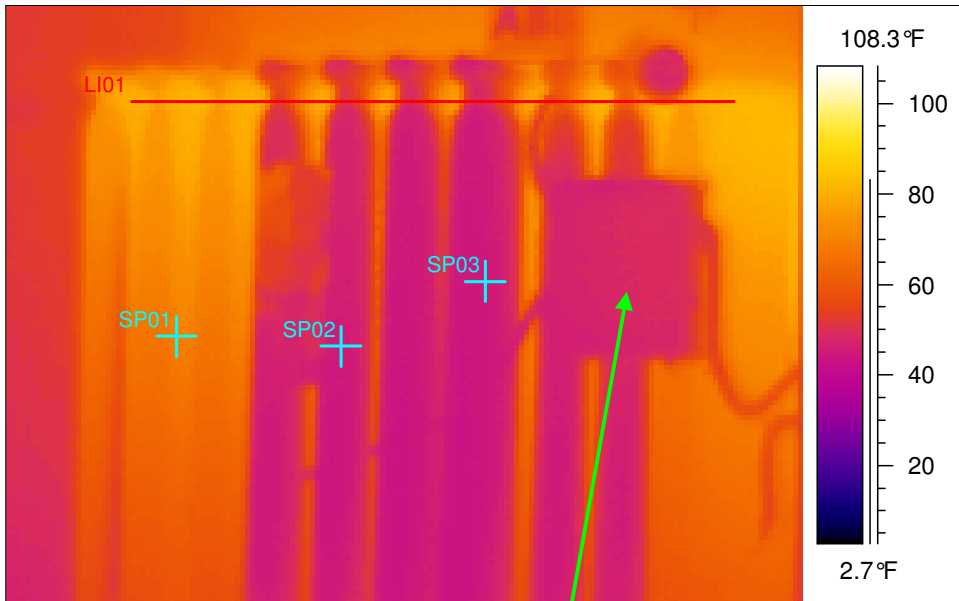
| Component | Equipment/Bucket ID | Plant/Area | Date |
|---|---|---|---|
| North Radiator | SUB 248 | HCN | 12-26-19 |

| <b>Defect Rating</b> | Class 1 |

Check coolant level. Cooling but only across half. Recommend checking coolant levels.

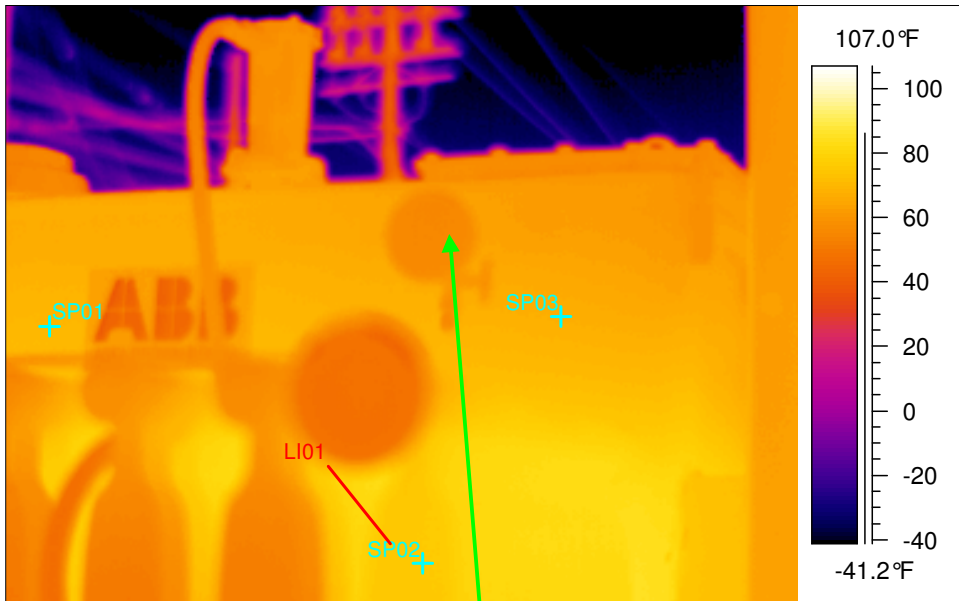
| Component | Equipment/Bucket ID | Plant/Area | Date |
|---|---|---|---|
| North Rad. Body | SUB 248 | HCN | 12-26-19 |

| <b>Defect Rating</b> | Class 1 |

Recommend checking coolant level.

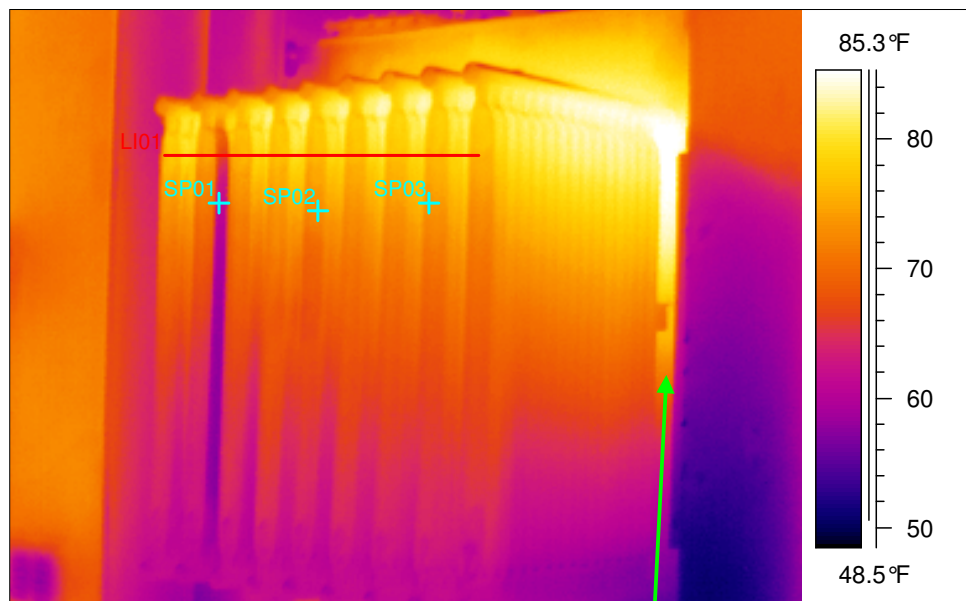
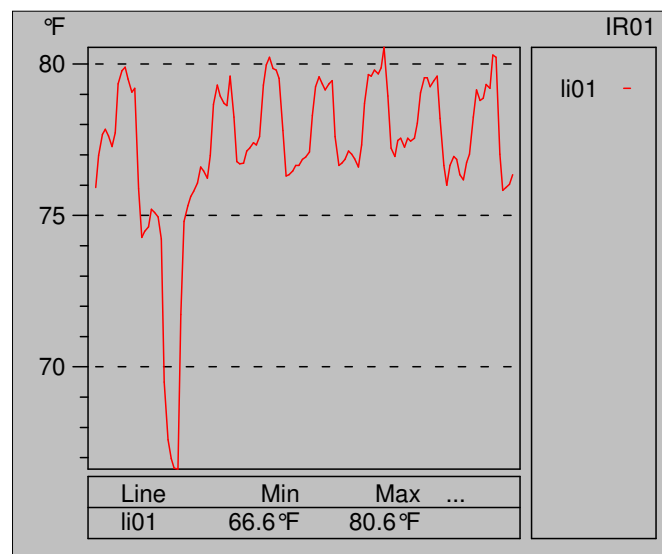
| Component | Equipment/Bucket ID | Plant/Area | Date |
|---|---|---|---|
| South Radiator | SUB 248 | HCN | 12-26-19 |

| <b>Fault</b> | Possible Blocked Tube |
| <b>Defect Rating</b> | Class 1 |

Operating normally; however, one or more tubes may be blocked. Recommend inspecting and checking coolant levels.

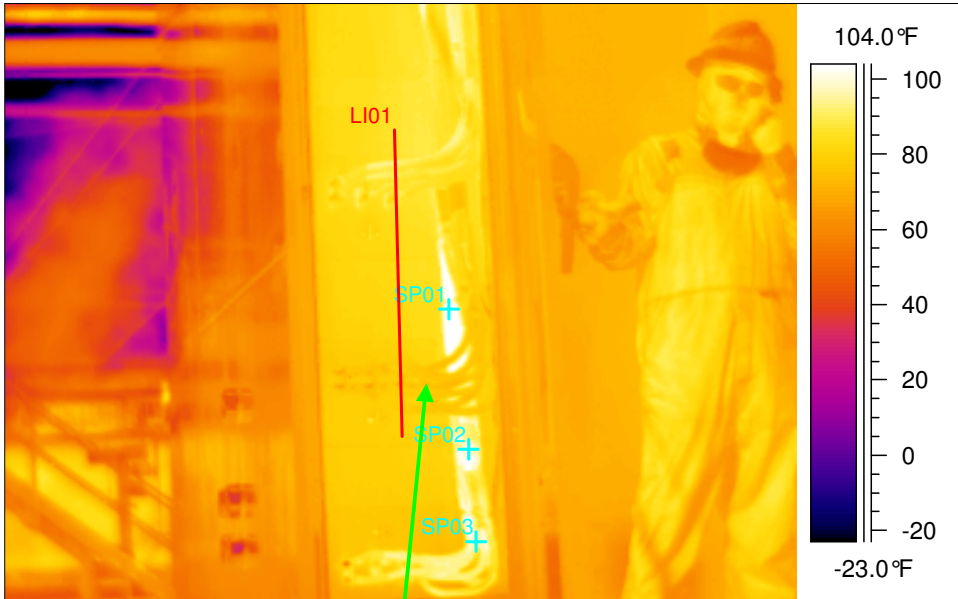
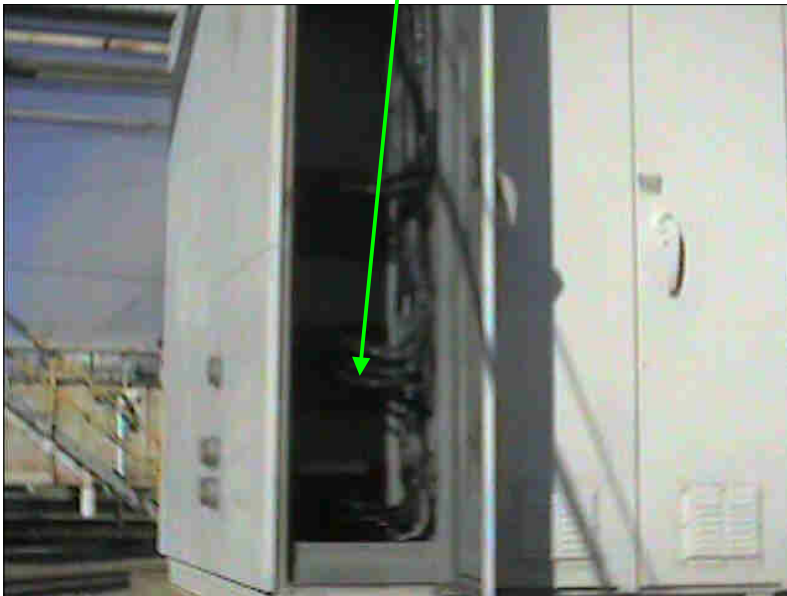
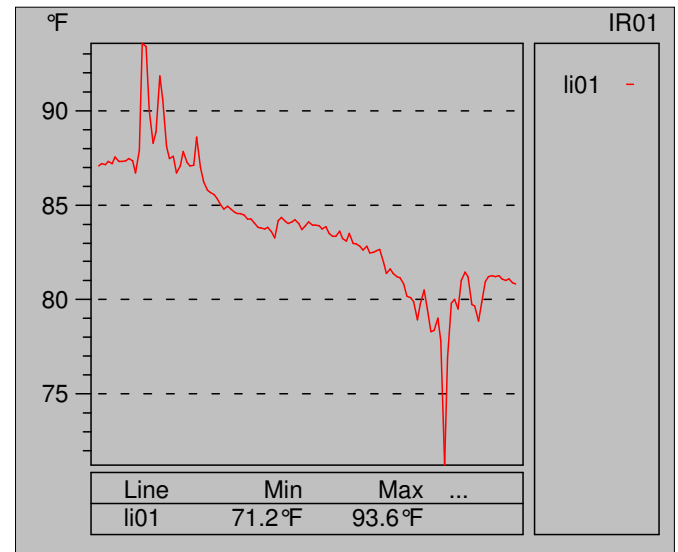
| Component | Equipment/Bucket ID | Plant/Area | Date |
|---|---|---|---|
| West Panel | SUB 248 | HCN | 12-26-19 |

| <b>Fault</b> | None |
| <b>Defect Rating</b> | NA |

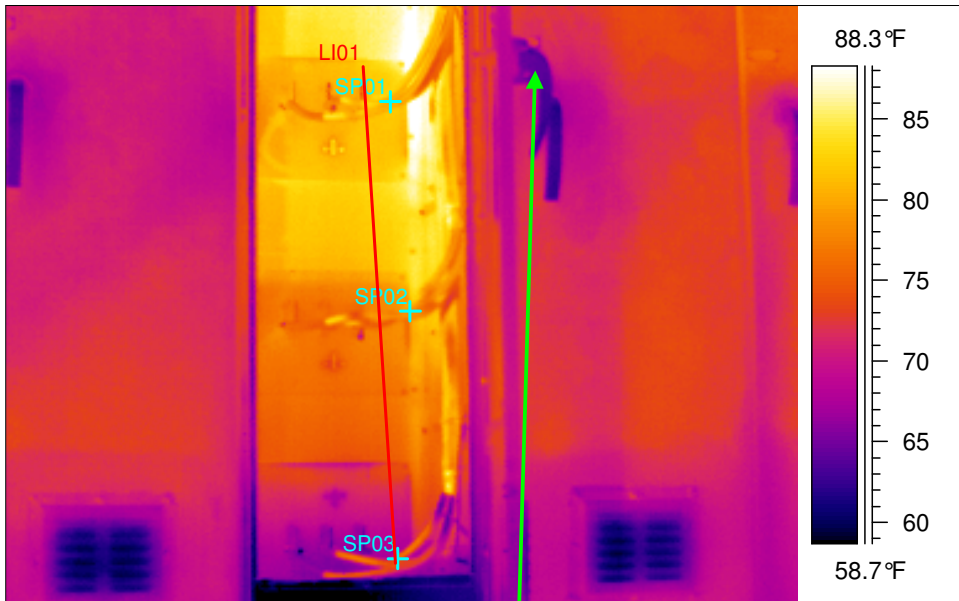
| Component | Equipment/Bucket ID | Plant/Area | Date |
|---|---|---|---|
| West Middle Panel | SUB 248 | HCN | 12-26-19 |

| <b>Defect Rating</b> | NA |

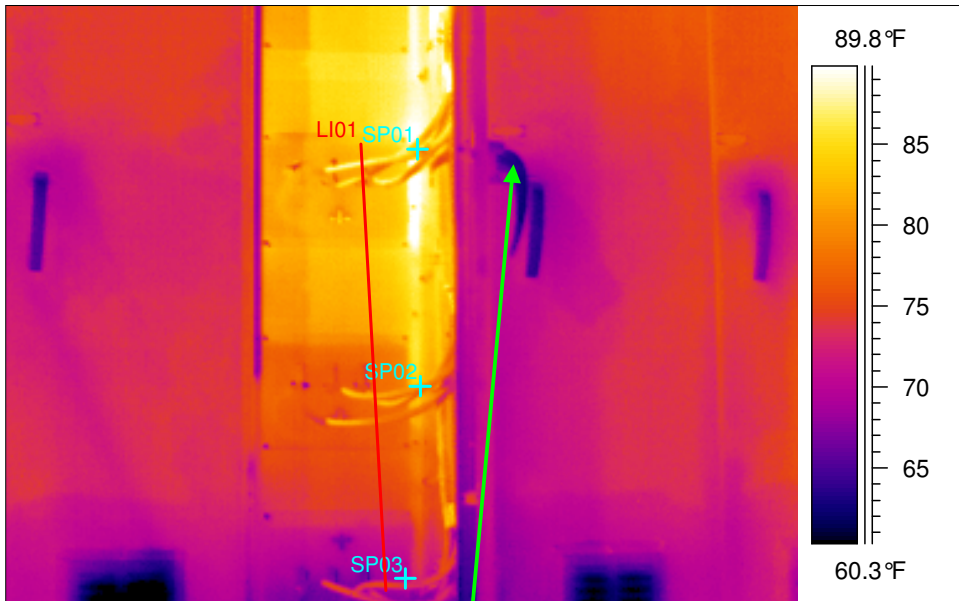
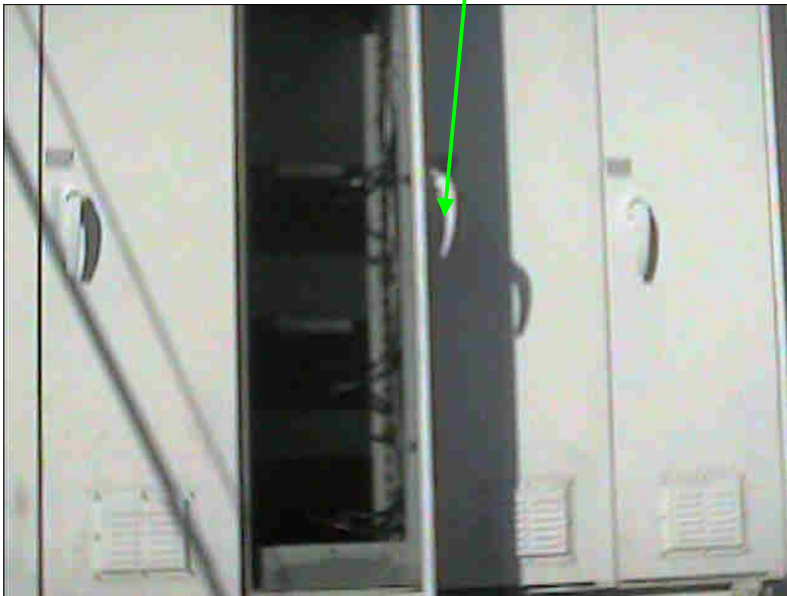
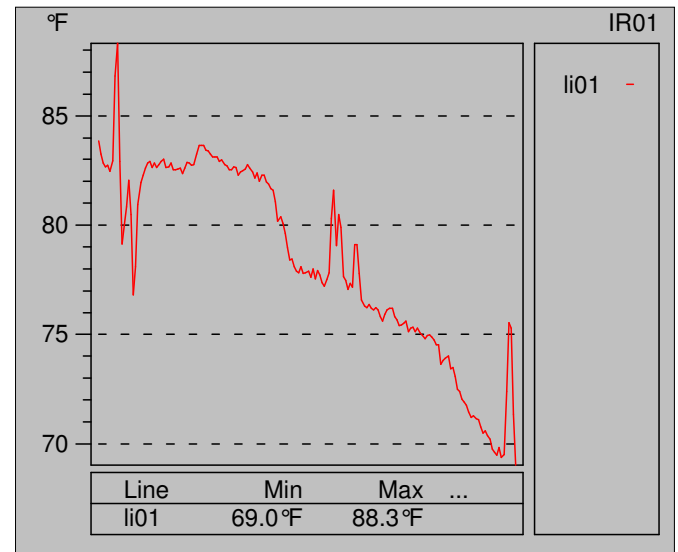
| Component | Equipment/Bucket ID | Plant/Area | Date |
|---|---|---|---|
| Middle Panel | SUB 248 | HCN | 12-26-19 |

| Label | Value |
|---|---|
| IR : max | 93.7°F |
| LI01 : max | 88.3°F |
| LI01 : min | 69.0°F |

| <b>Fault</b> | None |
| <b>Defect Rating</b> | NA |

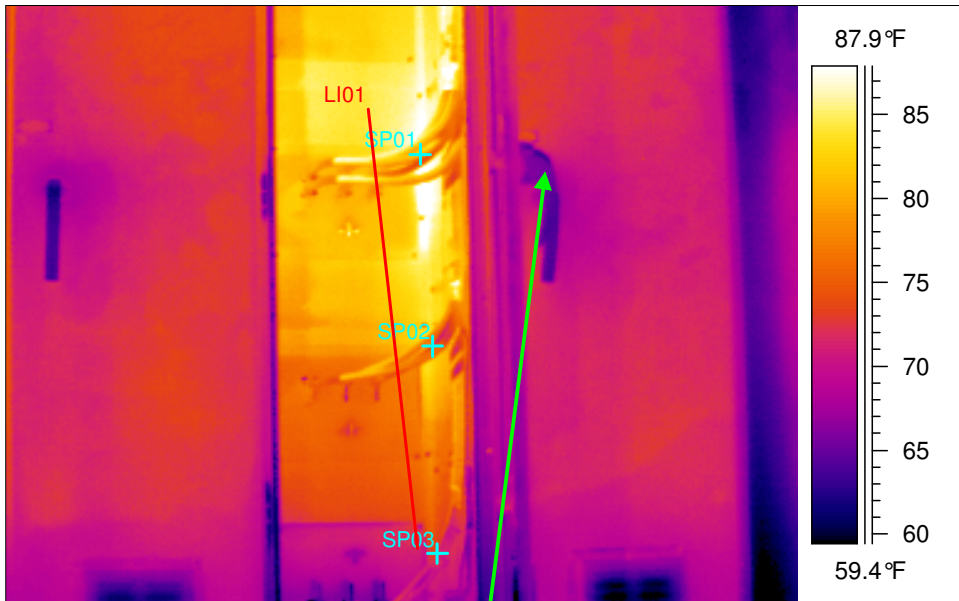
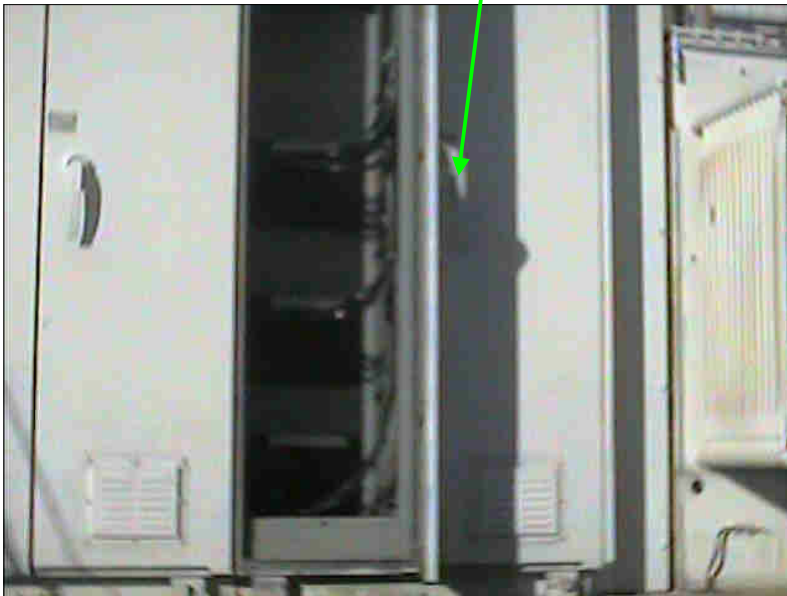
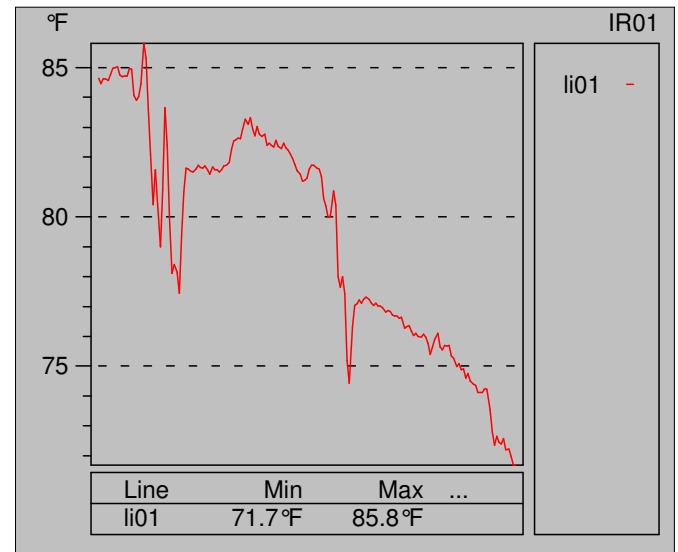
| Component | Equipment/Bucket ID | Plant/Area | Date |
|---|---|---|---|
| East Middle Panel | SUB 248 | HCN | 12-26-19 |

| Label | Value |
|---|---|
| IR : max | 93.2°F |
| LI01 : max | 85.8°F |
| LI01 : min | 71.7°F |

| <b>Fault</b> | None |
| <b>Defect Rating</b> | NA |

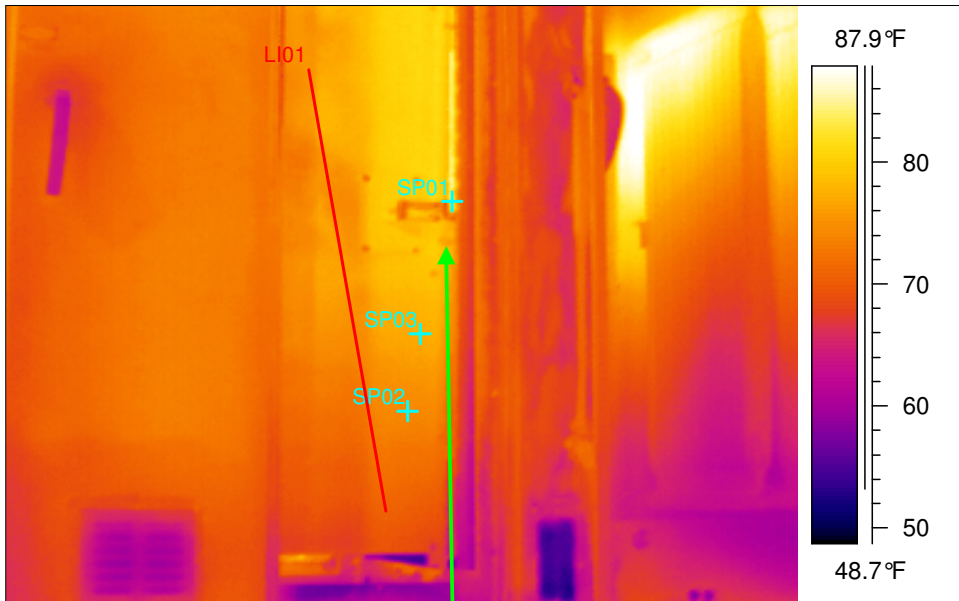
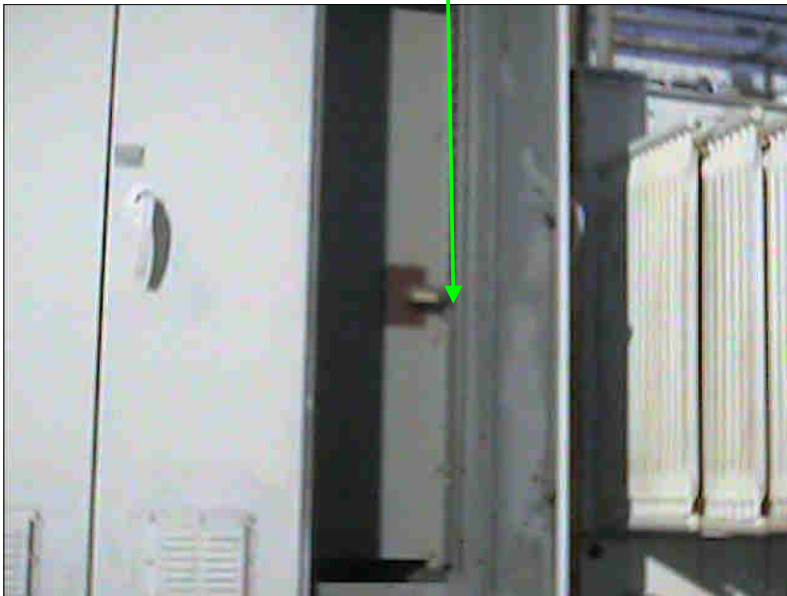
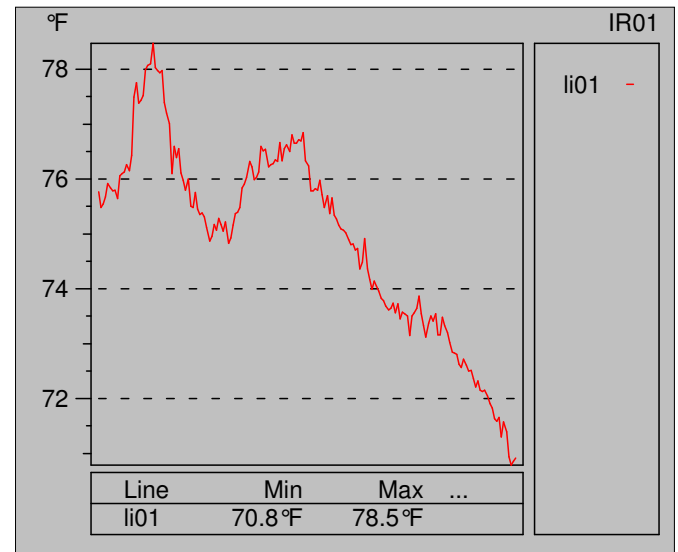
| Component | Equipment/Bucket ID | Plant/Area | Date |
|---|---|---|---|
| East Panel | SUB 248 | HCN | 12-26-19 |

| Label | Value |
|---|---|
| IR : max | 88.9°F |
| LI01 : max | 78.5°F |
| LI01 : min | 70.8°F |

| <b>Fault</b> | None |
| <b>Defect Rating</b> | NA |
