## Infrared Thermography Report

Chemours NaCN September 23, 2020

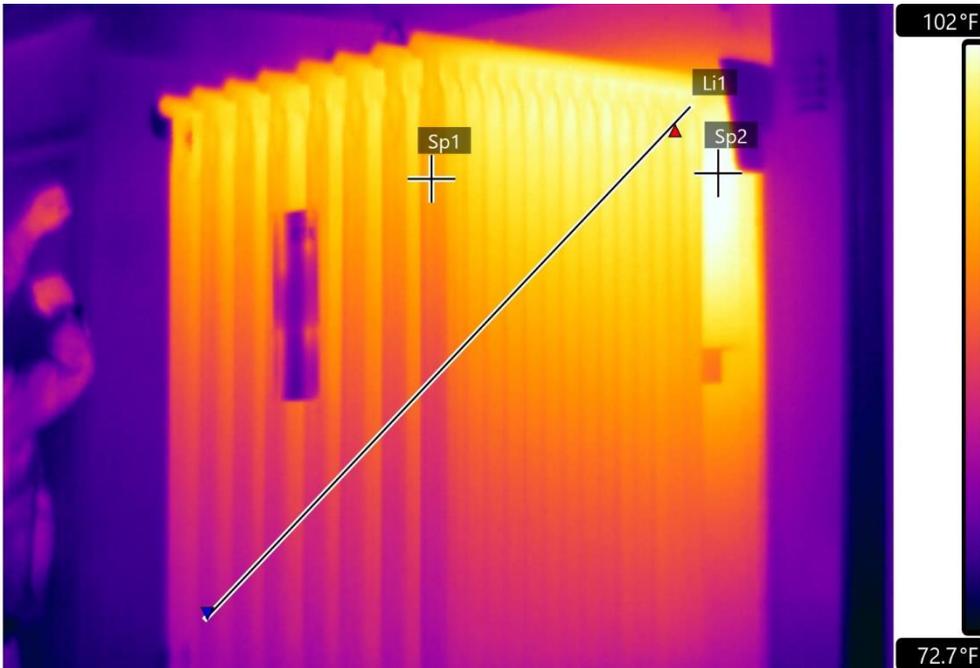
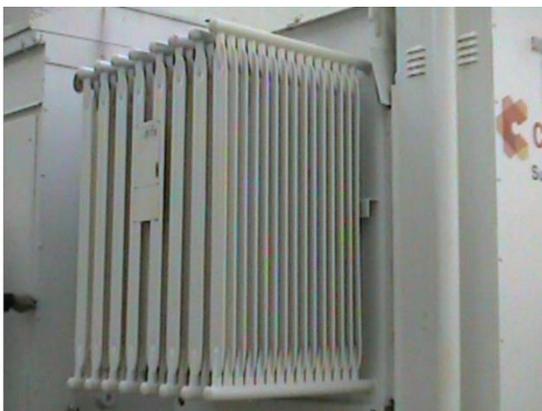
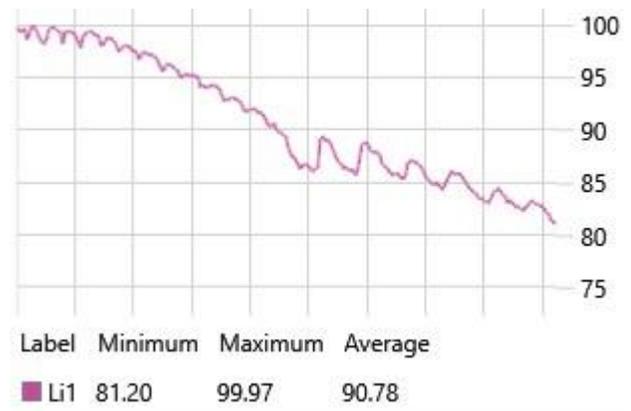
<b>Component</b>	North side cooling fins and transformer body
<b>Equipment/Bucket ID</b>	Sub 252-B

Sp1	92.8 °F
Sp2	101.7 °F
Li1 Minimum	81.2 °F
Li1 Maximum	100.0 °F
Areas	-

<b>Fault</b>	None
<b>Defect Rating</b>	NA

<b>Recommendations</b>	None
------------------------	------

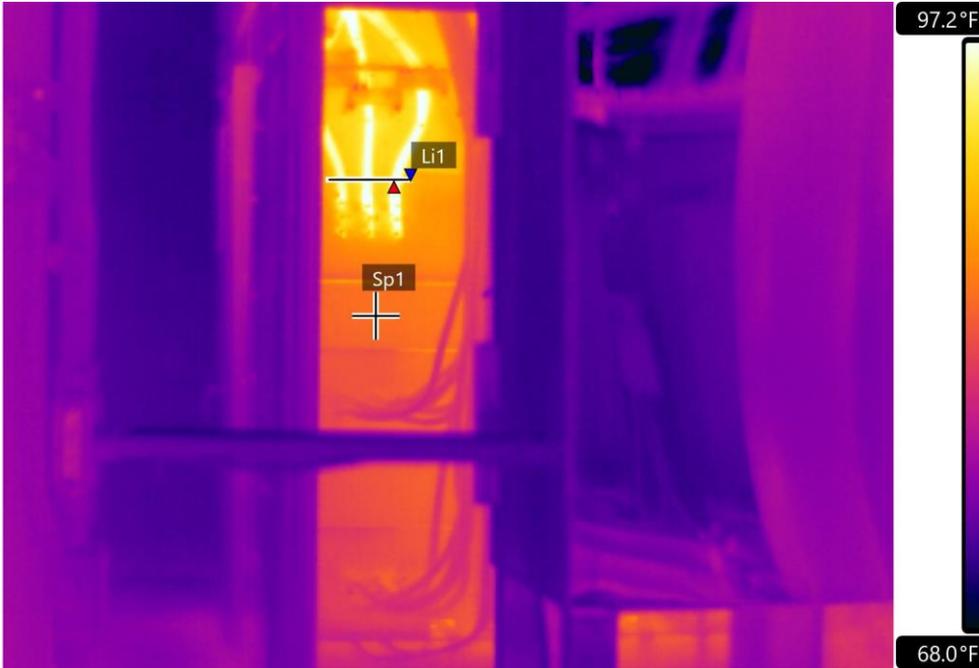
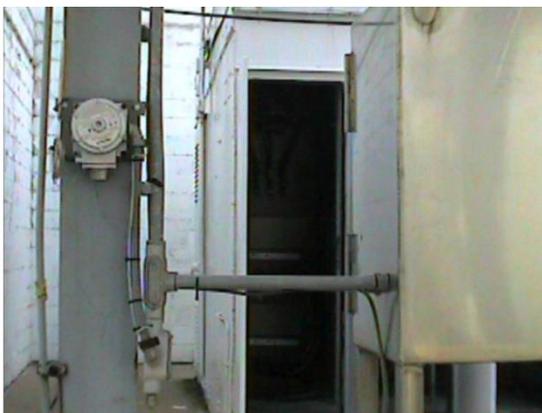
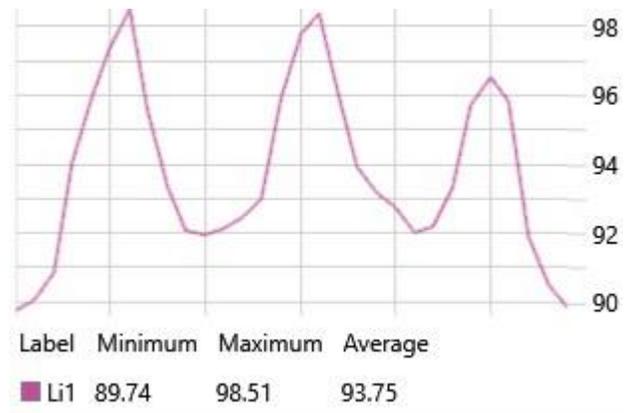
<b>Component</b>	Left (East) door connections
<b>Equipment/Bucket ID</b>	Sub 252-B

Sp1	85.0 °F
Li1 Minimum	89.7 °F
Li1 Maximum	98.5 °F
Areas	-

<b>Fault</b>	None
<b>Defect Rating</b>	NA

<b>Recommendations</b>	None
------------------------	------

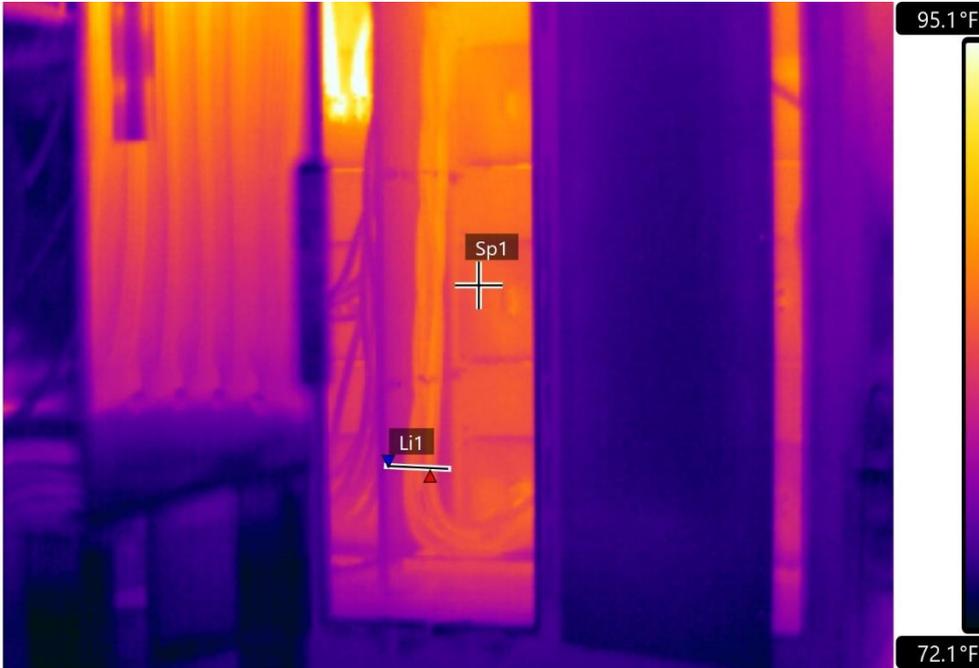
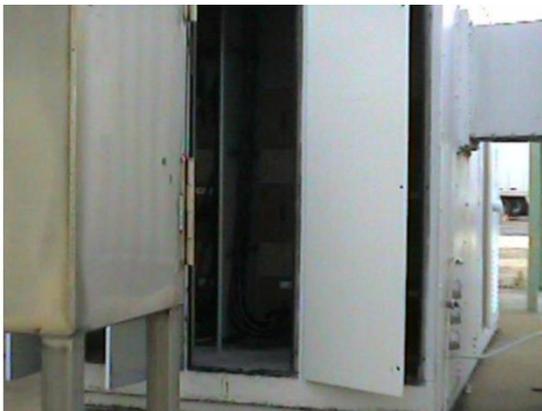
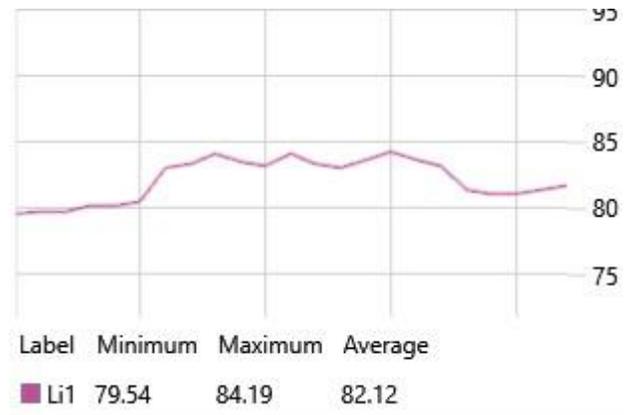
<b>Component</b>	Middle door connections
<b>Equipment/Bucket ID</b>	Sub 252-B

Sp1	84.4 °F
Li1 Minimum	79.5 °F
Li1 Maximum	84.2 °F
Areas	-

<b>Fault</b>	None
<b>Defect Rating</b>	NA

<b>Recommendations</b>	None
------------------------	------

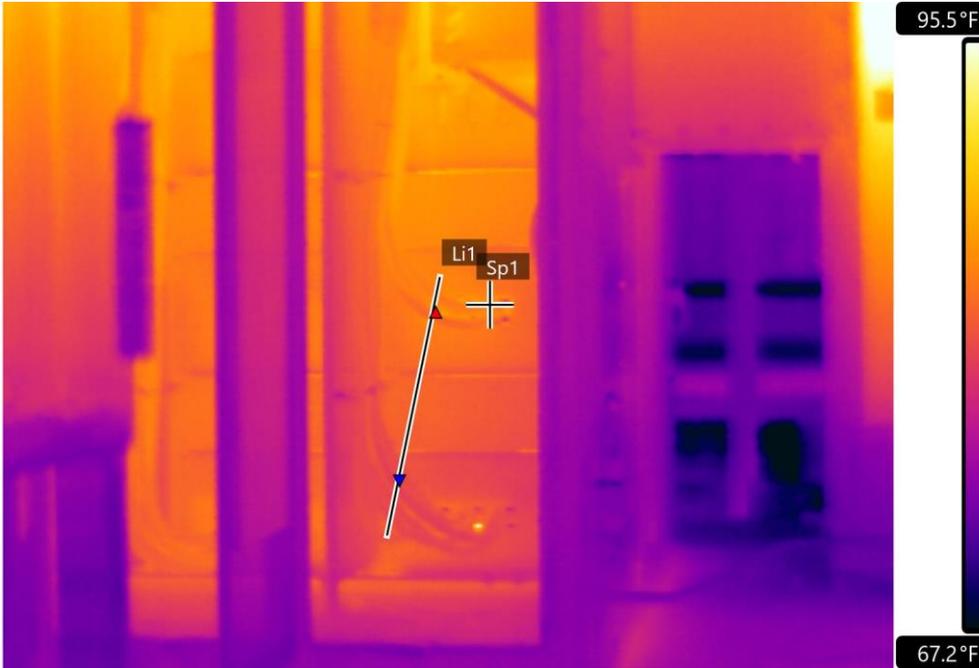
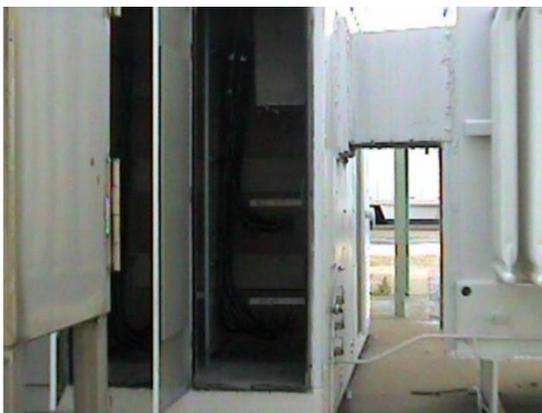
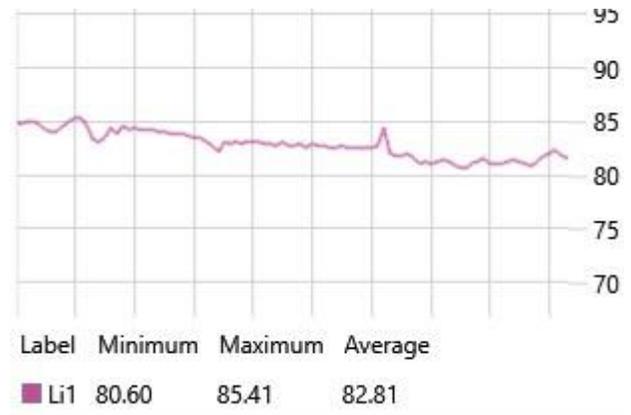
<b>Component</b>	Right (West) door connections
<b>Equipment/Bucket ID</b>	Sub 252-B

Sp1	84.4 °F
Li1 Minimum	80.6 °F
Li1 Maximum	85.4 °F
Areas	-

<b>Fault</b>	None
<b>Defect Rating</b>	NA

<b>Recommendations</b>	None
------------------------	------

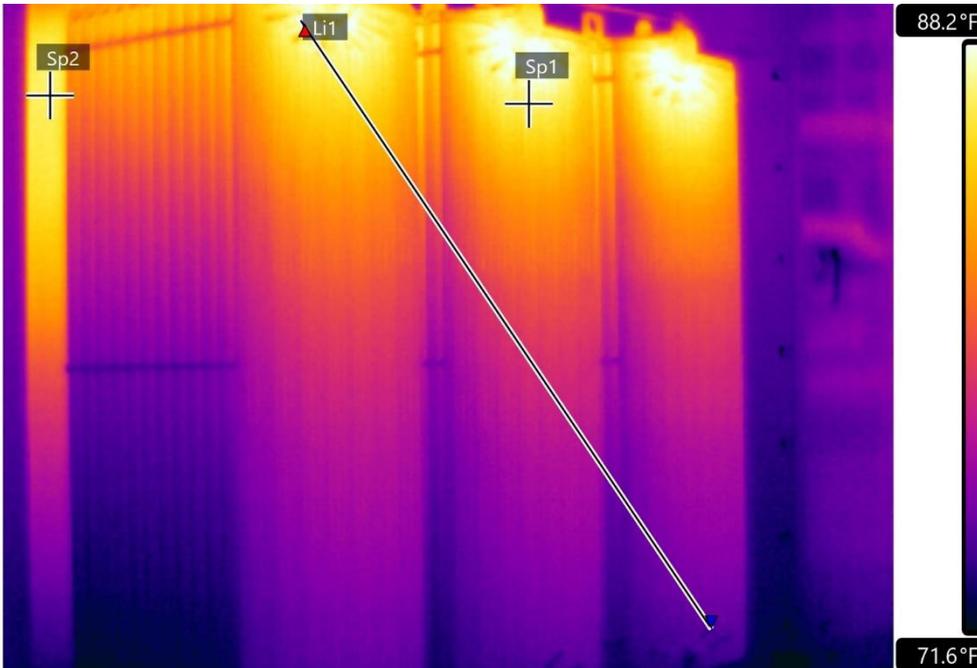
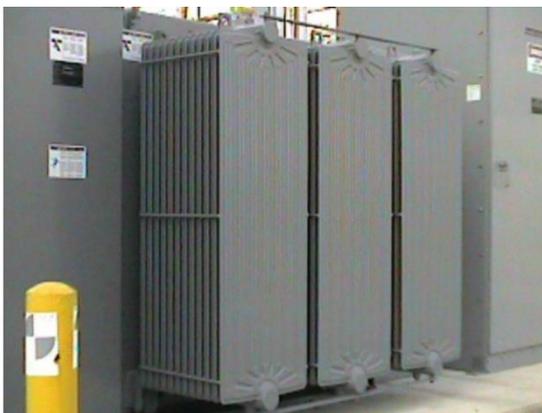
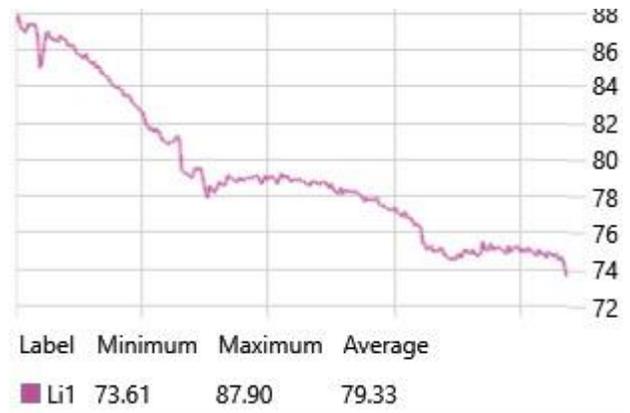
<b>Component</b>	North side cooling fins
<b>Equipment/Bucket ID</b>	Sub 231

Sp1	86.7 °F
Sp2	86.7 °F
Li1 Minimum	73.6 °F
Li1 Maximum	87.9 °F
Areas	-

<b>Fault</b>	None
<b>Defect Rating</b>	NA

<b>Recommendations</b>	None
------------------------	------
