# QualiTest IR Radiometric Survey Report

Chemours  
Power House, wells and sub stations

| Job Number | 141217 |
| Survey Date | 11/18-20/19 |

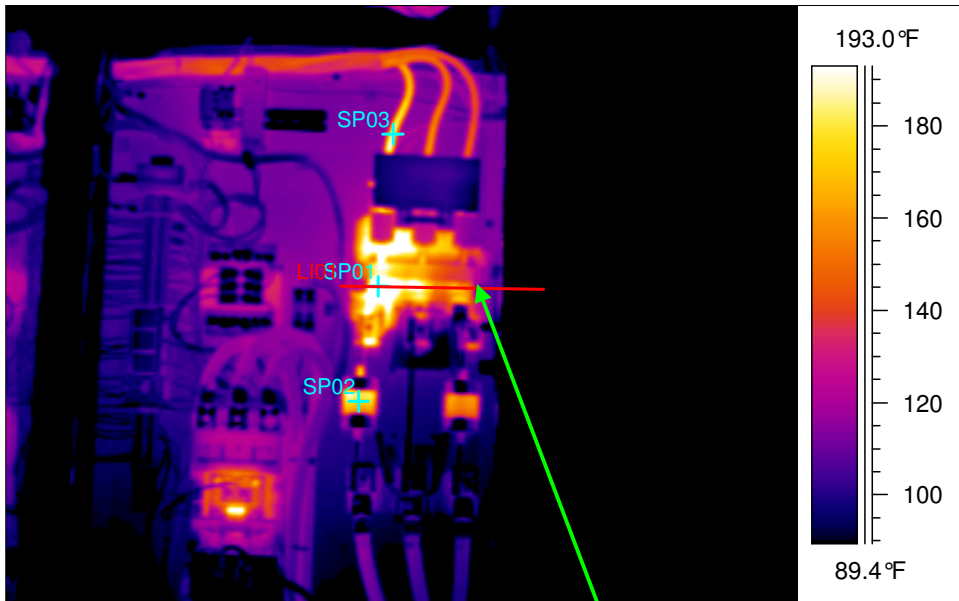
| Component | Equipment/Bucket ID | Plant/Area | Date |
|---|---|---|---|
| Main Switch | Well Pump 1 | Chemours | 11-18-19 |

| Label | Value |
|---|---|
| IR : max | *301.8°F |
| SP01 | *300.4°F |

| <b>Fault</b> | Poor connection at switch |
| <b>Defect Rating</b> | Class III |

The unit should be inspected ASAP. A phase is showing a very large temperature delta compared to the other phases. Clean and inspect, repair or replace as required.

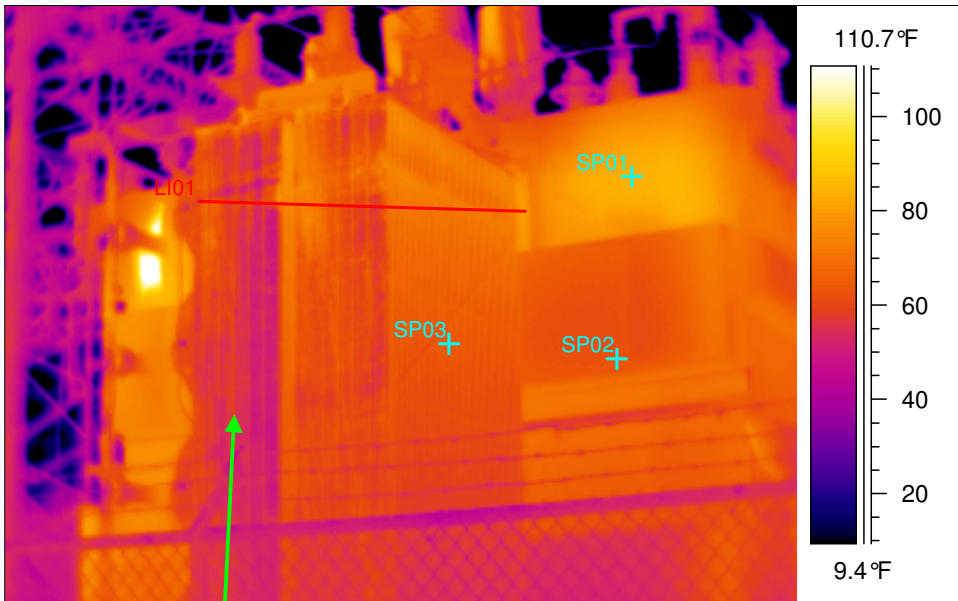
| Component | Equipment/Bucket ID | Plant/Area | Date |
|---|---|---|---|
| Middle Transformer | 4157 | Main Substation 24 | 11-19-19 |

| Label | Value |
|---|---|
| IR : max | 122.6°F |

| <b>Fault</b> | Possible cooling flow issue |
| <b>Defect Rating</b> | Class I |

Check oil level

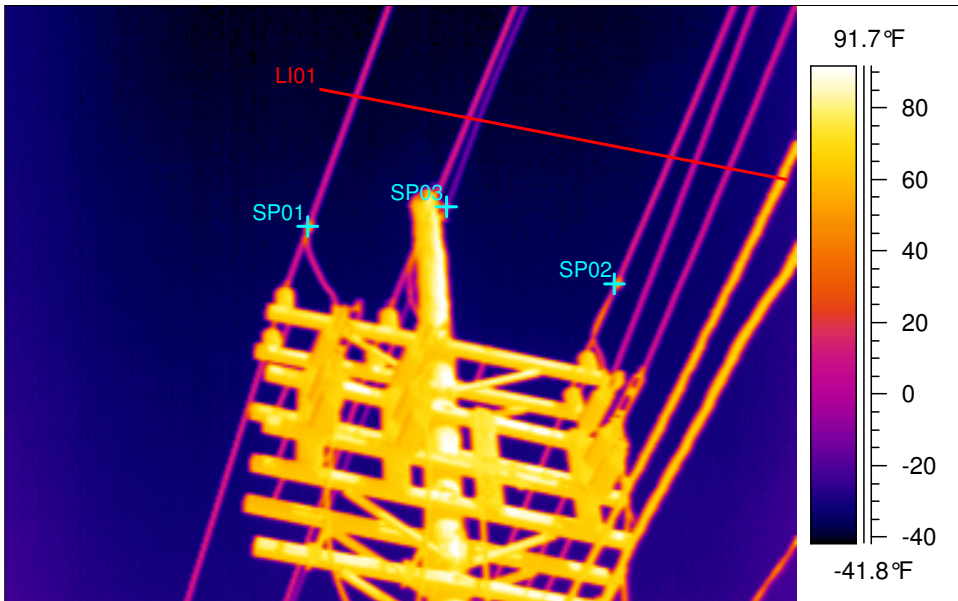
| Component | Equipment/Bucket ID | Plant/Area | Date |
|---|---|---|---|
| Connection | Pole 1125 | Chemours | 11-19-19 |

| <b>Fault</b> | Slight connection issue |
| <b>Defect Rating</b> | Class I |

Check top Line connectors.

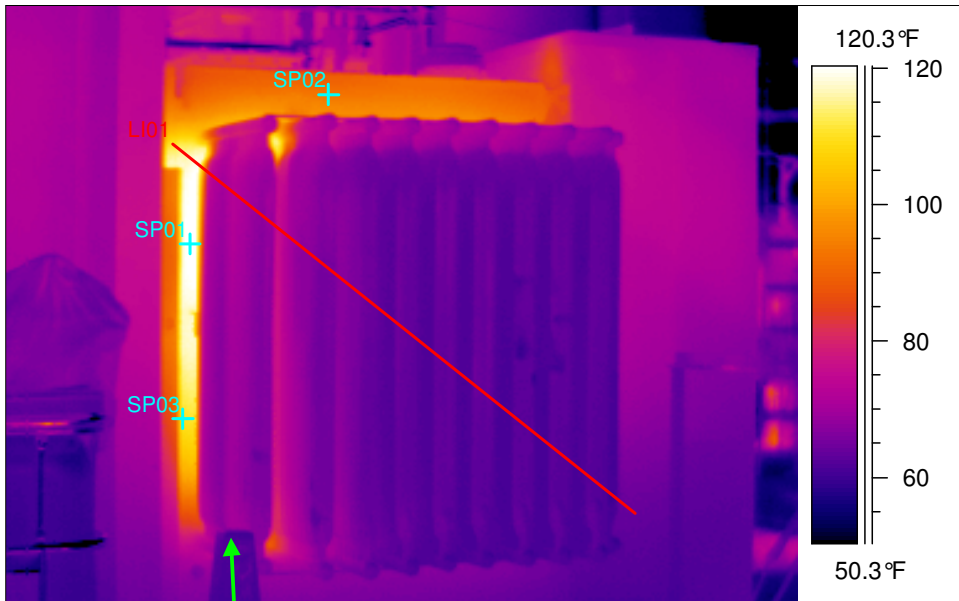
| Component | Equipment/Bucket ID | Plant/Area | Date |
|---|---|---|---|
| East Radiator | SUB 249A | Chemours | 11-19-19 |

| <b>Fault</b> | Cooling issue |
| <b>Defect Rating</b> | Class II |

Non-working radiator. Inspect in near future. Check oil level, valves, and associated controls if equipped. Fins could be plugged.

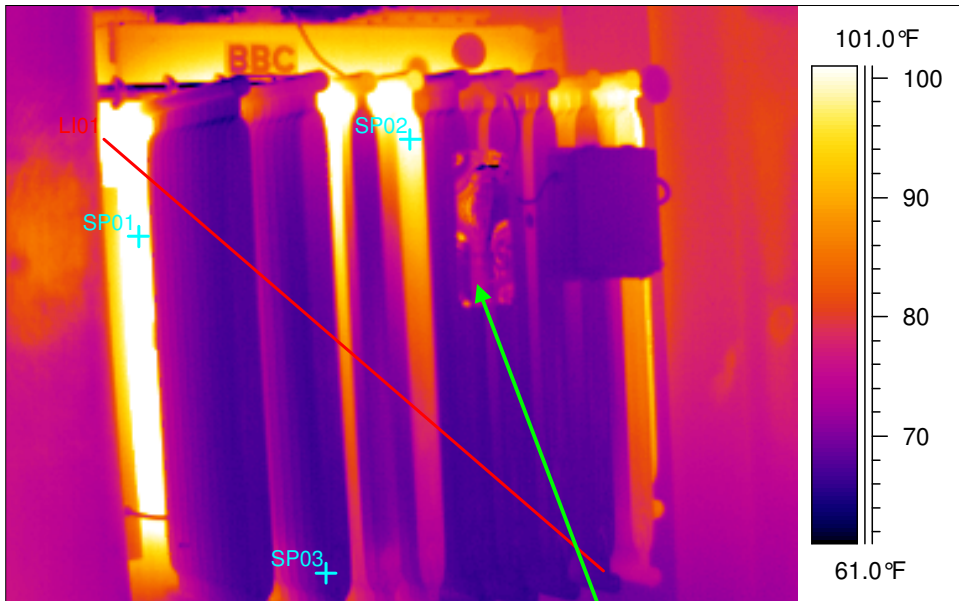
| Component | Equipment/Bucket ID | Plant/Area | Date |
|---|---|---|---|
| West Radiator | SUB 249A | Chemours | 11-19-19 |

| <b>Fault</b> | Cooling issues. |
| <b>Defect Rating</b> | Class II |

Multiple possible issues. Check for proper oil level and and plugges fins in the near future.

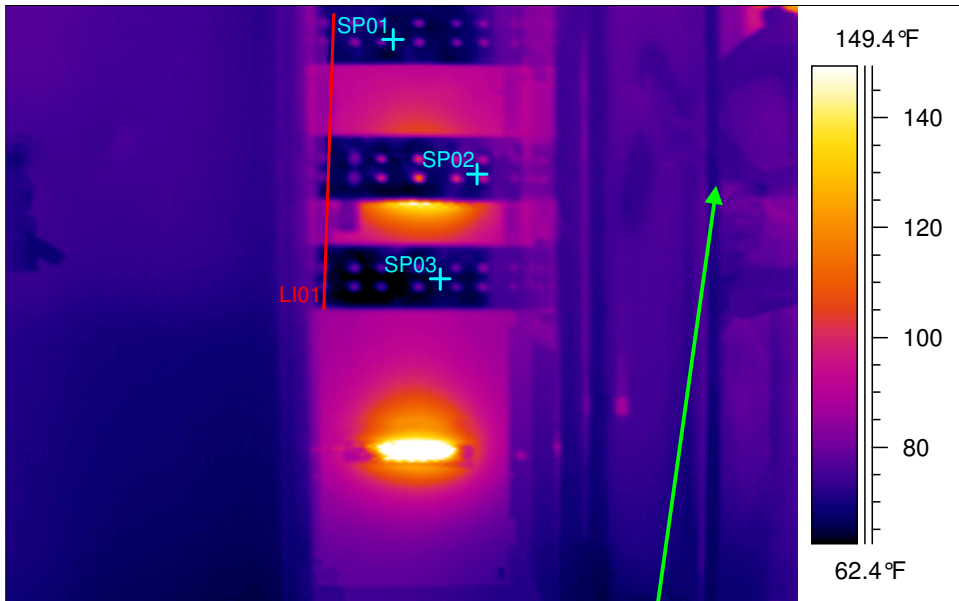
| Component | Equipment/Bucket ID | Plant/Area | Date |
|---|---|---|---|
| Right Panel | SUB 249A | Chemours | 11-19-19 |

Note:  
Hot spot is heater.

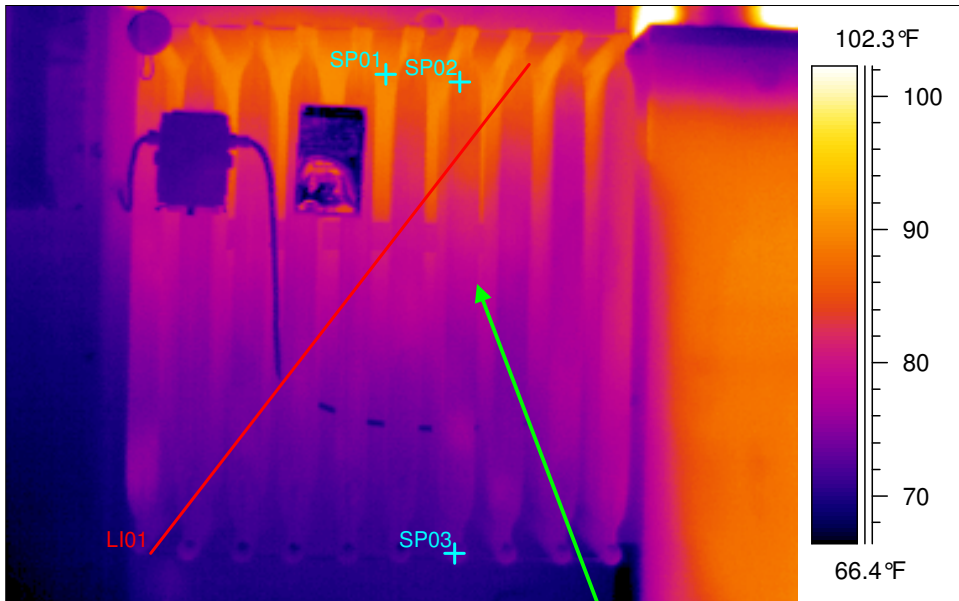
| Component | Equipment/Bucket ID | Plant/Area | Date |
|---|---|---|---|
| South Radiator | SUB 249C | Chemours | 11-19-19 |

| <b>Fault</b> | Slight variation in cooling fins |
| <b>Defect Rating</b> | none |

Check oil level for now.

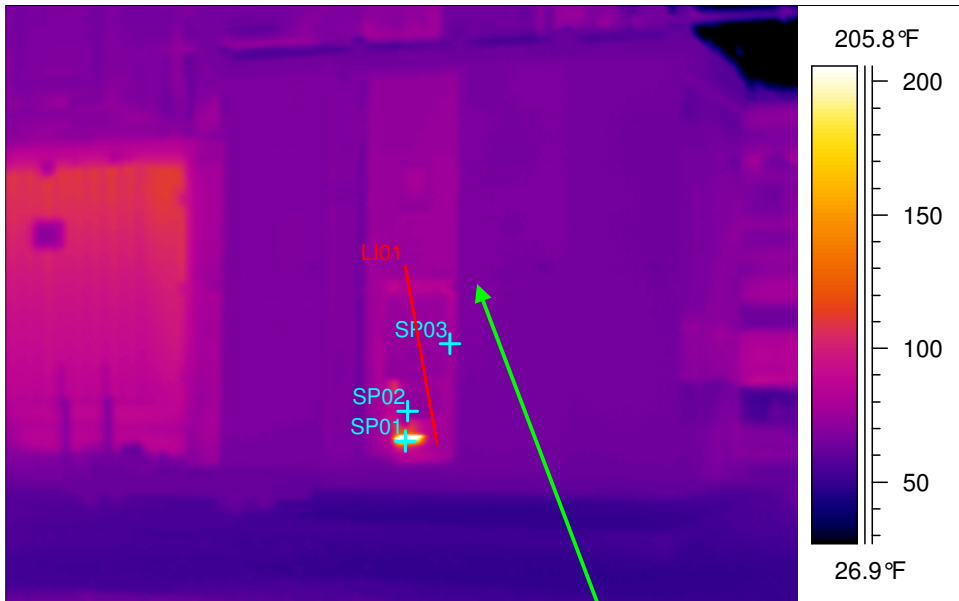
| Component | Equipment/Bucket ID | Plant/Area | Date |
|---|---|---|---|
| Left Center Panel | SUB 249D | Chemours | 11-19-19 |

Heater is the hot spot

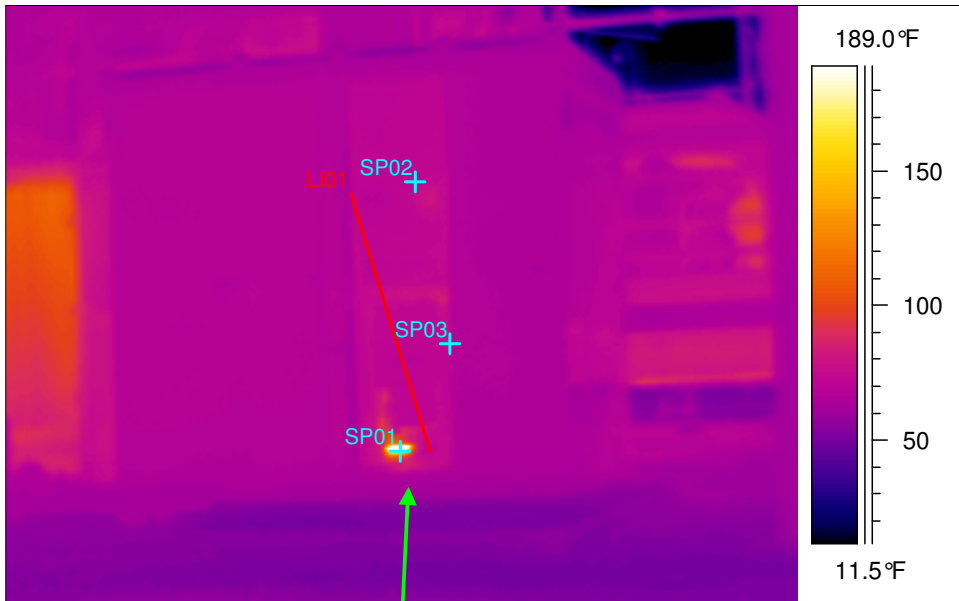
| Component | Equipment/Bucket ID | Plant/Area | Date |
|---|---|---|---|
| Right Center Panel | SUB 249D | Chemours | 11-19-19 |

Hot spot is the panel heater.

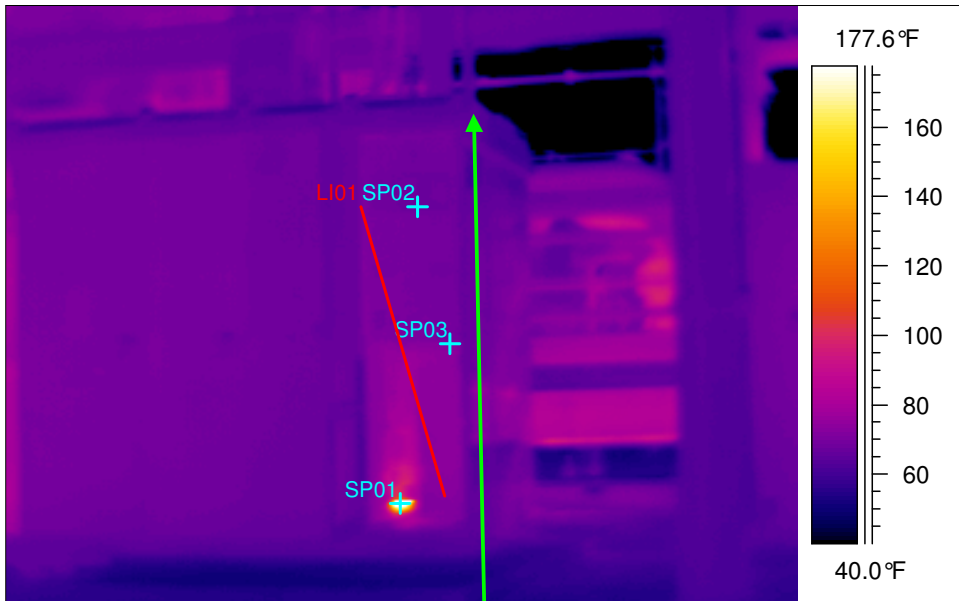
| Component | Equipment/Bucket ID | Plant/Area | Date |
|---|---|---|---|
| Right Panel | SUB 249D | Chemours | 11-19-19 |

Hot spot is the panel heater.

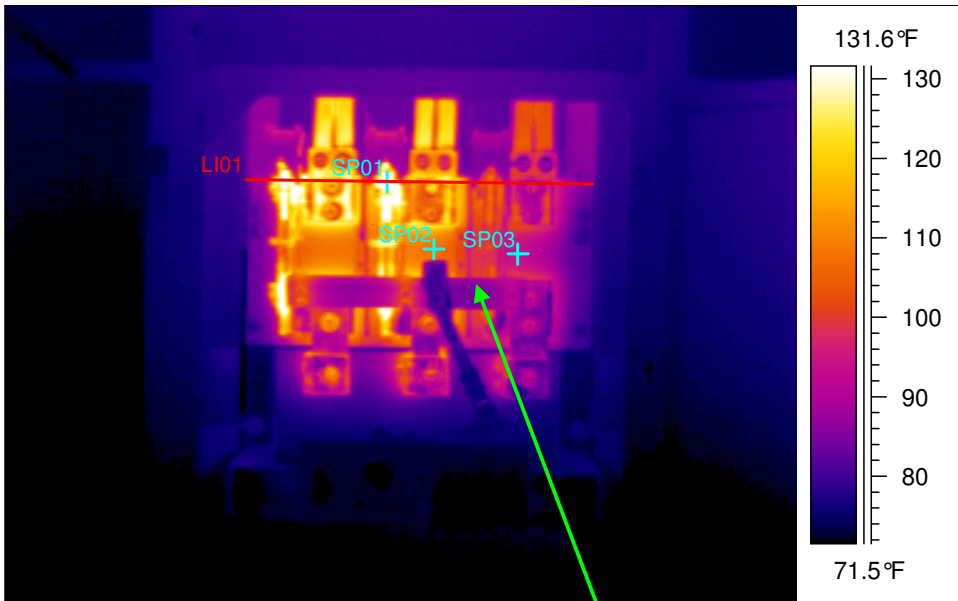
| Component | Equipment/Bucket ID | Plant/Area | Date |
|---|---|---|---|
| Switch Contacts | Load Break Switch 2 | Chemours | 11-19-19 |

| <b>Fault</b> | Temperature delta at switch contacts. |
| <b>Defect Rating</b> | Class I |

Inspect and Clean, repair or replace switch.

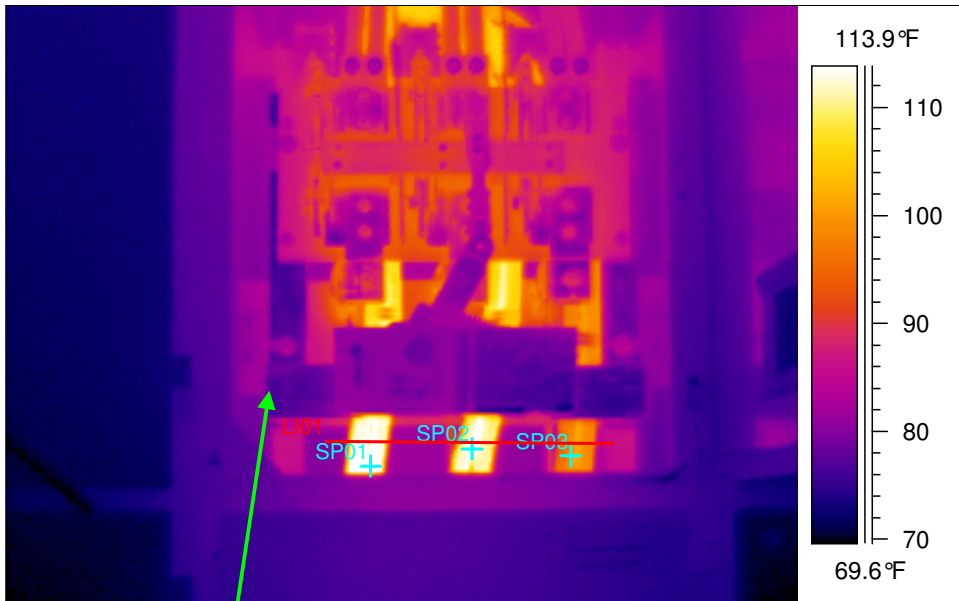
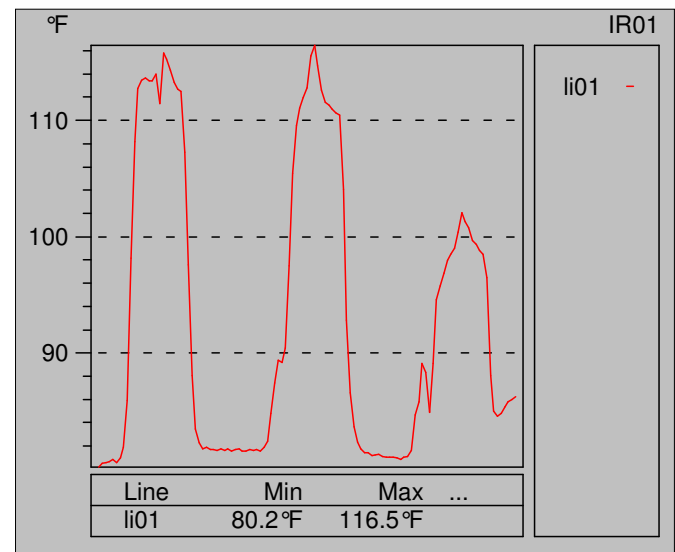
| Component | Equipment/Bucket ID | Plant/Area | Date |
|---|---|---|---|
| A/B phase from bottom | Load Break Switch 2 | Chemours | 11-19-19 |

| <b>Fault</b> | Bottom switch issue |
| <b>Defect Rating</b> | See previous sheet on Bottom Switch |

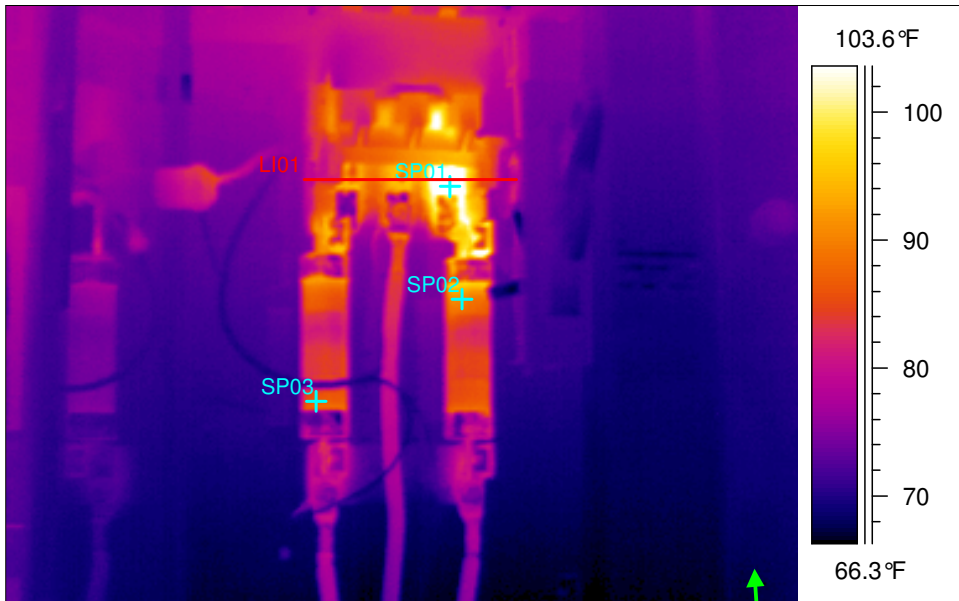
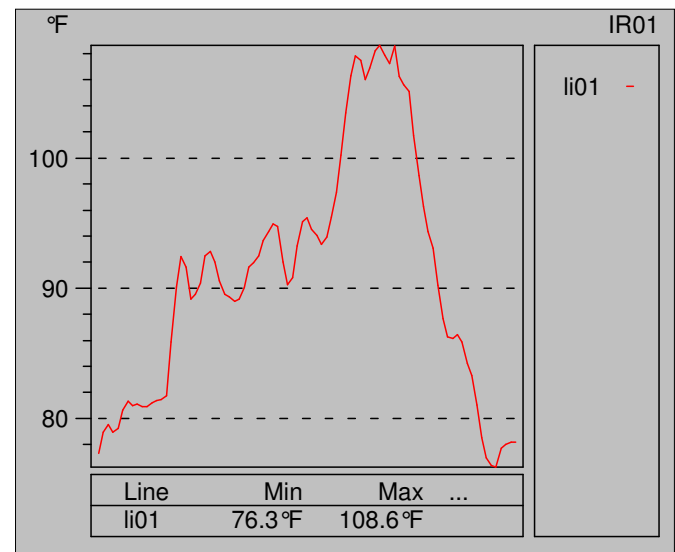
| Component | Equipment/Bucket ID | Plant/Area | Date |
|---|---|---|---|
| Switch/fuse clip | 2 E Clearwell Pump | MCC 4 | 11-20-19 |

| <b>Fault</b> | Poor connection at switch |
| <b>Defect Rating</b> | Class I |

The AC phase switch contact and/or fuse clip shows what looks to be a localized hot spot.  
Clean and inspect, repair or replace.

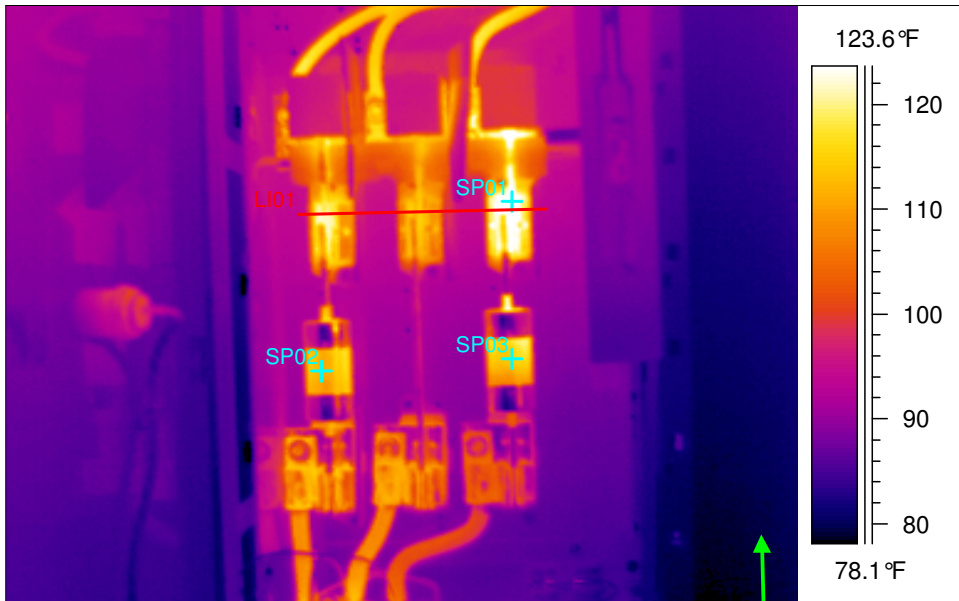
| Component | Equipment/Bucket ID | Plant/Area | Date |
|---|---|---|---|
| Switch | 5D #6 BFWP | MCC 2 | 11-20-19 |

| <b>Defect Rating</b> | Class I |

Slight temperature delta at C phase switch contact suggests a poor connection.  
Clean and inspect, repair or replace.

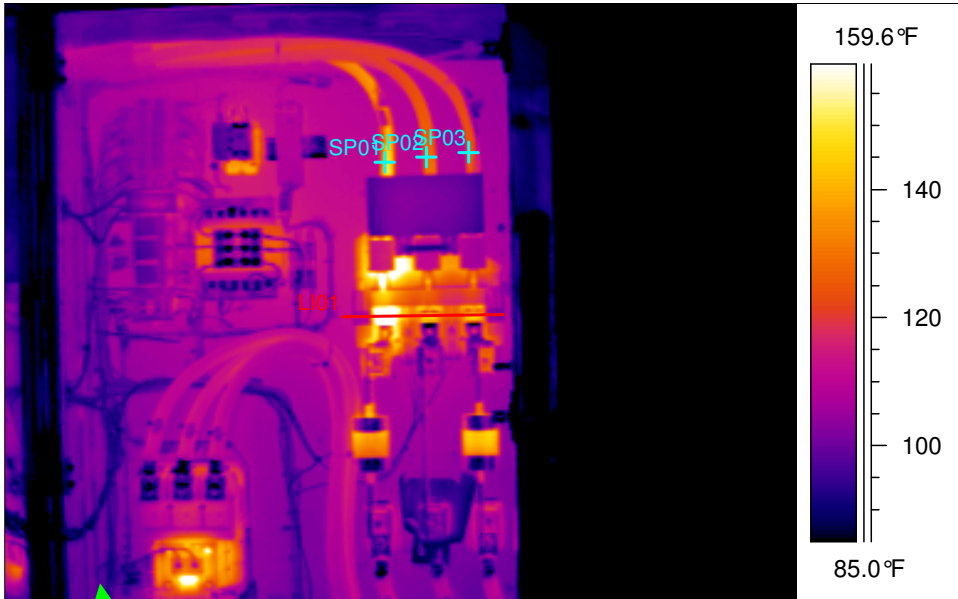
| Component | Equipment/Bucket ID | Plant/Area | Date |
|---|---|---|---|
| Switch | Well Pump 3 | Chemours | 11-20-19 |

| <b>Defect Rating</b> | Class II |

The A phase shows a significant temperature delta. We believe the switch contacts are in poor condition. Clean and inspect, repair or replace.

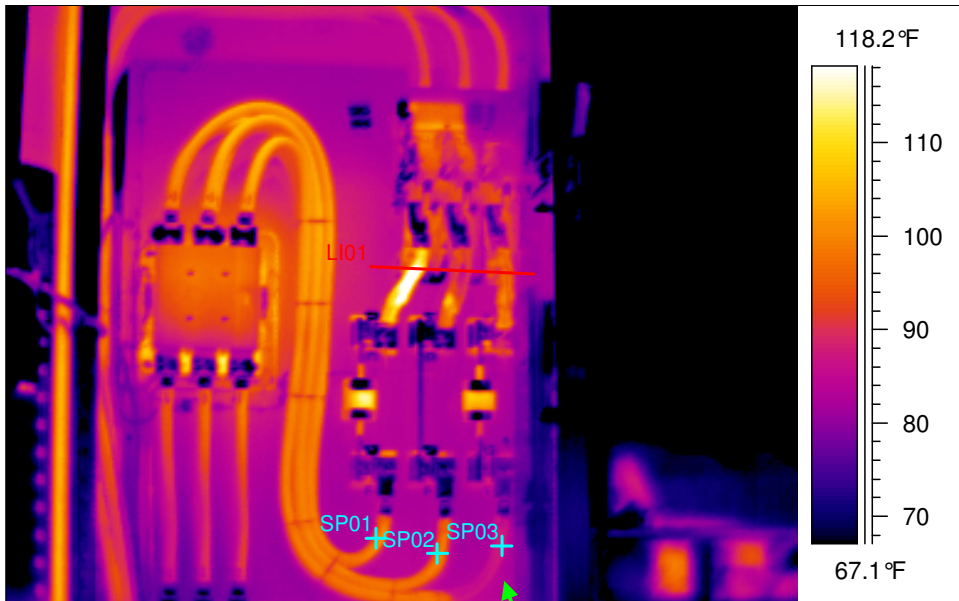
| Component | Equipment/Bucket ID | Plant/Area | Date |
|---|---|---|---|
| Switch conductors | Well Pump 10 | Chemours | 11-20-19 |

| <b>Defect Rating</b> | Class I |

Temperature delta at or near the switch A phase. Check all connections, Clean and inspect, repair or replace.

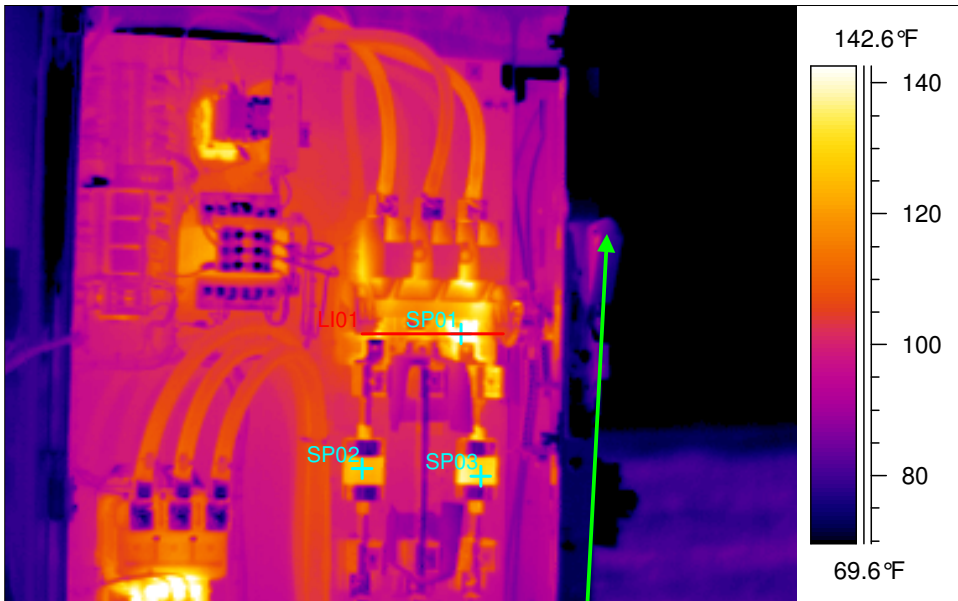
| Component | Equipment/Bucket ID | Plant/Area | Date |
|---|---|---|---|
| Switch | Well Pump 9 | Chemours | 11-20-19 |

| <b>Defect Rating</b> | Class II |

Unit shows temperature delta at switch C phase. We suspect a weak contact.  
Clean and inspect, repair or replace.
