Infrared Thermography Report

USG Greenville, MS

February 2021

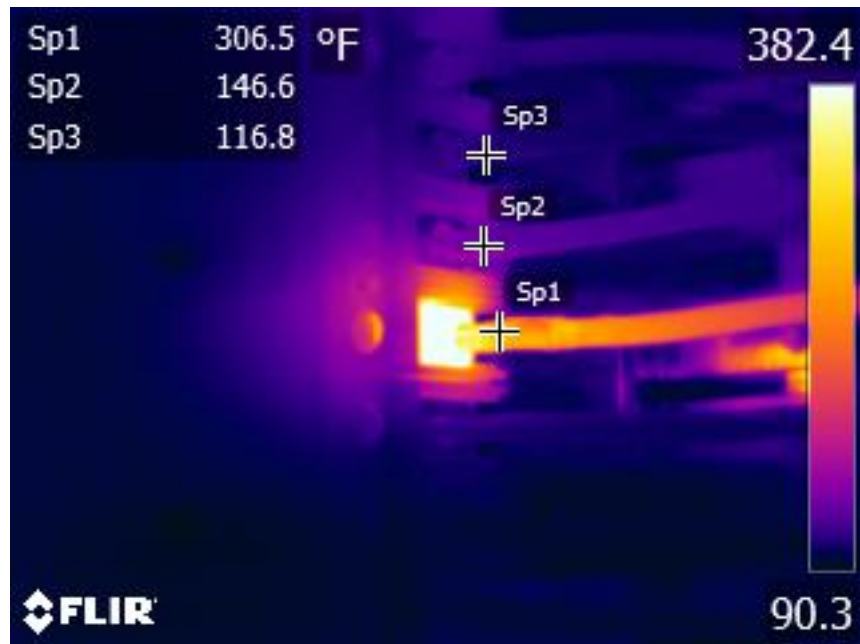
Component	Lead/Lug Connection
Equipment/Bucket ID	MCC-7C1 VFD-HTA Main Power (Board Line Area)

Fault	Load Imbalance/Loose Connections
Defect Rating	CLASS I

Recommendations
IR image suggests a possible load imbalance and/or loose connections. Inspect connections and measure current on each phase.
