Infrared Thermography Report

Gold Strike August 2021 Infrared Inspection

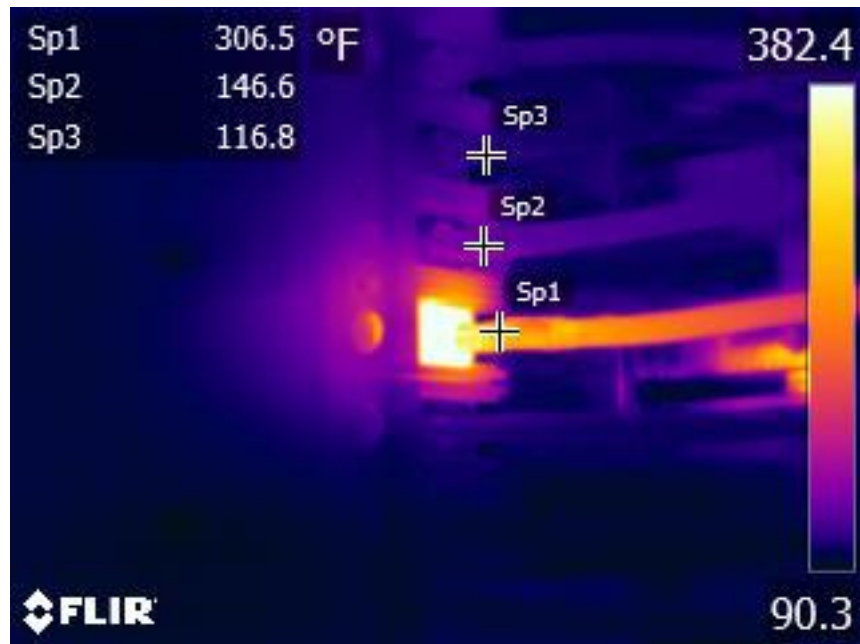
Component	B phase conductor below fuse
Equipment/Bucket ID	Chiller room motor control 13/ cond water pump ch 3

Fault	Temperature delta between phases
Defect Rating	II

Recommendations
The center phase conductor below the fuses appears to have a localized hot spot on the starter line side lug. There could be a loose connection or an unbalanced loading condition. Inspect all connections, clean and repair, or replace any defective components. Torque all lugs to specification.
