Client	A.E.C.I. Dell	Survey Date	7-30-19
Location	Dell, AR	Report Date	7-30-19
Machine	BFWP 2B	QMS No.	140203
Component	Nelson Drive and Pump	Analyst	DWS

Client	A.E.C.I. Dell	Survey Date	7-30-19
Location	Dell, AR	Report Date	7-30-19
Machine	Unit 2 LP Recirculator Pump	QMS No.	140203
Component	Motor/alignment	Analyst	DWS

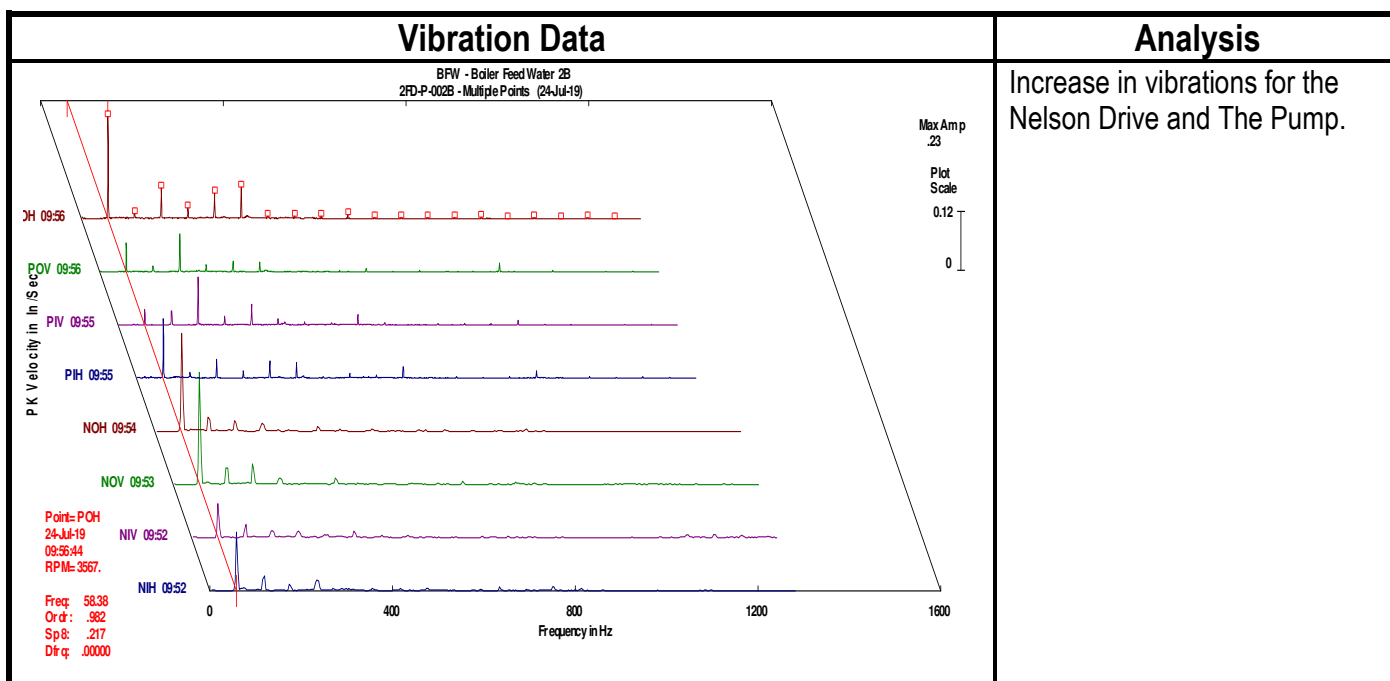
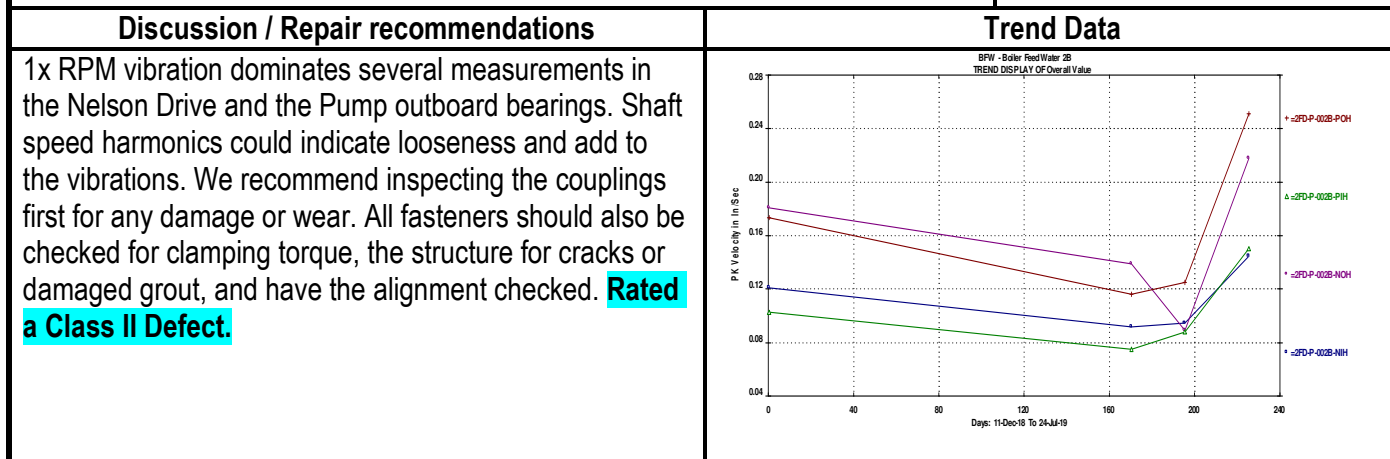
Defect Rating for this machine	Rated a Class II Defect.
Defect Rating System	
Class I: Defect is present, but effect on reliability is not clear; no immediate action is required. Continue normal monitoring.	Class III: Defect (s) present that may cause failure in short term (less than 2 mos.). Should be addressed as soon as practical, with a high maintenance priority. Increase monitoring frequency.
Class II: Defect (s) present that may cause problem in long term (2-6 mos.). Repair during normal maintenance scheduling. Continue to monitor.	Class IV: Defect (s) present that makes continued reliability unpredictable, and possibility of secondary damage is high. Repairs should be made ASAP. An unscheduled shutdown should be considered for repairs.
