Client	Lucite	Survey Date	2-1-21
Location	Memphis, TN	Report Date	2-3-21
Machine	SAR 03 turbine compressor main blower	QMS No.	133393
Component		Analyst	DWS

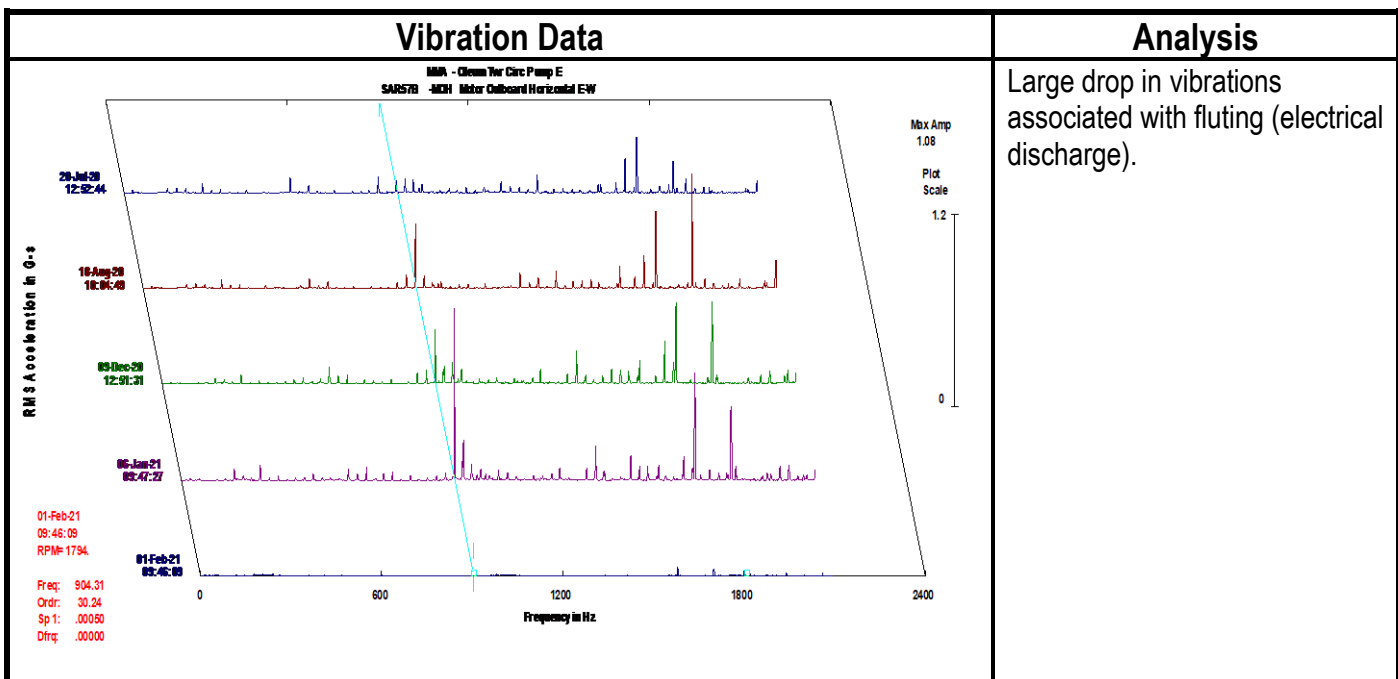
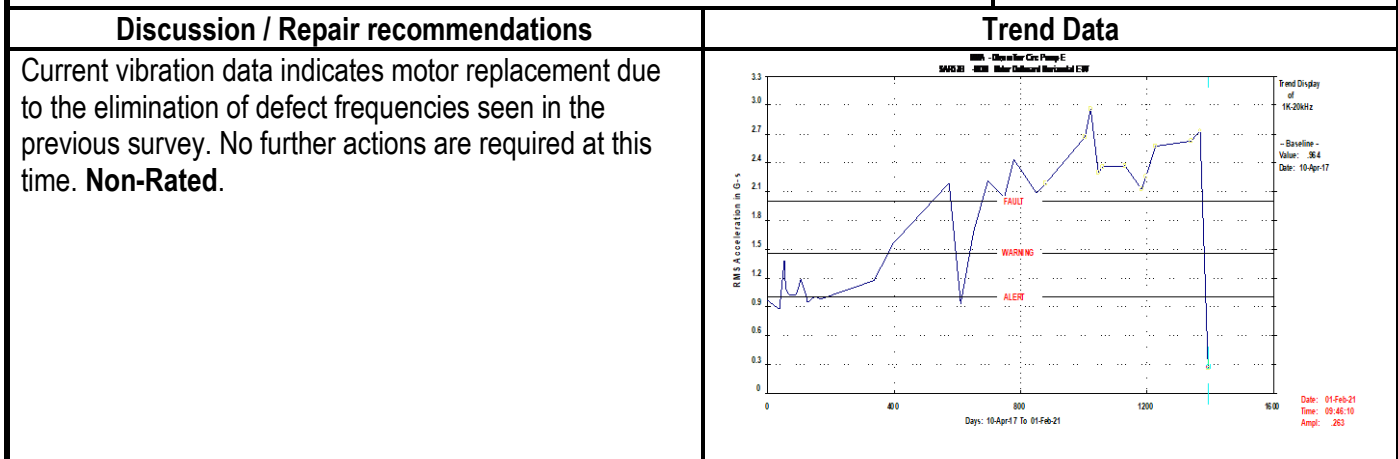
Defect Rating for this machine	NR
Defect Rating System	
<b>Class I:</b> Defect is present, but effect on reliability is not clear; no immediate action is required. Continue normal monitoring.	<b>Class III:</b> Defect (s) present that may cause failure in short term (less than 2 mos.). Should be addressed as soon as practical, with a high maintenance priority. Increase monitoring frequency.
<b>Class II:</b> Defect (s) present that may cause problem in long term (2-6 mos.). Repair during normal maintenance scheduling. Continue to monitor.	<b>Class IV:</b> Defect (s) present that makes continued reliability unpredictable, and possibility of secondary damage is high. <b>Repairs should be made ASAP. An unscheduled shutdown should be considered for repairs.</b>
