ITEM PART NO.		DES	CRIPTION				QT	Y
	TIEM TAKENO.		BILL OF	MATERIAL				- Q I	
MATERIAL:				PROD.:	PROJECT:		SALES NO.:	:	
	CONDUCTIX DRAWING TITLE: END MAINTENANCE					BAY	/		
FINISH: MATERIAL P.N:	10102 F Street Omaha, NE 68127-1181 800-521-4888	O DELACHAVX GRO	mpfler						
This drawing and the information shown is unpublished confidential property of Conductix Inc. Subject to recall, and	UNLESS OTHERWISE SPECIF ARE IN INCHES TOLERANCES		ENGINEER: K FORMA	N 10/11/13	SCALE: NTS	SHEET:	2	OF	4
is loaned for use only in connection with the authorized manufacture or installation of Conductix Inc. products, and	DECIMAL ANG. FRAC.  X = ±060 ±1° ±1/16	DRAWN: M SALAZA		DWG. PART NO.: SIZE:			REV.	.:	
on the condition that it will be treated as confidential and will not be disclosed, published or reproduced in whole	.XX = ±.030 .XXX = ±.010	250 /	CHECKED:			_			
or in part, or diverted to other uses, without specific	MINIMUM MACHINE SURFACE	\ /	APPROVED:		D  -		•

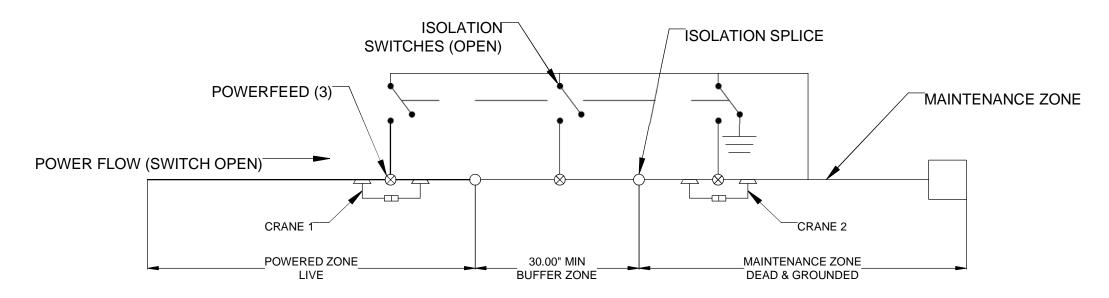
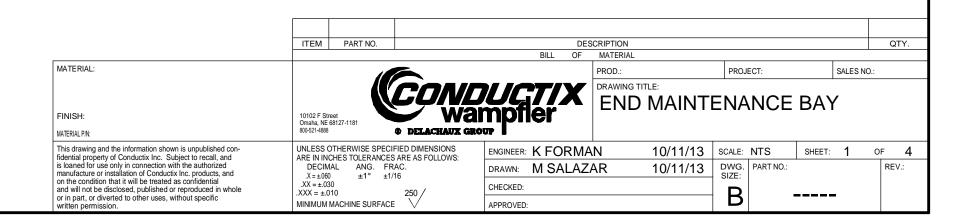
Crane 2 is in the Maintenance Zone. The Isolation Switch is open and the Maintenance Zone is de-energized and grounded. The voltage indicator on the disconnect panel is unlit - indicating that the Maintenance Zone is de-energized. The Buffer Zone is de-energized but not grounded. Crane 1 is able to operate in the Powered Zone to the left of the Buffer Zone. It is safe to perform maintenance on Crane 2 while operating Crane 1.

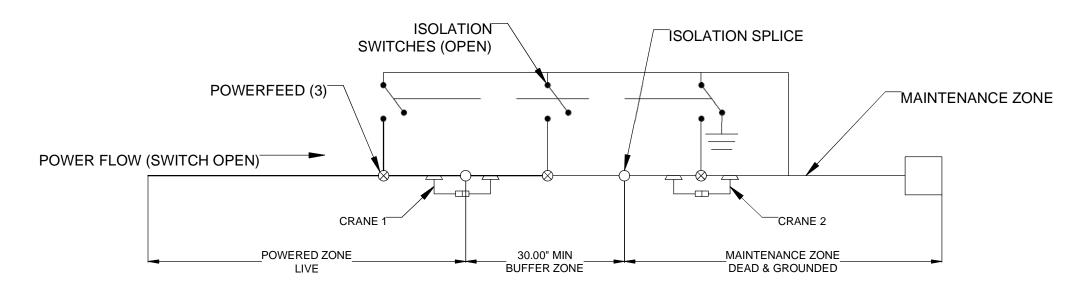
Crane 1 has bridged the outer isolation splice in the power rail, energizing the Buffer Zone. The inner isolation splice (between the Buffer Zone and the Maintenance Zone) maintains the electrical isolation (protection) of the Maintenance Zone. It is still safe to perform work on Crane 2.

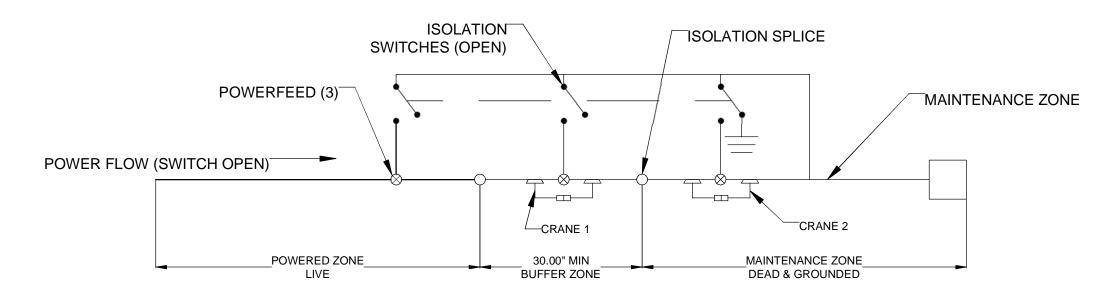
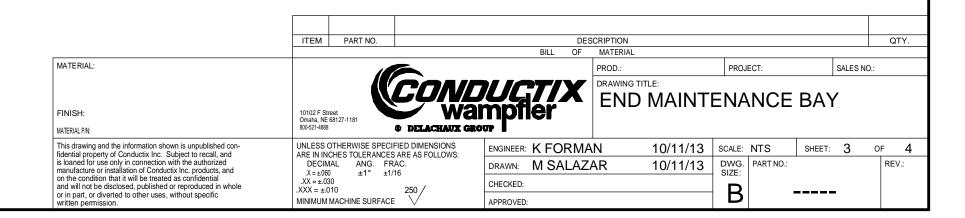
Crane 1 has moved completely into the Buffer Zone. Because the length of the Buffer Zone is greater than the span of Crane 1's tandem collectors, it is unable to bridge power from the Powered Zone into the Maintenance Zone. The Buffer Zone and the Maintenance Bay remain de-energized. It is still safe to perform work on Crane 2.

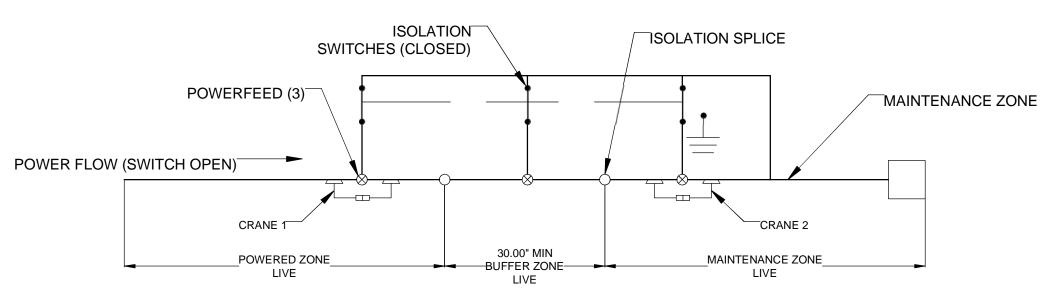
Maintenance on Crane 2 is completed and the disconnect switch is closed. All sections are energized and normal crane operation is restored. The voltage indicator on the disconnect switch enclosure shows the Maintenance Zone to be energized.
