ITEM	PART NO.		DES	CRIPTION			QTY.
				BILL OF	MATERIAL			
MATERIAL:					PROD.:	PROJECT:	SALES	S NO.:
		CONDUCTIX MIDDLE MAINTENANCE BY Wampfler				ICE BA	Υ	
FINISH:	Onlana, NE 00127 1101							
MATERIAL P/N:	000-021-4000	)	o delachaux gro					
This drawing and the information shown is unpublished confidential property of Conductix Inc. Subject to recall, and		UNLESS OTHERWISE SPECIFIED DIMENSIONS ARE IN INCHES TOLERANCES ARE AS FOLLOWS: DECIMAL ANG. FRAC. X=2060 ±1° ±1/16		ENGINEER: K FORMA	N 10/11/13	SCALE: NTS	SHEET: 4	of <b>4</b>
is loaned for use only in connection with the authorized manufacture or installation of Conductix Inc. products, and	DECIN			DRAWN: M SALAZA	AR 10/11/13	DWG. PART NO.: SIZE:		REV.:
on the condition that it will be treated as confidential and will not be disclosed, published or reproduced in whole	.XX = ±.030 .XXX = ±.010 250 / MINIMUM MACHINE SURFACE			CHECKED:		R

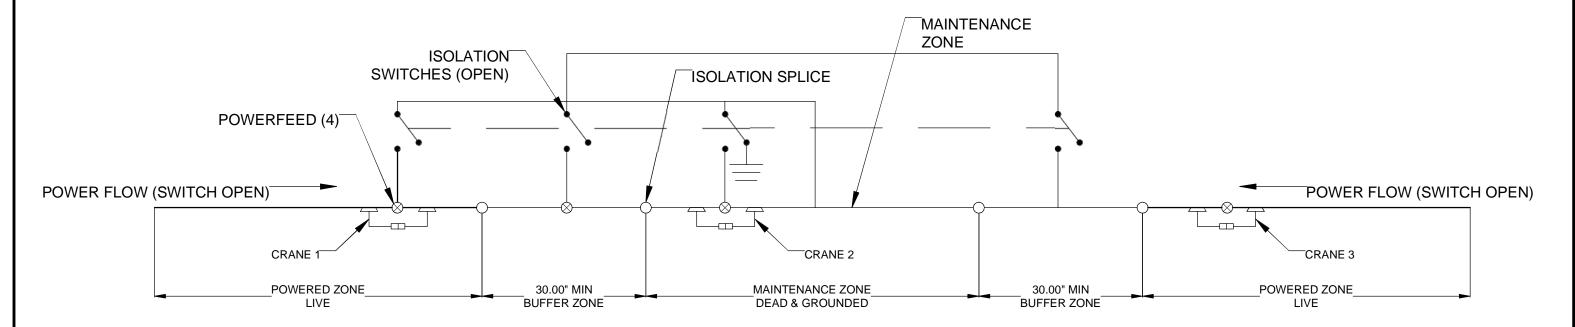
Crane 2 is in the Maintenance Zone. The Isolation Switch is open and the Maintenance Zone is de-energized and grounded. The voltage indicator on the disconnect panel is unlit - indicating that the Maintenance Zone is de-energized. The Buffer Zones on either side of the Maintenance Zone are de-energized but not grounded. Crane 1 and Crane 3 are able to operate in the Powered Zones to the left and right of the Buffer Zones. It is safe to perform maintenance on Crane 2 while operating Cranes 1 and 3.

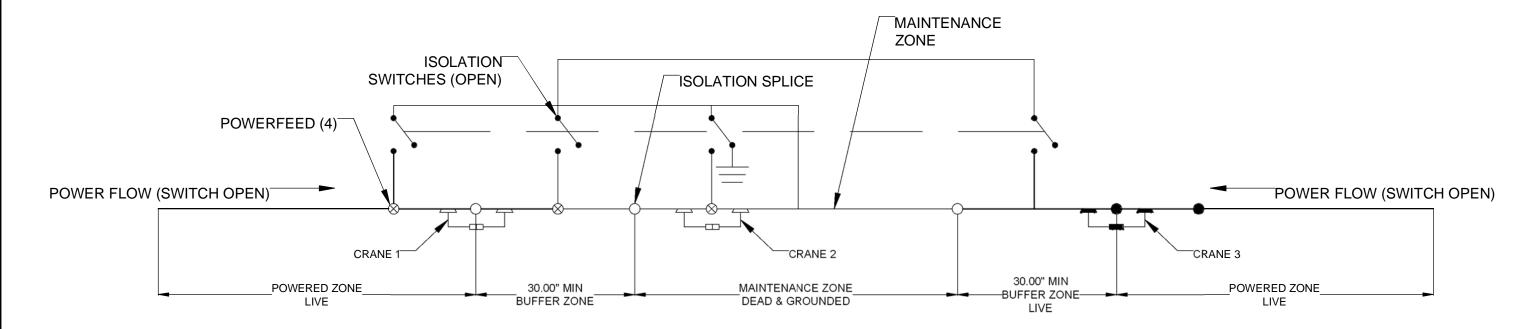
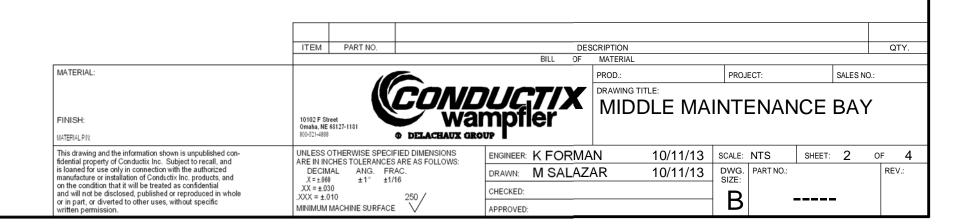
Either Crane 1 or Crane 3 may bridge the outer isolation splices in the power rail, energizing the Buffer Zones. The inner isolation splices (between the Buffer Zone and the Maintenance Zone) maintain the electrical isolation (protection) of the Maintenance Zone. It is still safe to perform work on Crane 2 under this condition.

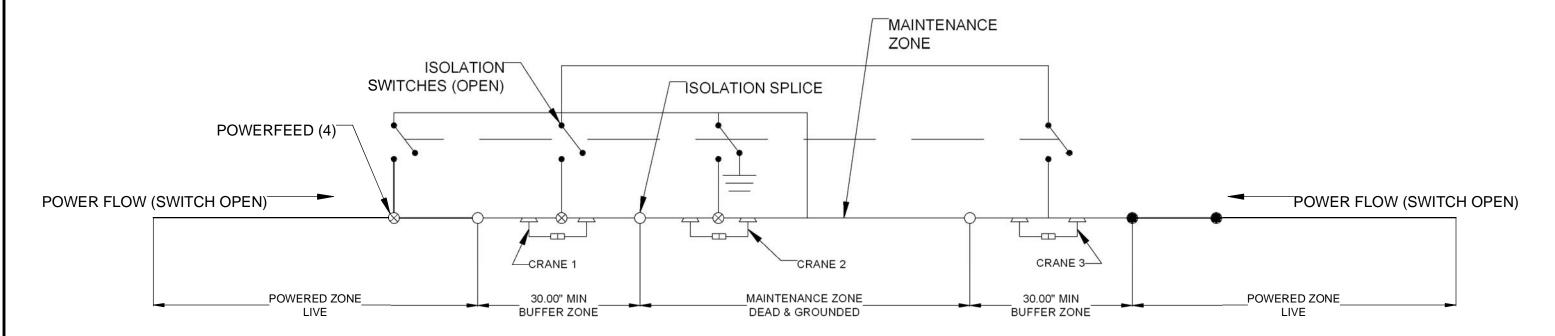
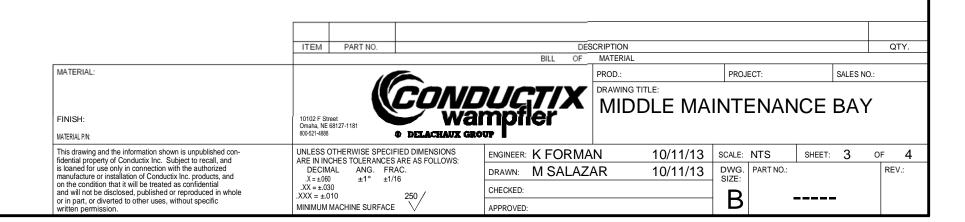
Cranes 1 and 3 have moved completely into the Buffer Zones. Because the length of the Buffer Zones are greater than the spans of Crane 1 and Crane 3's tandem collectors, they cannot bridge power from the Powered Zones into the Maintenance Zone. The Buffer Zones and the Maintenance Bay remain de-energized. It is still safe to perform work on Crane 2.

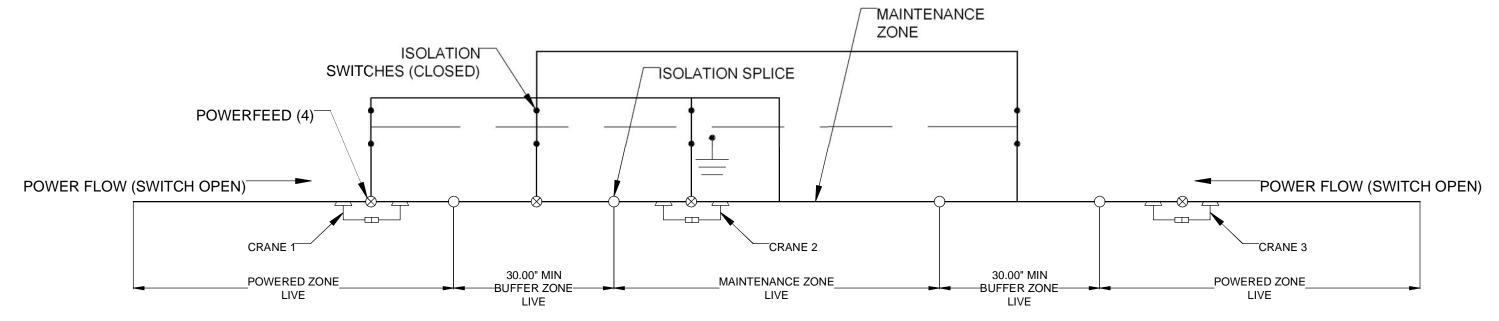
Maintenance on Crane 2 is completed and the disconnect switch is closed. All sections are energized and normal crane operation is restored. The voltage indicator on the disconnect switch enclosure shows the Maintenance Zone to be energized.
