Job Information

Job #:	94425			Date:	June 18, 2018	
Priority:	_	Authorized OT:	No	Authorized by:

Name:	Flakeboard		Reason:	
Contact:		Motor#:		PO#:
Application:	_	Special notes:

Manufacturer:	Reliance	Enclosure :	Open Drop Proof (ODP)
Serial#:		Model#:	2MA460269-G5- KY
Service Factor:		Frame:	444TS
Horsepower/kW:	100	Rated RPM:	1180
Rated Amps:	120	Rated Voltage:	460
Phase:	3	Cycles:	60
Special design:	No

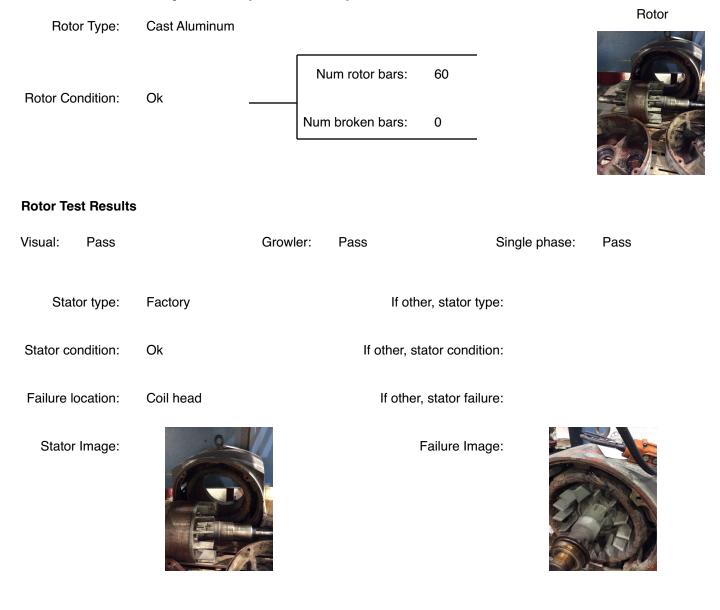
AC Electrical Inspection (Continued)

Winding color: Winding condition		Winding) image Wind	ling Thermal Protection	n: No
Winding Therma Protection DE					
Winding Therma Protection ODE					
Stator test results	Rewind				
Megs incoming: B	ad	Surge incoming:	Bad	Hi-pot incoming:	Bad
Winding Resistance	eIncoming				
Př	nases A to B	Phases B to C	Phases C to	A Resistive	imbalance
Incoming 0	.149	0.120	0.149	19.3	
Leads/jui If other, leads/jui			Lead jumper li	mage. :

Windings failed on coil edge

Found excessive amounts of dirt and debris in windings. Also found water inside end bell housing.
