Job Information

Job #:	96485				Date:	January 27, 2020
Priority:	_	Authorized OT:	No	Authorized by:

Manufacturer:	BARTEC	Enclosure :	Totally Enclosed Fan Cooled	Enclosure Type image
Serial#:	200941670	Model#:	3KTC180M-2	
Service Factor:		Frame:	180M	
Horsepower/kW:	26KW	Rated RPM:	3525	
Rated Amps:		Rated Voltage:	480	
Phase:	3	Cycles:	60	
Special design:	No

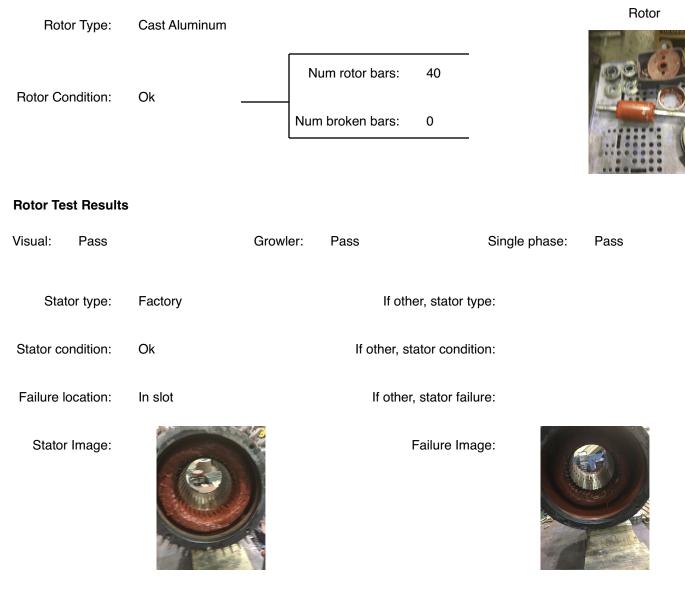
AC Electrical Inspection (Continued)

Winding color:	Like new	Winding	g image N	Winding Thermal P	Protection: Yes
Winding condition :	Solid				T-1-C WINCING ANALYZEI Discussion
Winding Thermal Protection DE:					
Winding Thermal Protection ODE:		7.	reitt		
Stator test results:	Salvageable				
Megs incoming:	Good	Surge incoming:	Good	Hi-pot inco	ming: Good
Winding Resistance	Incoming				
Ph	ases A to B	Phases B to C	Phases	C to A R	Resistive imbalance
Incoming 0.	00	0.00	0.00	(0.00
Leads/jun	npers: Ok		Lead j	umper Image. :	605
If other, leads/jumpers:					
Mechanical In	spection				
Inspect bolt holes and	d fasteners. Validat	te correct fasteners.
